Hayden Pass Fire July 2016

Date of Report: August 1, 2016

BURNED-AREA REPORT
(Reference FSH 2509.13)**PART I - TYPE OF REQUEST****A. Type of Report**

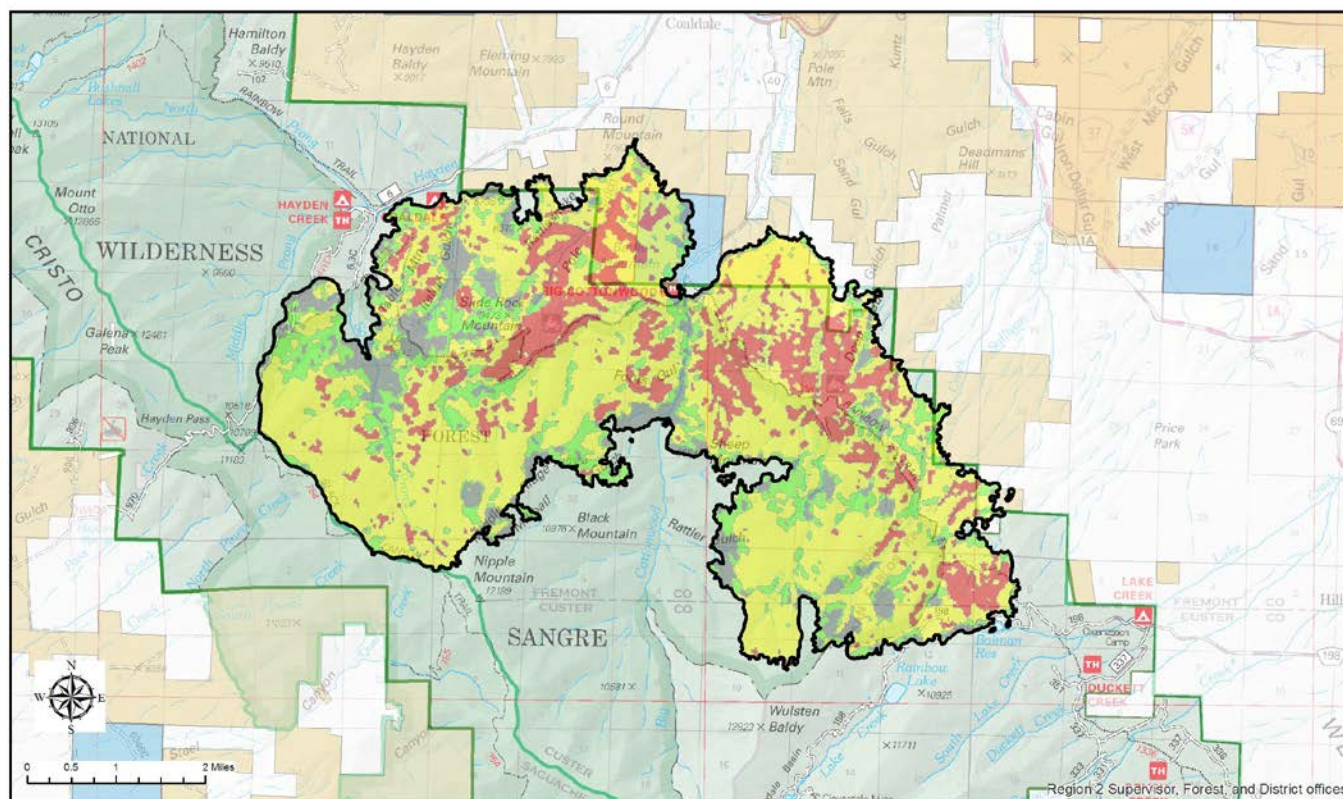
Figure 1: Soil Burn Severity Map.

Severity	Acres Burned	Percent
High	2974	18%
Moderate	9240	56%
Low	2613	16%
Unburned	1693	10%

2016 HAYDEN PASS FIRE
SOIL BURN SEVERITY
BURNED AREA EMERGENCY RESPONSE (BAER)

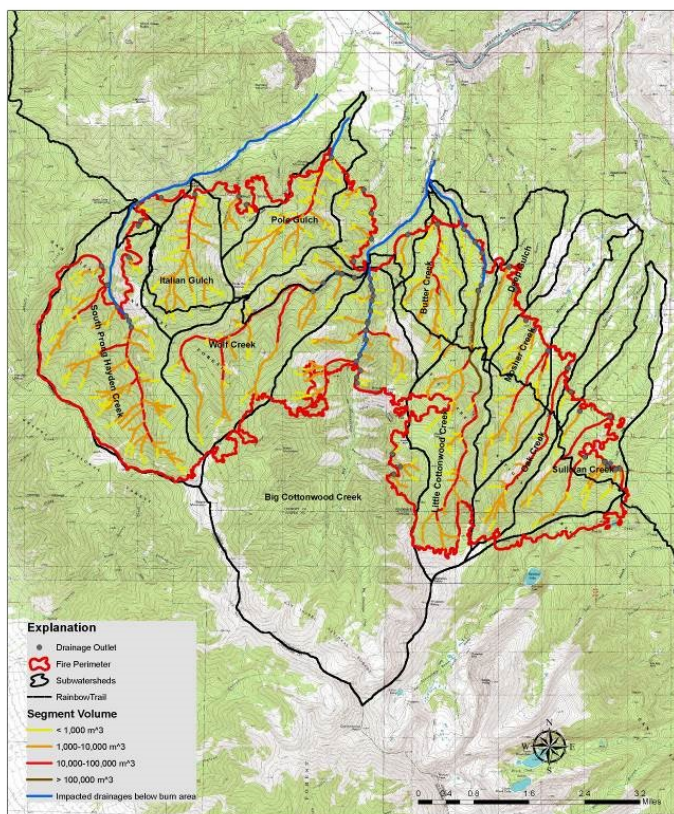
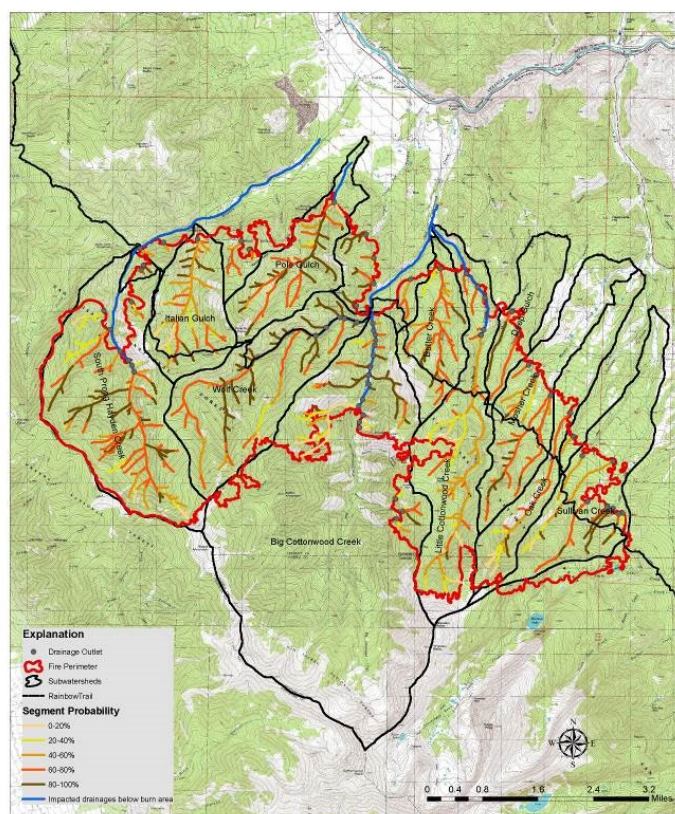
Figure 2: Landslide Assessment Maps showing predicted volume of debris flow, and likelihood of debris flow by channel

Throughout the burned area, the combined hazard ratings for debris-flow in first order tributaries to the main stem stream channels are moderate to high. At the fire perimeter exiting the burned area, the hazard ratings are high for all main stem channels, except the Italian Gulch and Deep Gulch channels which have moderate hazard ratings. At the burned area perimeter, volumes are predicted to be >100,000m³ for Little Cottonwood Creek. Volumes in the range of 10,000 to 100,000m³ are predicted for Oak Creek, Mosher Creek, Sullivan Creek, Butter Creek, Big Cottonwood Creek, Wolf Creek, Pole Gulch, Italian Gulch and South Prong Hayden Creek.

Volume of debris flow by stream channel (m^3), Likelihood of debris flow by stream channel (%). Preliminary debris flow hazard for a design storm with a 15 minute rainfall intensity of 24 millimeters per hour (mm/h).
