# Hayden Pass Fire – Big Cottonwood Drainage Recovery Plan | 2018

## *Hazard Characterization Report*

Arkansas River Watershed Collaborative

River Science

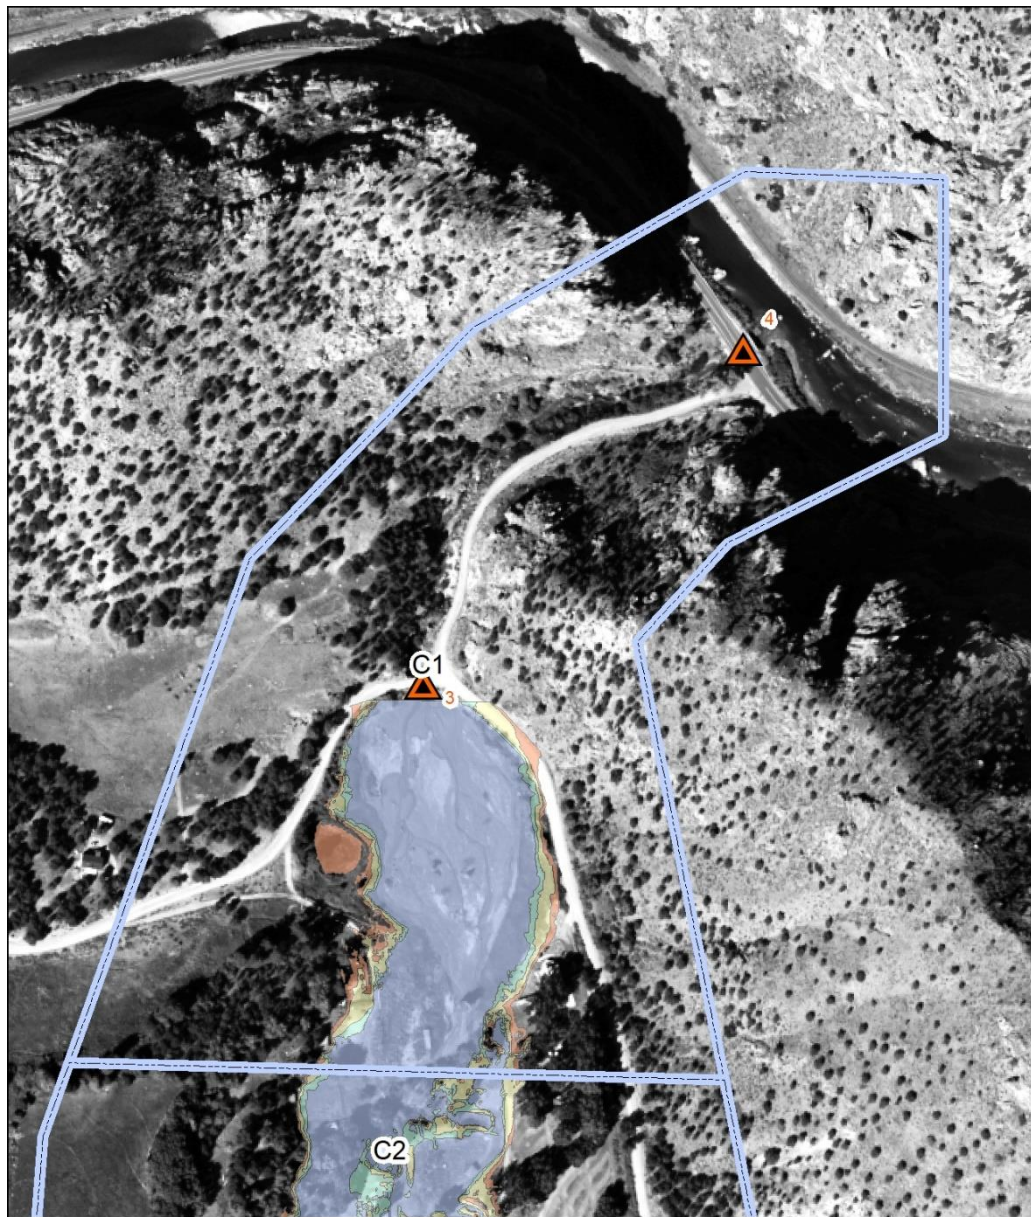
Figure 2: Hazard identification and prioritization for Reach C1 of Big Cottonwood Creek.

Id:	Description	Rank (1= high, 3 =low)
<b>Danger</b>		
3	Road overtopping. Potential to strand 5 landowners if CR39 is damaged.	2
4	Potential for clogging and overtopping. Several large boulders have come down during July 2018 flood. These cause concern for flow passage near bridge.	2

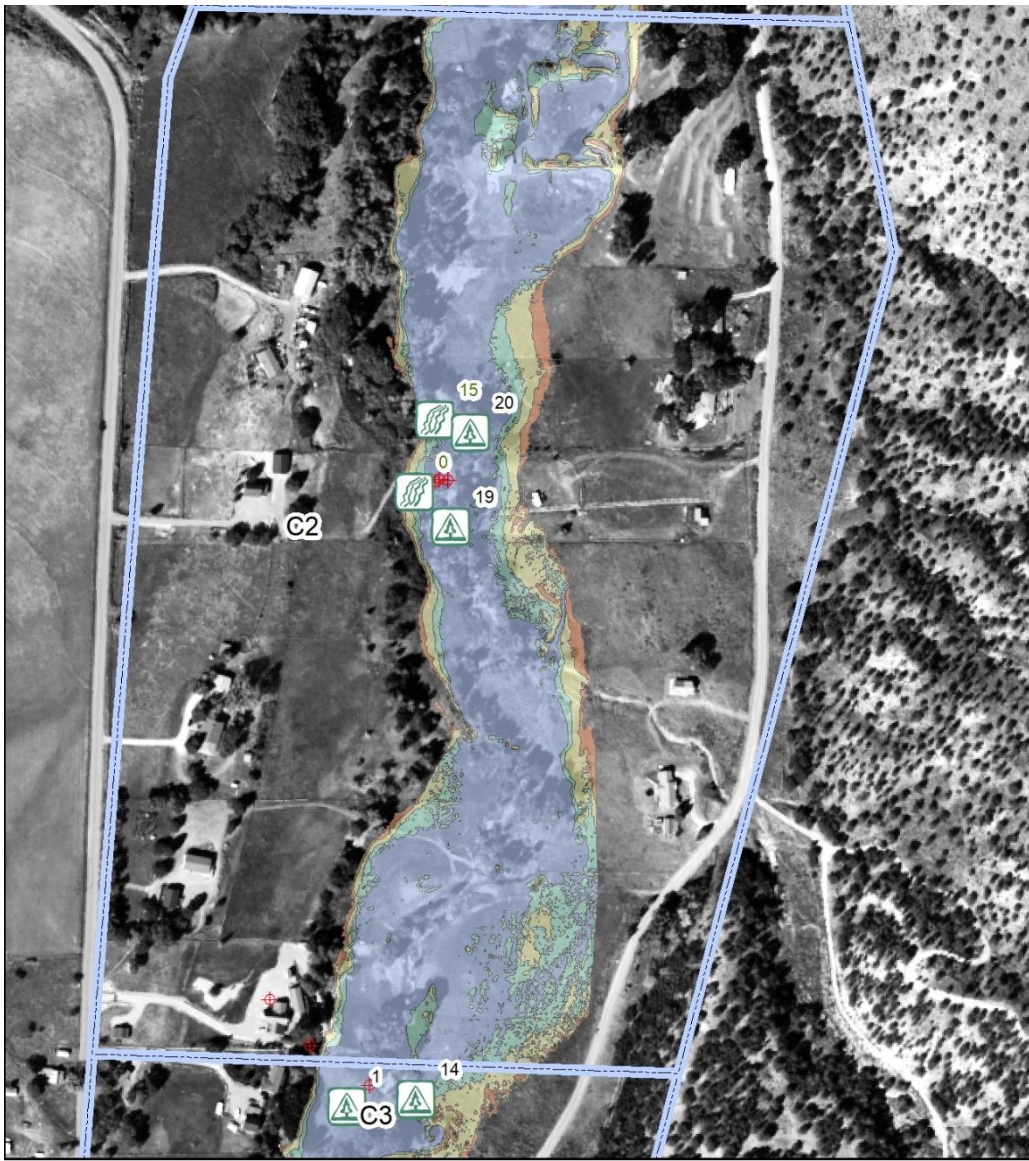
Figure 3: Hazard identification and prioritization for Reach C2 of Big Cottonwood Creek.

Id:	Description	Rank (1= high, 3 =low)
<b>Danger</b>		
19	Channel Spanning tree	2
20	Small to medium debris jam.	2
<b>Channel Issues</b>		
0	High bank erosion	3
15	Channel incision	3

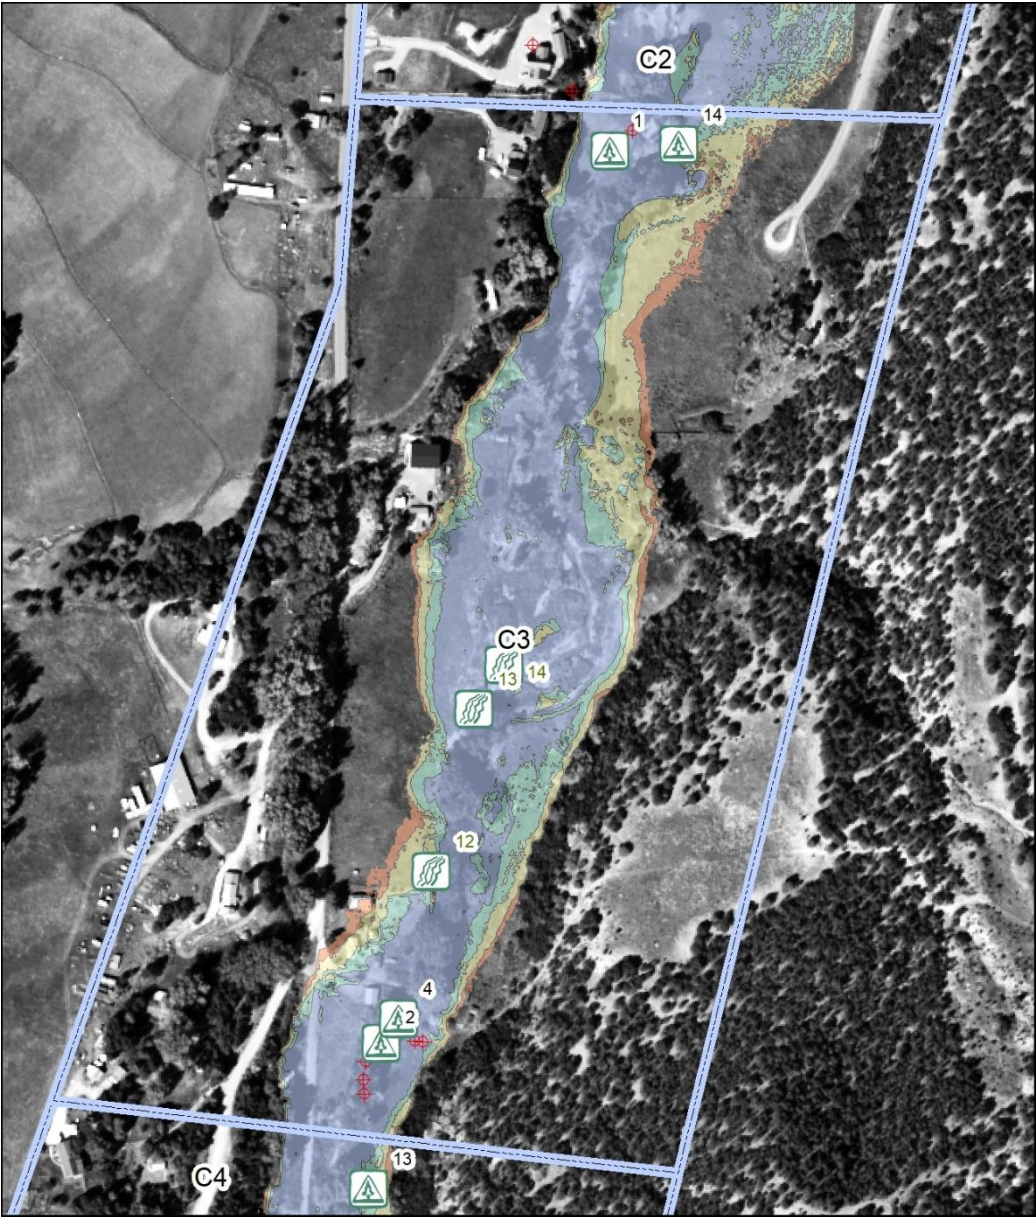
Figure 4: Hazard identification and prioritization for Reach C3 of Big Cottonwood Creek.

Id:		Description	Rank (1= high, 3 =low)
Debris			
1		Very large tree. Owners want it gone. Neighbor afraid of it coming down on his property in next flood	3
2		Fallen/deposited tree spanning the creek with debris piling up. Removal of the left bank material so that it continues to act like a trash rack.	1
4		Owner wants to keep this tree and debris jam since they feel it protects their house downstream.	0
14		Juniper fallen in the creek. Possibly large enough to get caught in HWY 50 bridge	1
Channel			
12		Channel incision	3
13		Channel incision	3
14		Channel incision	3

- Debris id: 1, 14 (Figure 4)
- Debris id: 21, 22, 23 (Figure 5)
- Debris id: 10 and 11 (Figure 7)

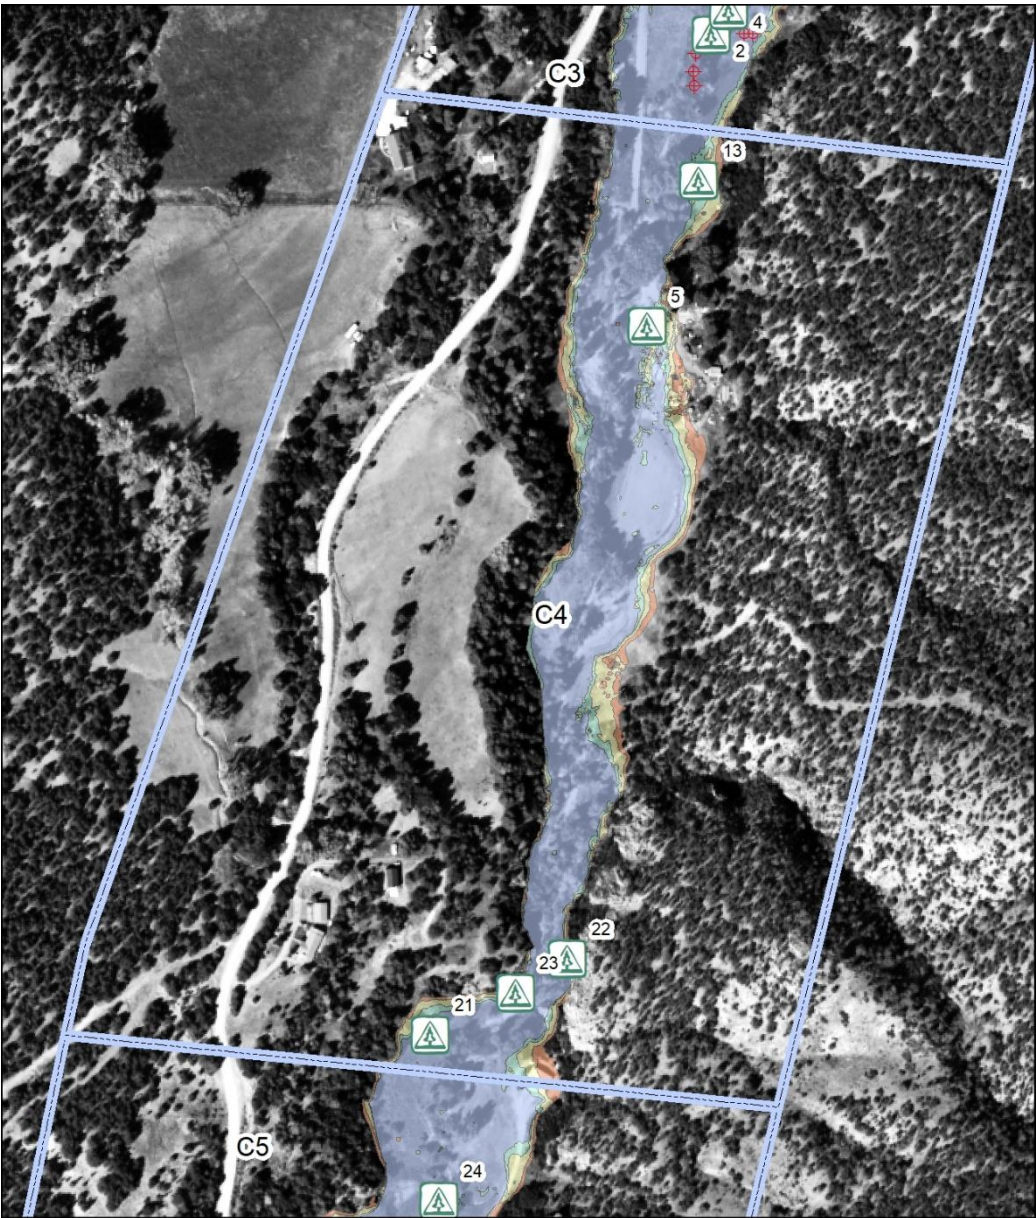
Figure 5: Hazard identification and prioritization for Reach C4 of Big Cottonwood Creek.

Id:	Description	Rank (1= high, 3 =low)
Debris		
5	Debris pile may still exist.	2
13	Some smaller debris piled in trees	3
21	Large debris deposits - likely to be re-mobilized and clog downstream bridges.	2
22	2 trees down and spanning the creek. Potential to cause debris dams.	1
23	Moderate debris jam in standing trees.	1

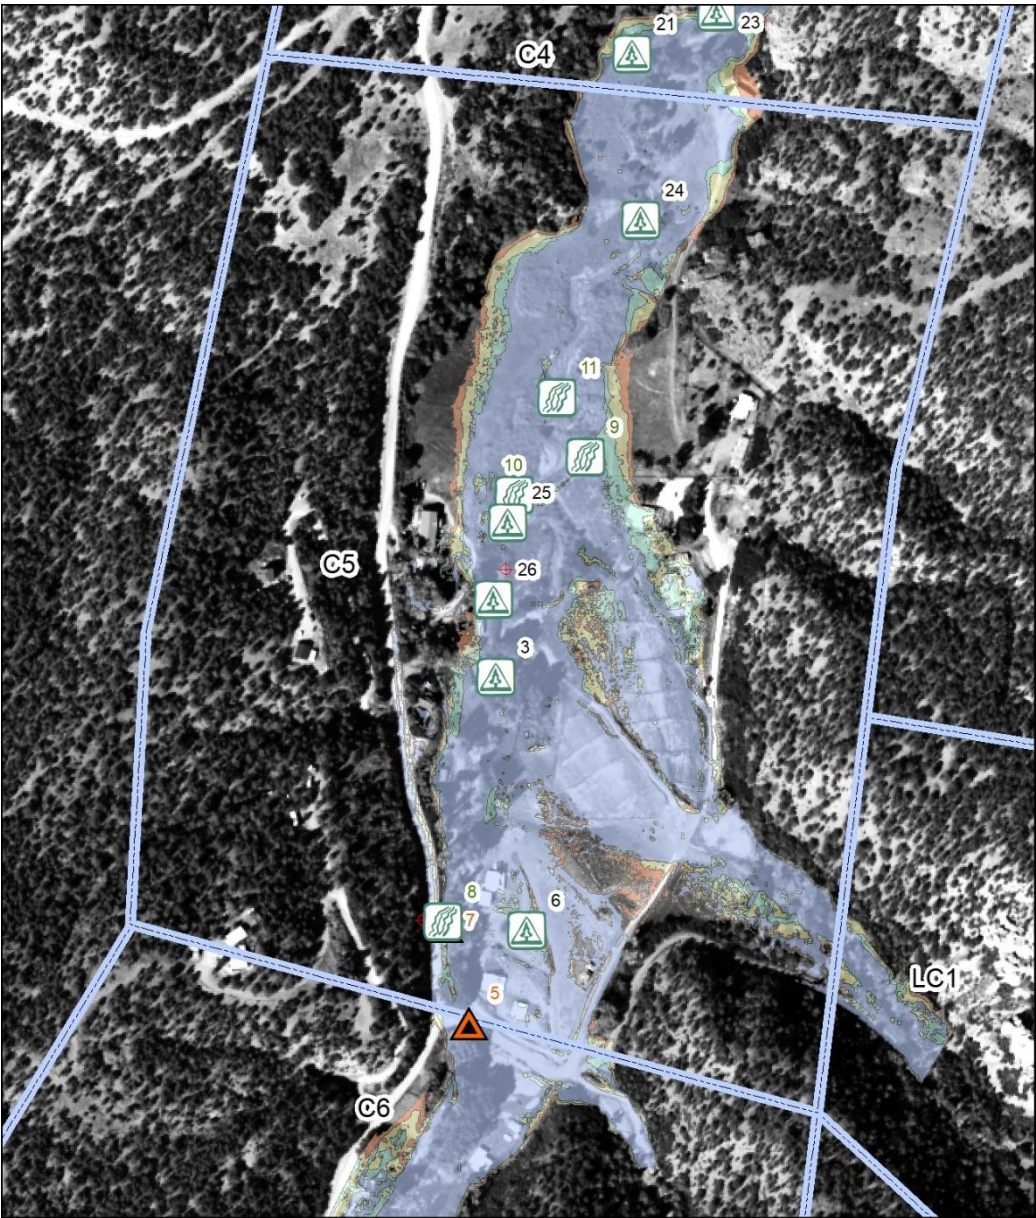
Figure 6: Hazard identification and prioritization for Reach C5 of Big Cottonwood Creek.

Id:	Description	Rank (1= high, 3 =low)
Danger		
7	Road erosion potential	1
Debris		
3	Large debris jam in tree	2
6	Debris pile may still exist.	2
24	Debris pile	2
25	Several smaller piles of deposited debris around this property that could be remobilized	3
26	Several smaller piles of deposited debris around this property that could be remobilized	3
Channel Issues		
8	Channel incision	3
9	Channel incision	3
10	Channel incision	3
11	Channel incision	3

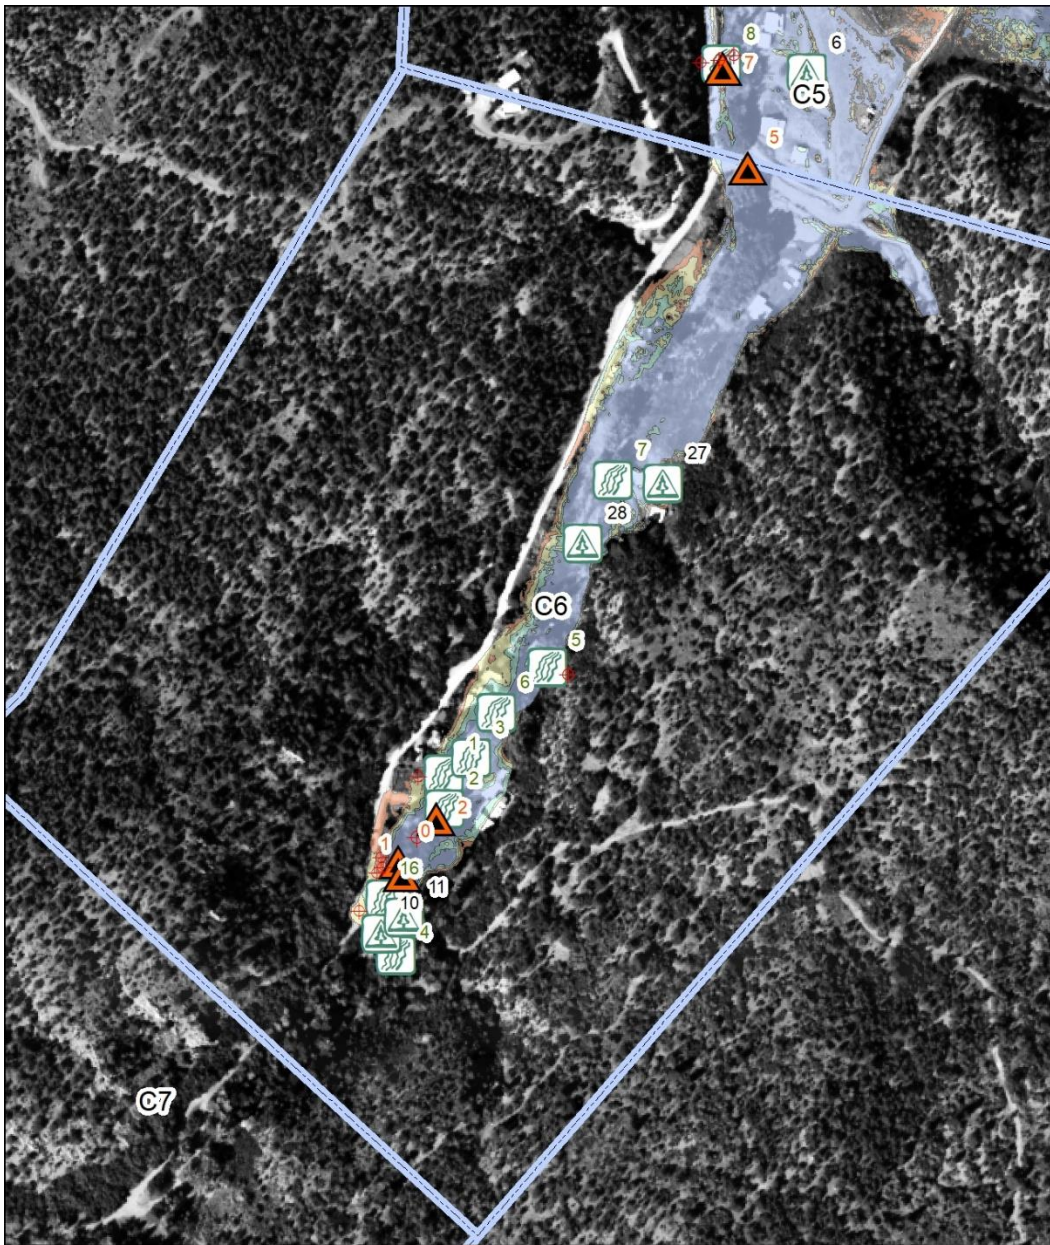
Figure 7: Hazard identification and prioritization for Reach C6 of Big Cottonwood Creek.

<b>Id:</b>	<b>Description</b>	<b>Rank (1= high, 3 =low)</b>
<b>Danger</b>		
0	Bridge is not secure and its foundation is eroded.	1
1	Trees being undermined by bank erosion. Too close to houses to allow to fall in during an event.	1
2	Tree being undermined and it is likely to fall in creek near houses	1
5	Overtopping and potential failure in large events with debris flow.	1
<b>Debris</b>		
10	Small wood jam, but directly upstream of houses	1
11	Moderate amounts of wood to be cleared since it is upstream of houses	1
27	2 large piles of debris at fringe	2
28	Two small debris jams.	2
<b>Channel Issues</b>		
1	Channel incision / flow close to Bill Woods house. Bill banks to be graded. High priority, but may have too much liability?	3
2	Head cut	3
3	Channel incision	3
4	start of head cut	3
5	Channel incision / bank erosion	3
6	High priority, but expensive engineering solution. Danger to house. Narrow stream between hill and house. High priority, but an expensive engineering solution needed.	1

7	Channel incision	3
16	Channel incision	3

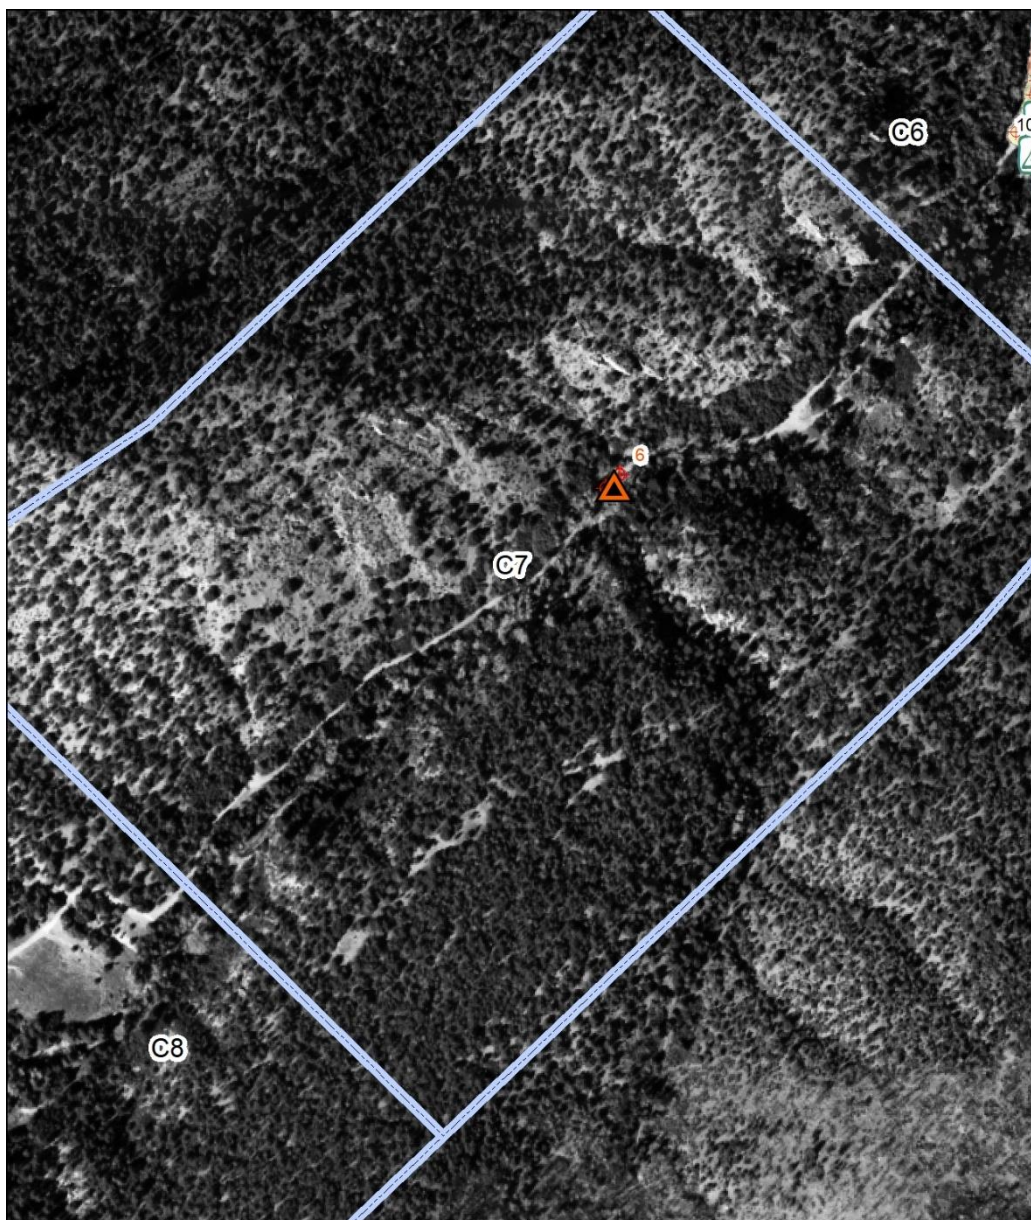
Figure 8: Hazard identification and prioritization for Reach C7 of Big Cottonwood Creek.

Id:	Description	Rank (1= high, 3 =low)
<b>Danger</b>		
6	USFS/BLM/State road being eroded. Also a few trees near here are already falling and others being undermined	3

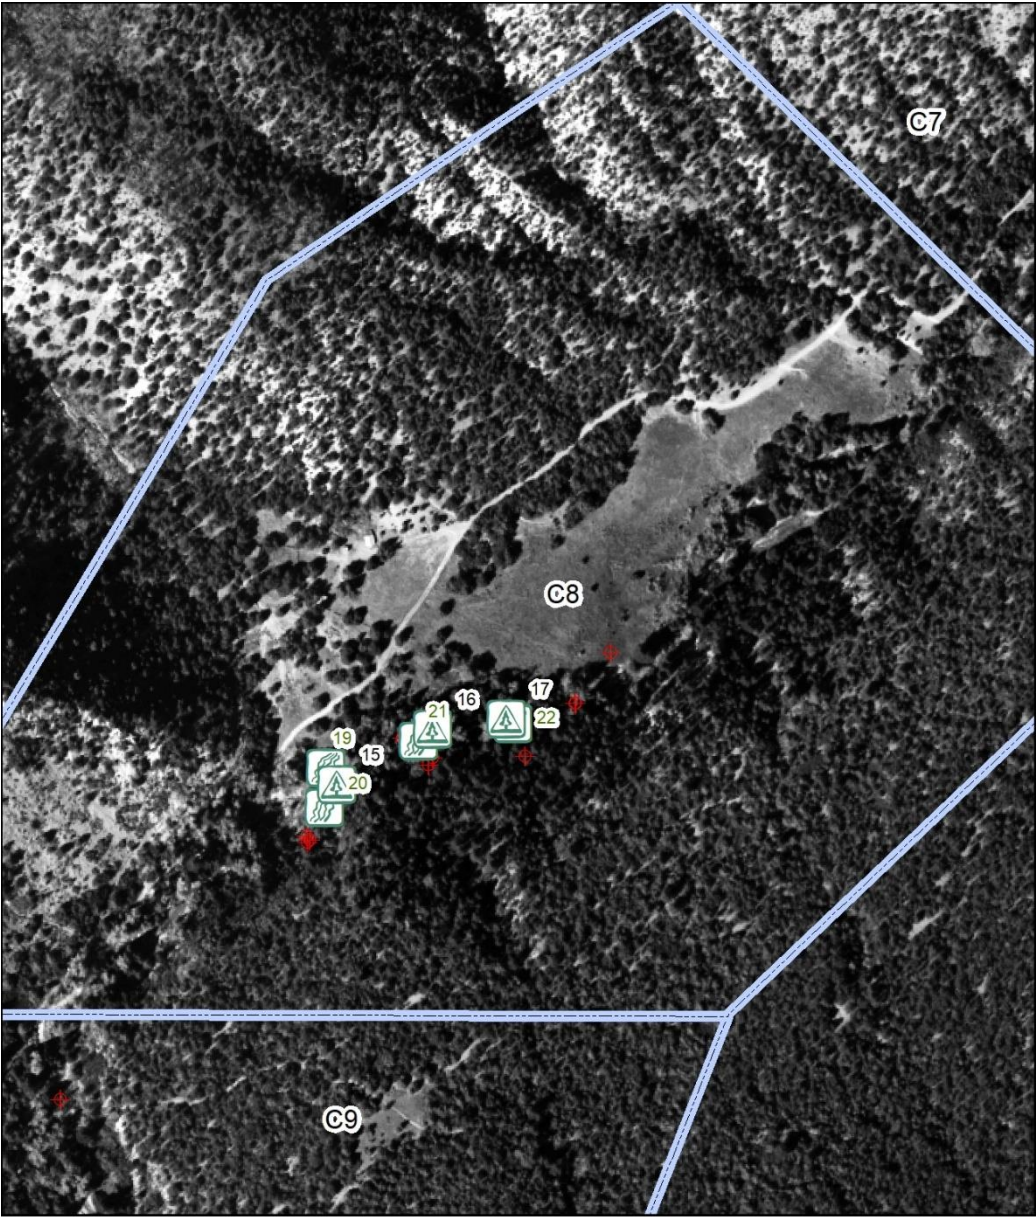
Figure 9: Hazard identification and prioritization for Reach C8 of Big Cottonwood Creek.

Id:	Description	Rank (1= high, 3 =low)
Debris		
15	Several fallen trees - on state land	2
16	Several fallen trees - on state land or USFS	2
17	Several fallen trees - on state land	2
Channel Issues		
19	Deep incision. Head cut was here, but moved upstream	3
20	Deep incision	3
21	Deep incision	3
22	Deep incision	3

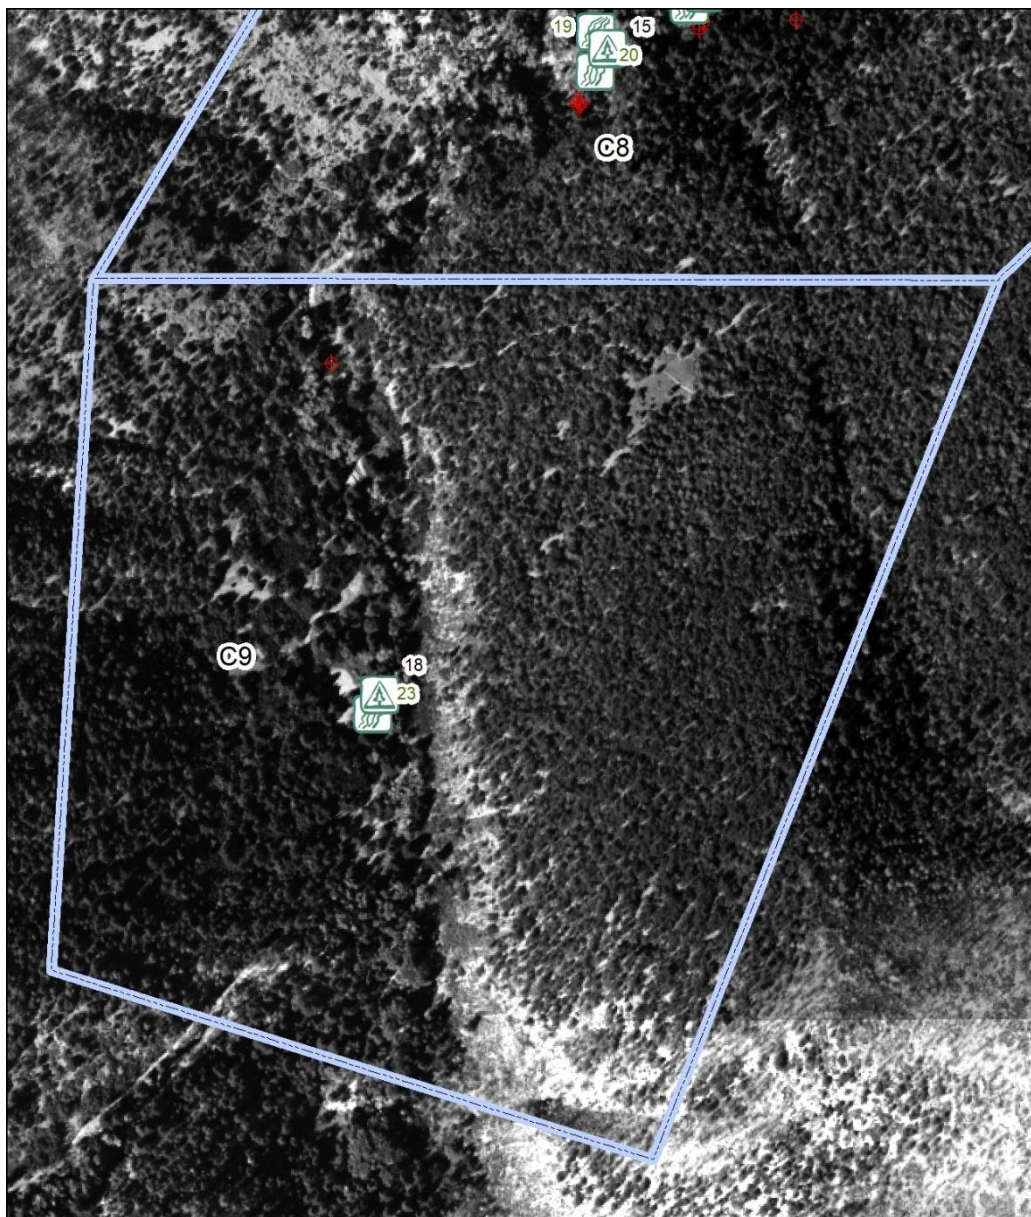
Figure 10: Hazard identification and prioritization for Reach C9 of Big Cottonwood Creek.

Id:	Description	Rank (1= high, 3 =low)
<b>Debris</b>		
18	Several trees about to fall in - USFS land	2
<b>Channel Issues</b>		
23	Deep incision on USFS land	3

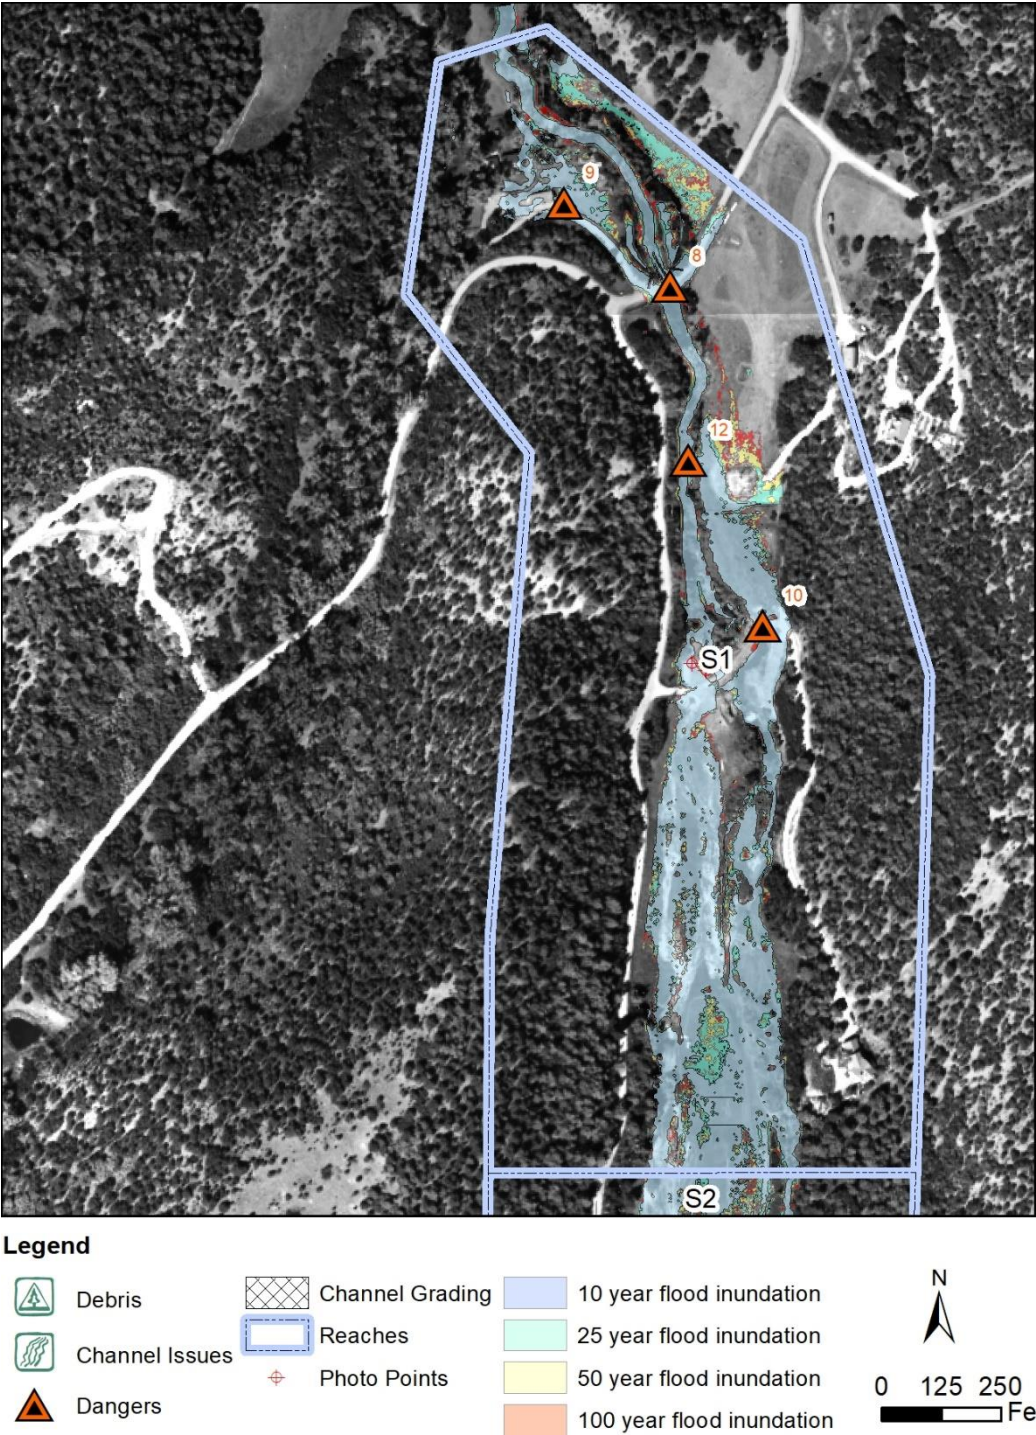
Figure 13: Hazard identification and prioritization for Reach S1 of Sullivan Creek.

Id:	Description	Rank (1= high, 3 =low)
Danger		
8	Road will easily overtop due to small culvert and low road elevation. Downstream side has large elevation drop, likely leading to a head cut and eroding the road. This is only exit for 5 landowners.	1
9	Small inundation near house during flood events. Flow goes down his driveway and may trap him.	3
10	Overtopping area during floods. This is just dirt, so highly likelihood of being eroded. This is only exit for 1 landowner and could cause him being trapped.	2
12	CR has steep banks to the creek. Overland flow leaving the upstream detention pond re-enters the creek here at an angle that may cause bank erosion. This area is heavily vegetated, so may not be a problem.	3

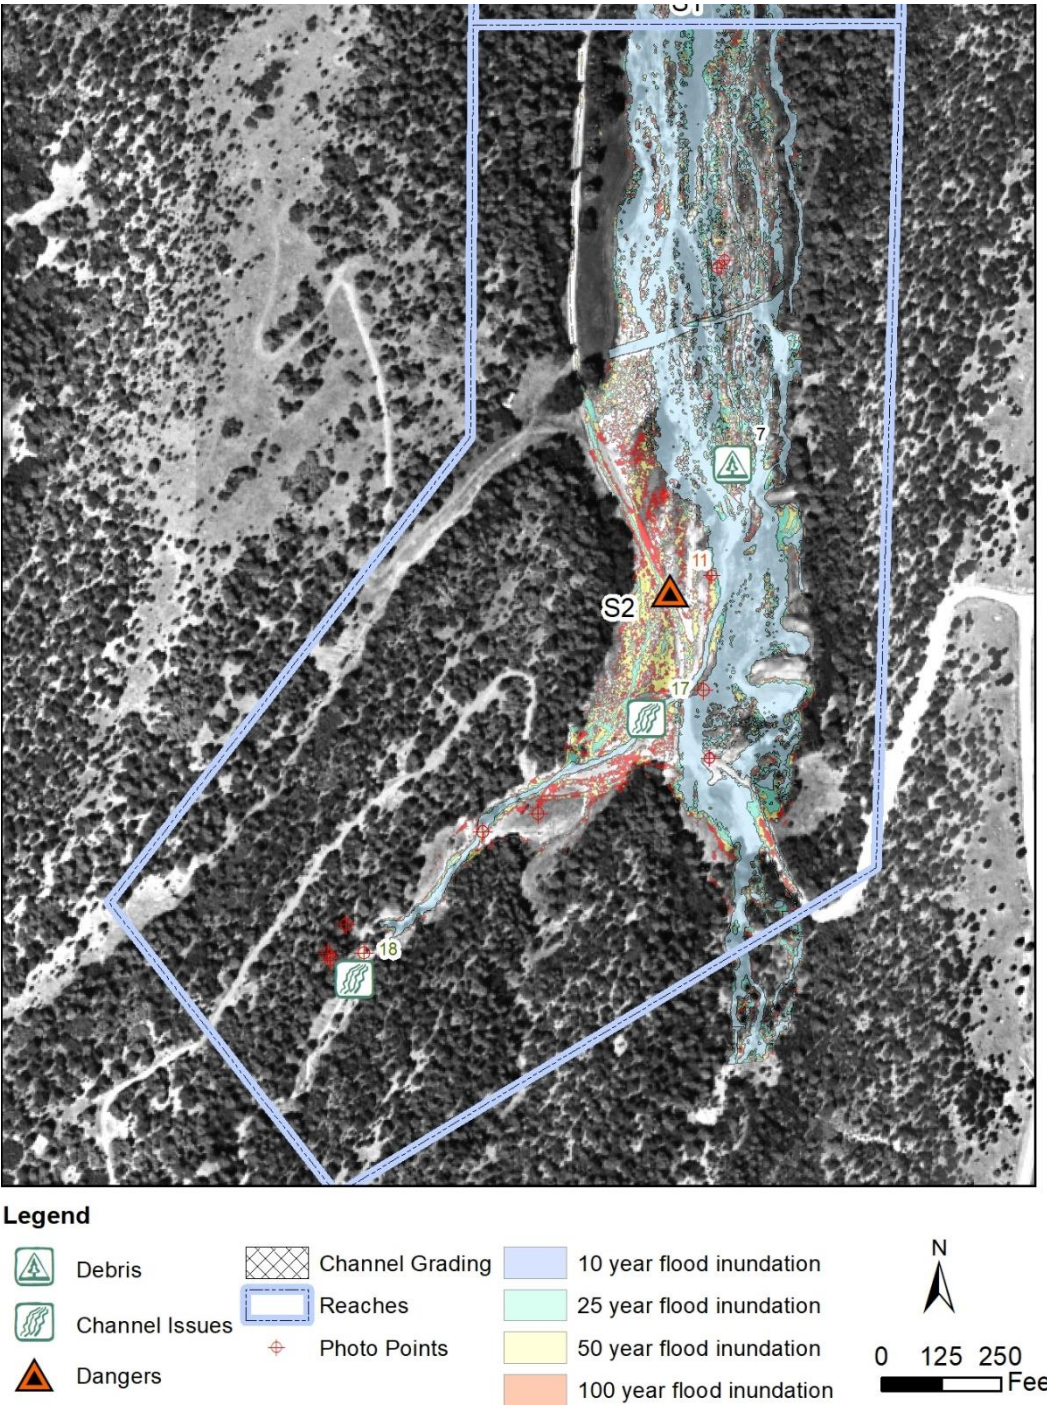
Figure 14: Hazard identification and prioritization for Reach S2 of Sullivan Creek.

Id:	Description	Rank (1= high, 3 =low)
Danger		
11	Road eroded. Cut power line.	3
Debris		
6	Debris pile may still exist.	2
Channel Issue		
17	Channel incision	3
18	Start of headcut	3

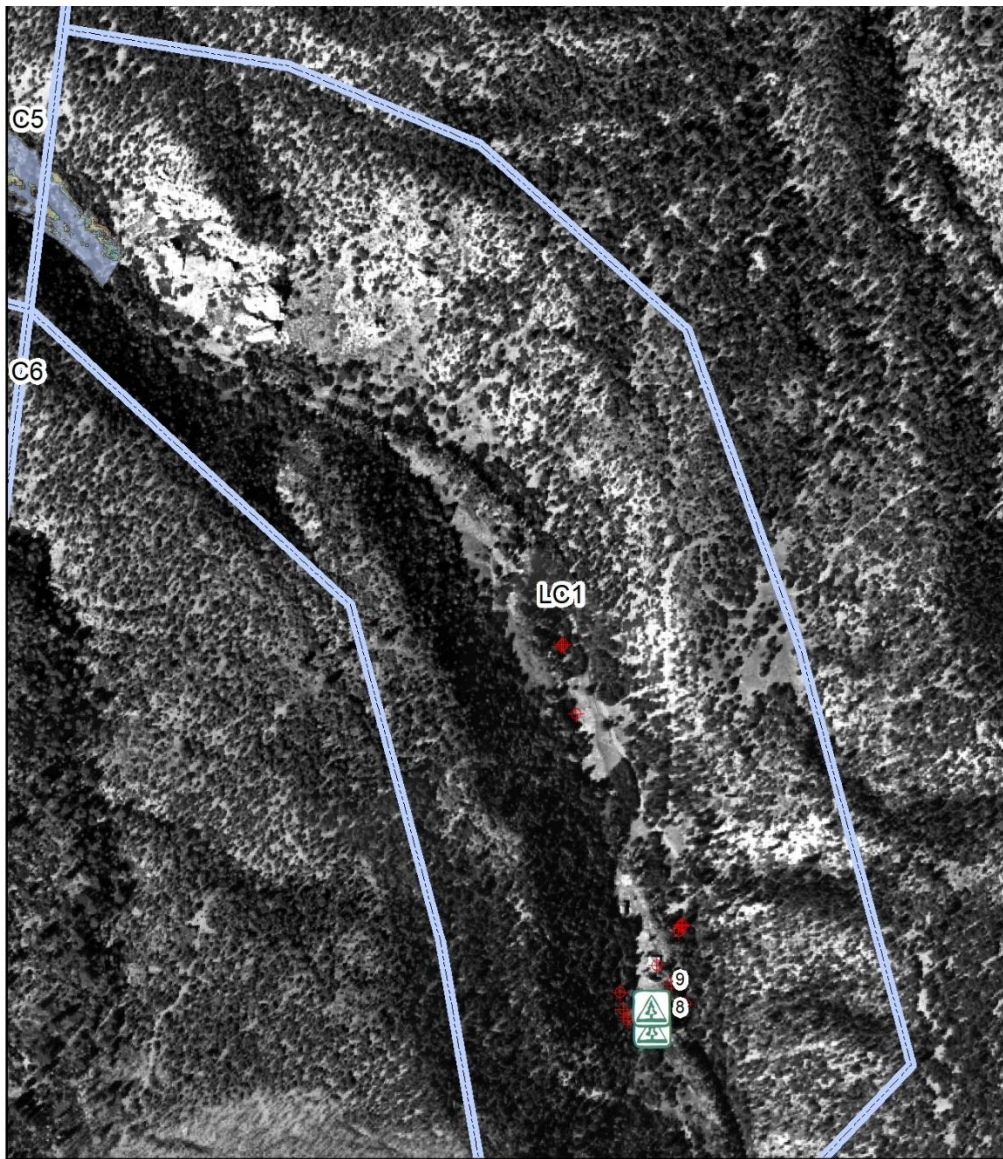
Figure 15: Hazard identification and prioritization for Reach LC1 of Little Cottonwood Creek. Note, landowners are not participating in any work with the Hayden Pass Fire and Flood Recovery Coalition, but we include this as information to be considered in the future.

Id:	Description	Rank (1= high, 3 =low)
<b>Debris</b>		
8	Large amounts of wood jam around trees.	2
9	Large amounts of wood jam around trees.	2

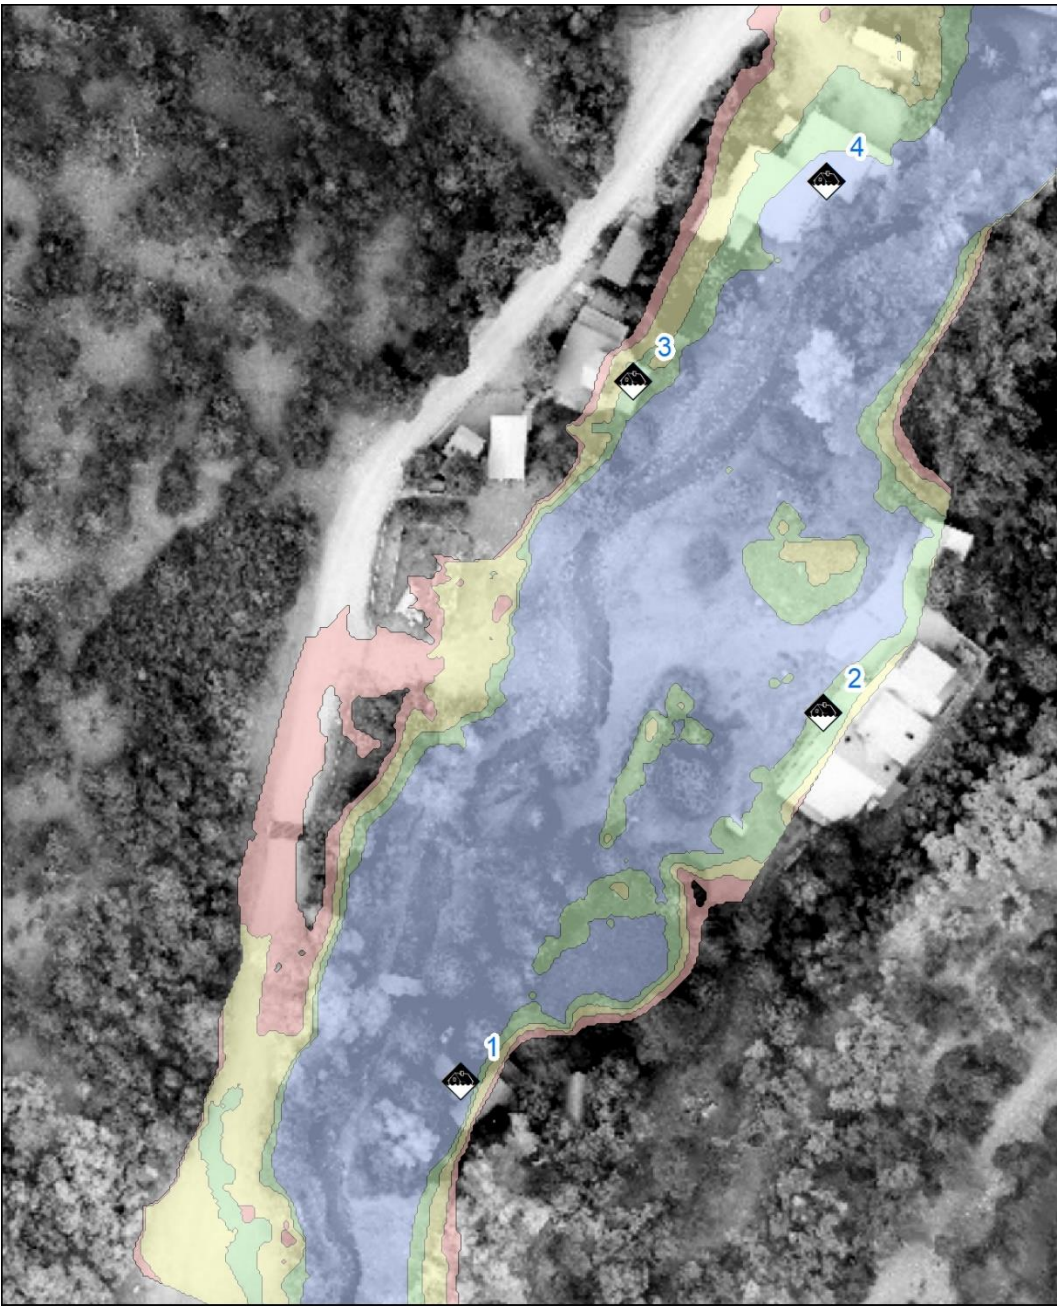
Figure 16: Identified properties that are at high and moderate risk for future flooding under 10, 25, 50, and 100-year flood events.

ID	Flood Risk	Description (Associated depths and velocities of the 10-, 25-, 50-, and 100-year floods, respectively)	Address
1	High	Depths: 1.8, 2.4, 3.9, and 5 ft; Velocity: 8, 13, 20, and 23 ft/s.	2192 CR 40
2	Moderate	Depths: 0, 1, 2.8, and 3.9 ft; Velocity: 0, 2.9, 3.2, and 4 ft/s.	2190 CR 40
3	Moderate	Depths: 0, 0.7, 1.8, and 2.3 ft; Velocity: 0, .2, 0.8, and 1.3 ft/s.	2118 CR 40
4	High	Depths: 3.6, 6.0, 9.8, and 12 ft; Velocity: 0, 0.3, 9, and 12 ft/s.	2110 CR 40

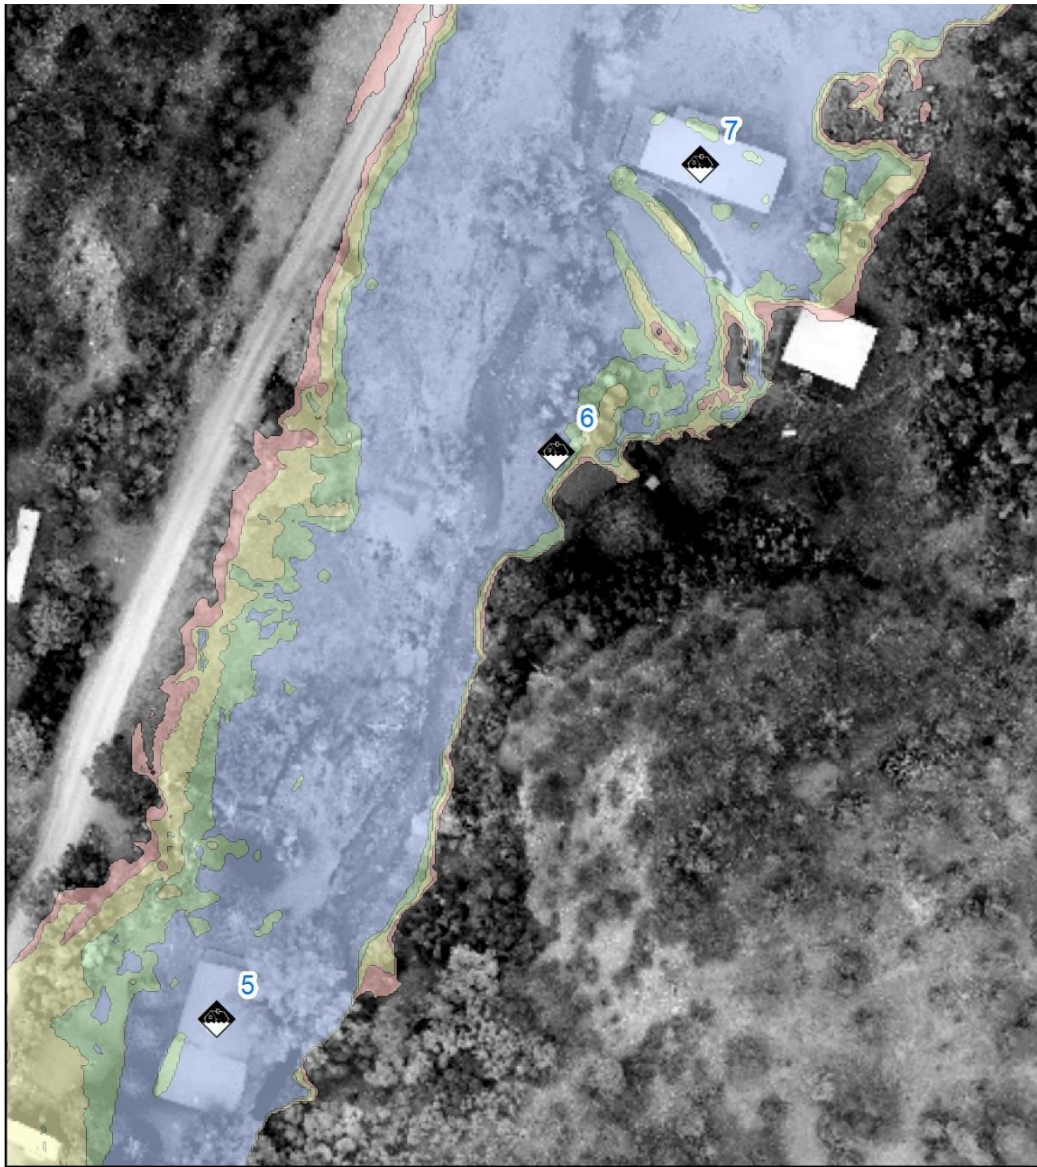
Figure 17: Identified properties that are at high and moderate risk for future flooding under 10, 25, 50, and 100-year flood events.

ID	Flood Risk	Description (Associated depths and velocities of the 10-, 25-, 50-, and 100-year floods, respectively)	Address
5	High	Depths: 2.0, 3.6, 6.5, and 8.4 ft; Velocity: 16, 20, 23 and 25 ft/s.	2054 CR 40
6	Moderate	Depths: 0, 0, 0, and 0.3 ft; Velocity: 0, 0, 0, and 7 ft/s.	2022 CR 40
7	High	Depths: 0, 0.5, 1.7, and 2.4 ft; Velocity: 0, 9, 15, and 20 ft/s.	2020 CR 40

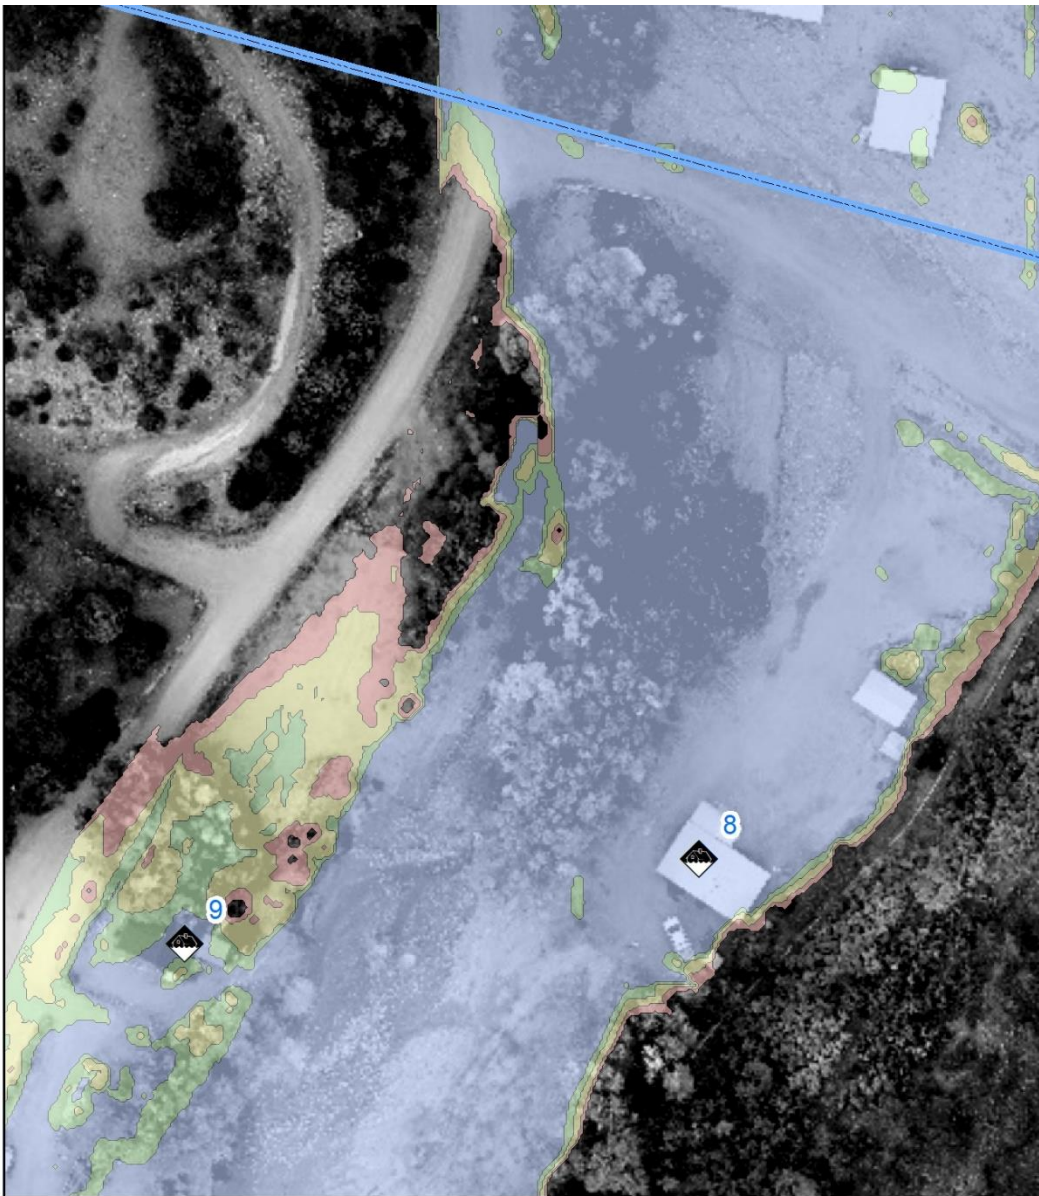
Figure 18: Identified properties that are at high and moderate risk for future flooding under 10, 25, 50, and 100-year flood events.

ID	Flood Risk	Description (Associated depths and velocities of the 10-, 25-, 50-, and 100-year floods, respectively)	Address
8	High	Depths: 1.4, 2.0, 3.2, and 4.2 ft; Velocity: 8, 12, 16 and 18 ft/s.	34 Dinkle Ditch
9	Moderate	Depths: 0, 0.2, 1.2, and 1.8 ft; Velocity: 0, 4, 8, and 11 ft/s.	1918 CR 40

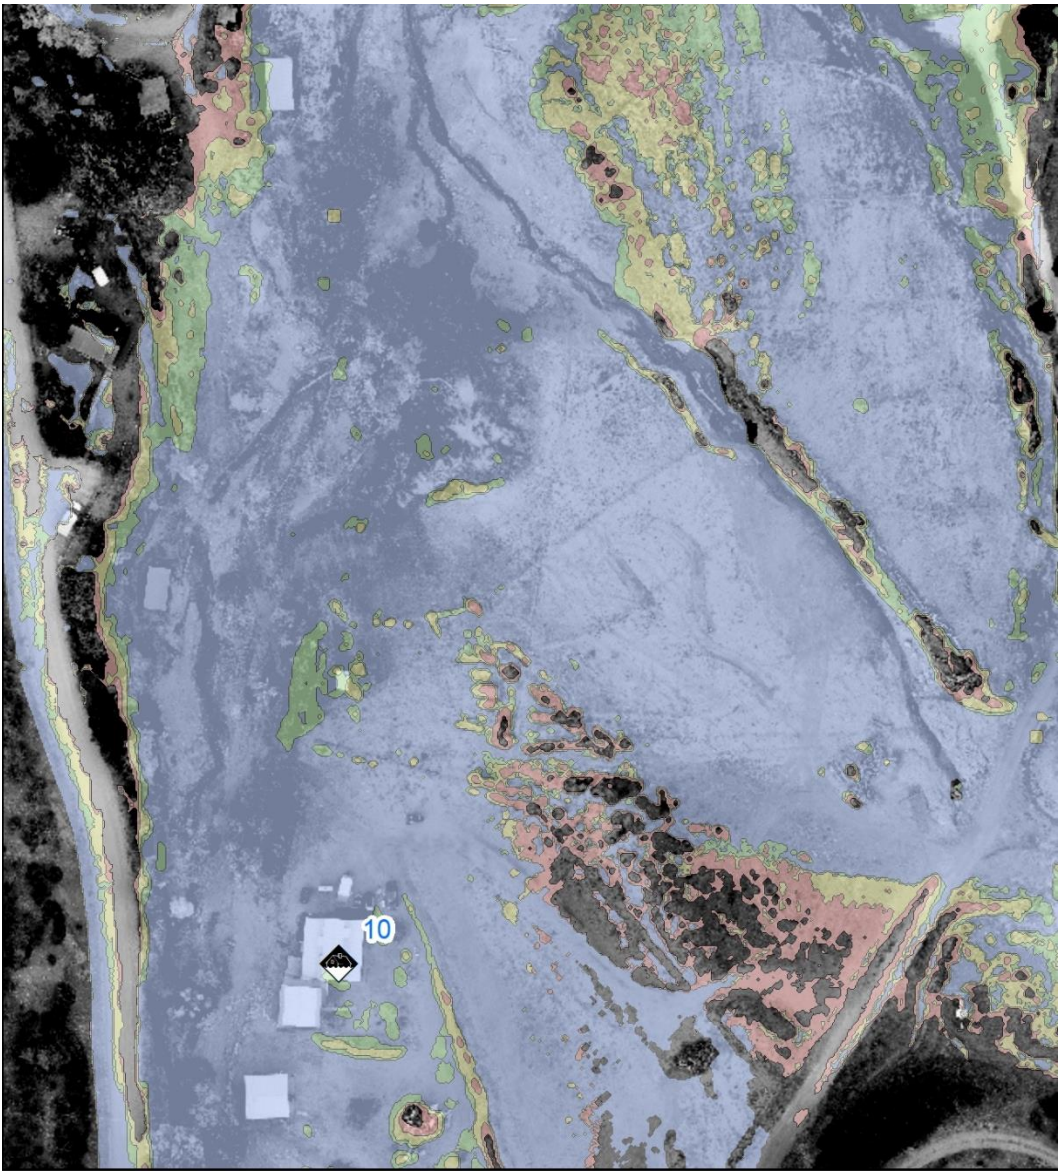
Figure 19: Identified properties that are at high and moderate risk for future flooding under 10, 25, 50, and 100 - year flood events.

ID	Flood Risk	Description (Associated depths and velocities of the 10-, 25-, 50-, and 100-year floods, respectively)	Address
10	High	Depths: 0.4, 1.2, 2.4, and 3.2 ft; Velocity: 4, 9, 15 and 19 ft/s.	47 Dinkle Ditch
11	Moderate	Depths: 0, 0.1, 0.5, and 0.8 ft; Velocity: 0, 2, 5, and 7 ft/s.	309 Dinkle Ditch
