# Hayden Pass Fire – Big Cottonwood Drainage Recovery Plan | 2018

## *Hazard Characterization Report*

Arkansas River Watershed Collaborative

River Science

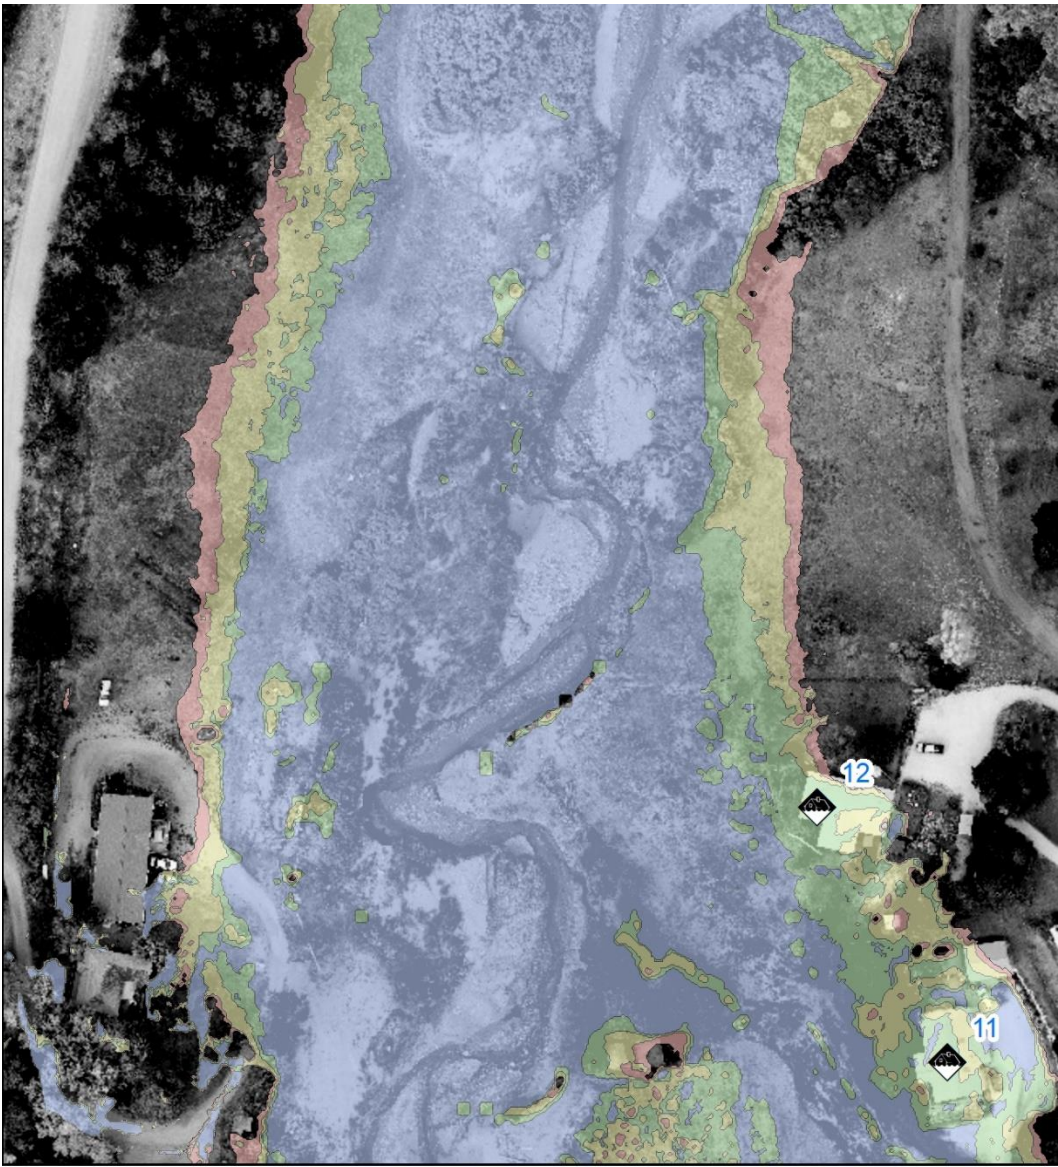
Figure 20: Identified properties that are at high and moderate risk for future flooding under 10, 25, 50, and 100-year flood events.

ID	Flood Risk	Description (Associated depths and velocities of the 10-, 25-, 50-, and 100-year floods, respectively)	Address
11	Moderate	Depths: 0, 0.1, 0.5, and 0.8 ft; Velocity: 0, 2, 5, and 7 ft/s.	309 Dinkle Ditch
12	Moderate	Depths: 0, 0.1, 0.8, and 1.2 ft; Velocity: 0, 3, 8 and 10 ft/s.	311 Dinkle Ditch

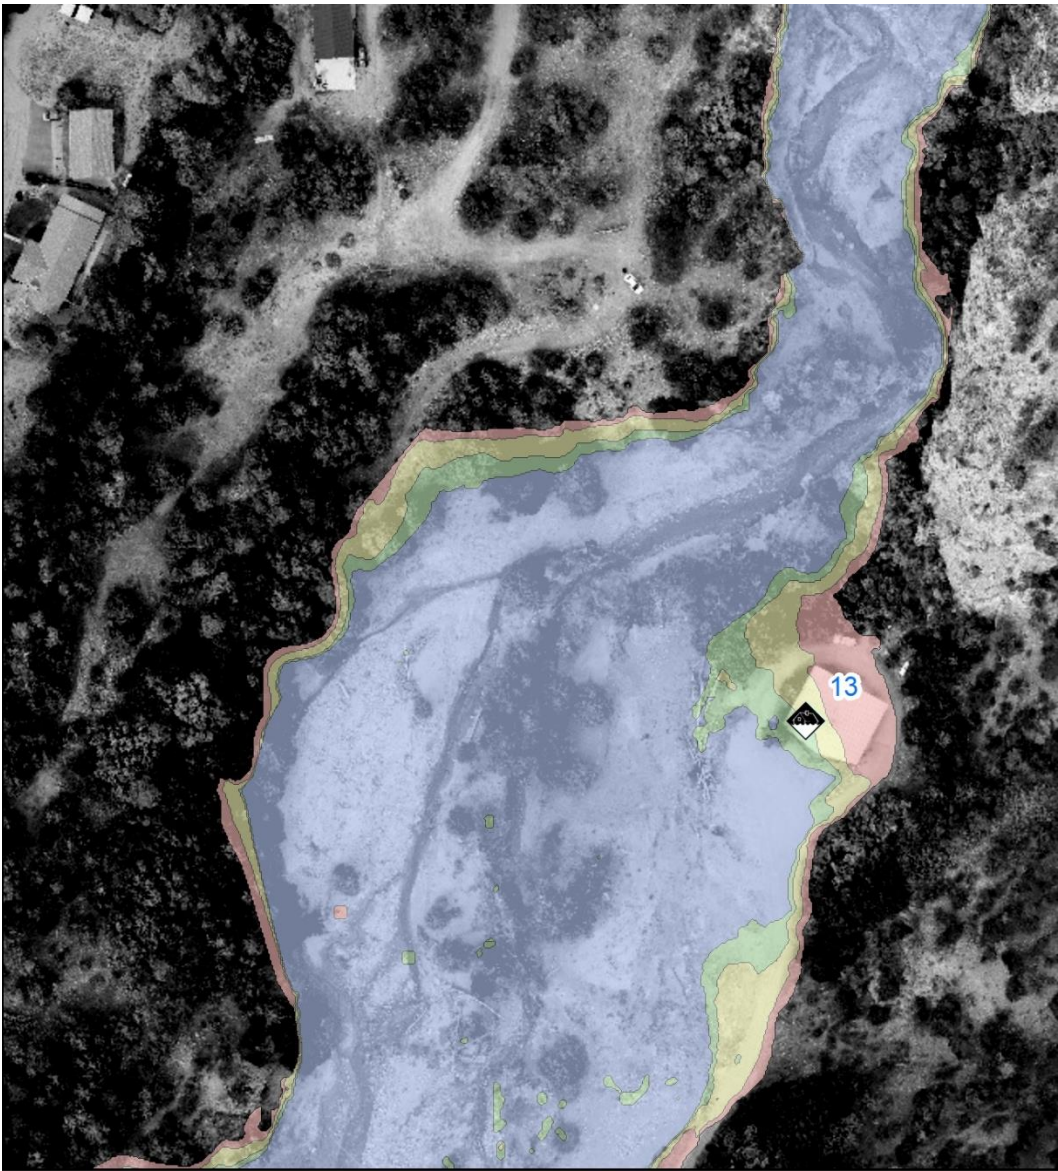
Figure 21: Identified properties that are at high and moderate risk for future flooding under 10, 25, 50, and 100-year flood events.

ID	Flood Risk	Description (Associated depths and velocities of the 10-, 25-, 50-, and 100-year floods, respectively)	Address
13	Moderate	Depths: 0, 1, 4.5, and 8 ft; Velocity: 0, 1.5, 5 and 7 ft/s.	403 Dinkle Ditch

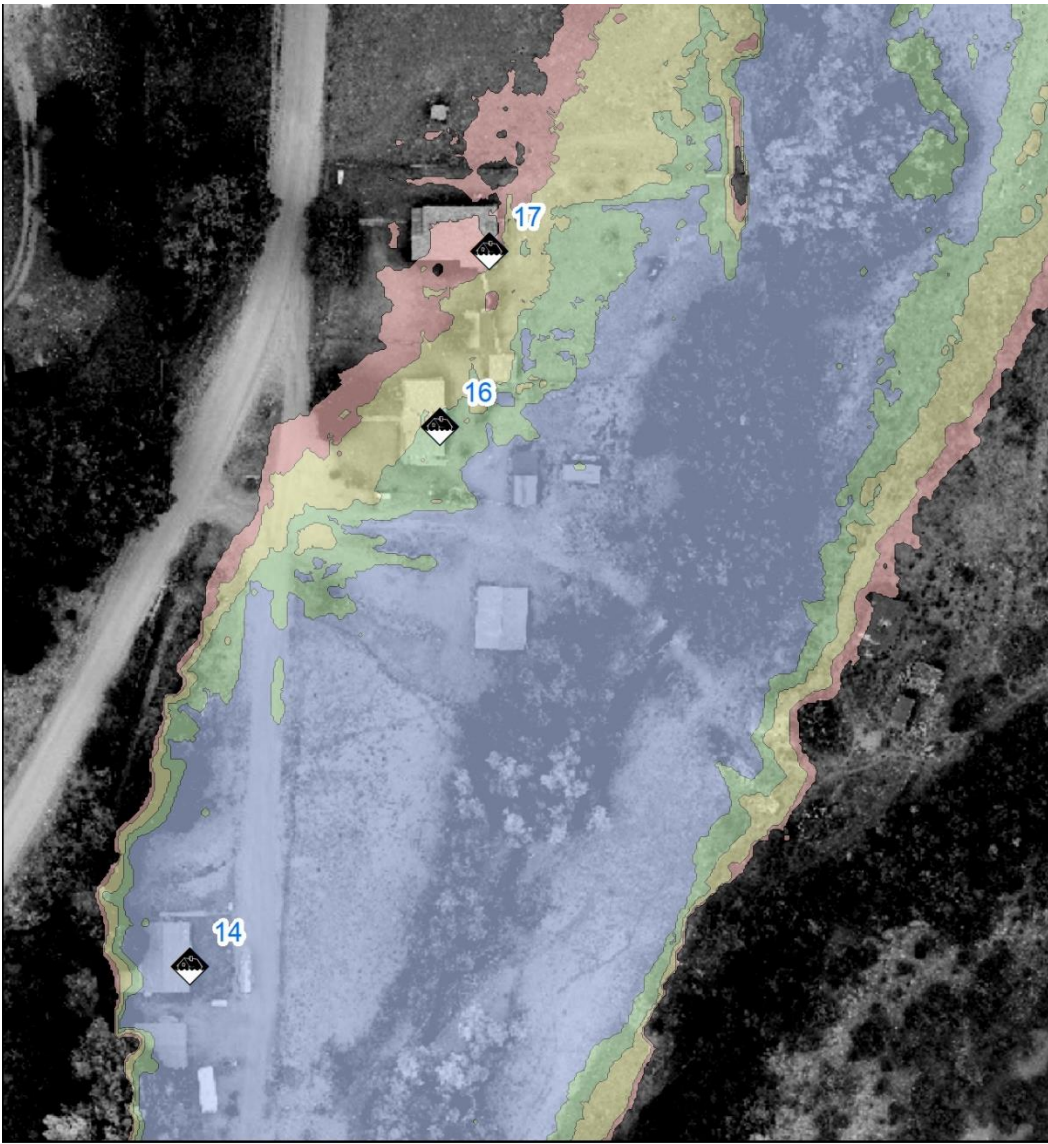
Figure 22: Identified properties that are at high and moderate risk for future flooding under 10, 25, 50, and 100-year flood events.

ID	Flood Risk	Description (Associated depths and velocities of the 10-, 25-, 50-, and 100-year floods, respectively)	Address
14	Moderate	Depths: 1.1, 1.9, 3.0, and 3.8 ft; Velocity: 5, 8, 11 and 12 ft/s.	920 CR 40
16	Moderate	Depths: 0, 0, 2.2, 3.9 and ft; Velocity: 0, 0, 13 and 16 ft/s.	910 CR 40
17	Moderate	Depths: 0, 0, 0, 0.7 and ft; Velocity: 0, 0, 0 and 7 ft/s.	910 CR 40

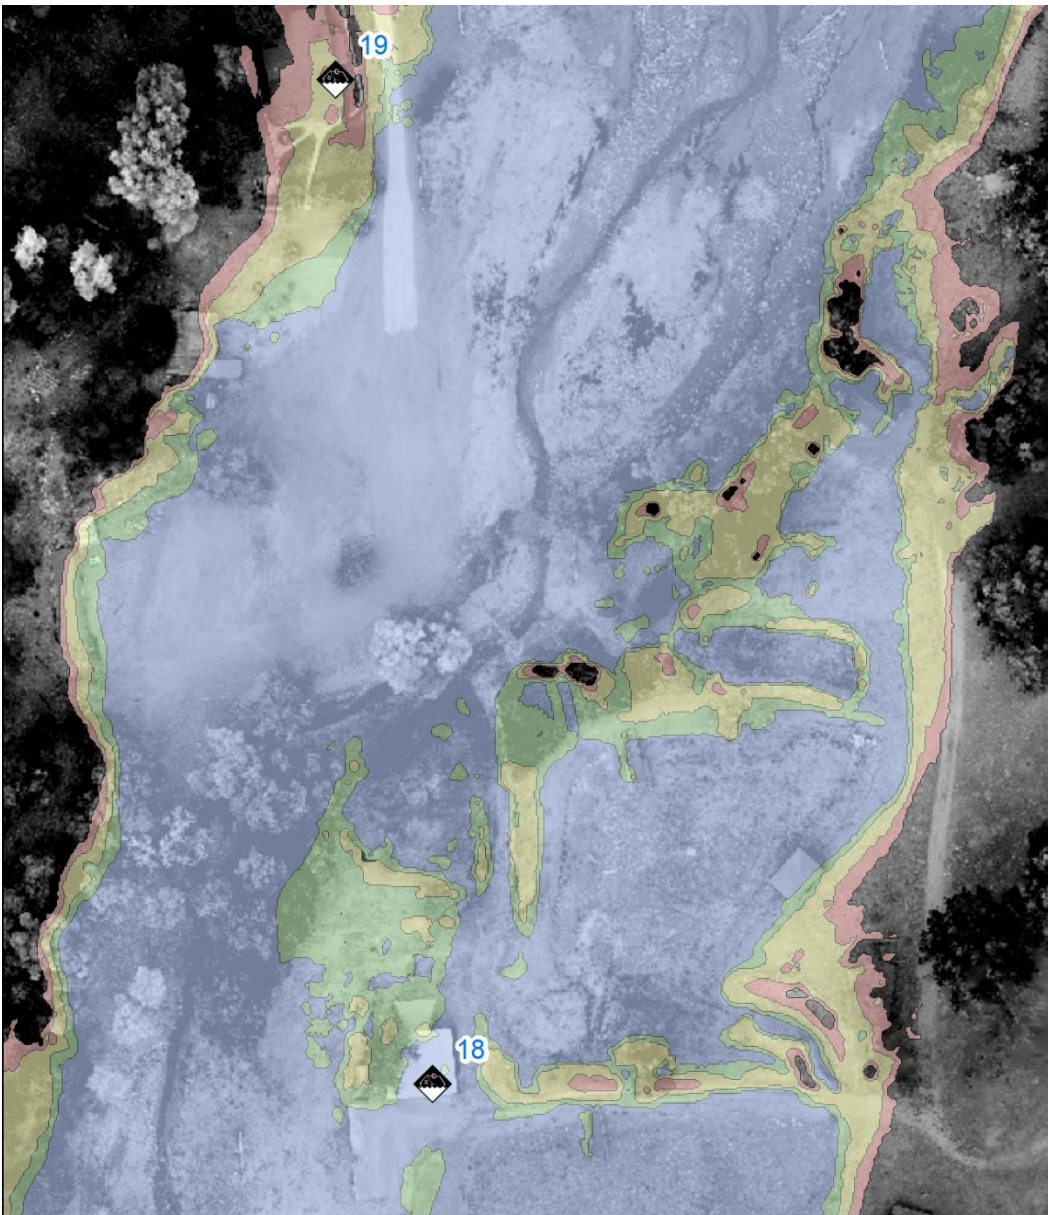
Figure 23: Identified properties that are at high and moderate risk for future flooding under 10, 25, 50, and 100-year flood events.

ID	Flood Risk	Description (Associated depths and velocities of the 10-, 25-, 50-, and 100-year floods, respectively)	Address
18	Moderate	Depths: 0, 0.5, 1.6, and 2.7 ft; Velocity: 0, 4, 9 and 11 ft/s.	340 Pole Mtn Lane
19	Moderate	Depths: 0, 0, 0, 1 and ft; Velocity: 0, 0, 0 and 7 ft/s.	376 CR 39

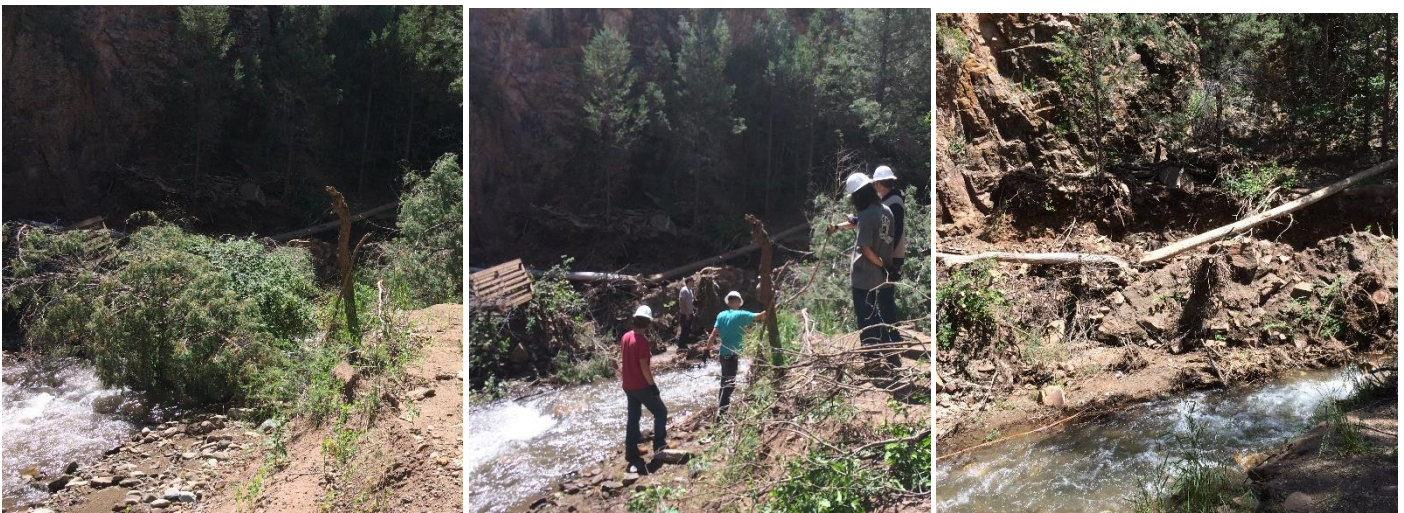
Figure 16: Debris jam (Debris id: 22, Figure 5) before removal (left); during removal with workforce crew, ARWC, and River Science (center); and after removal (right).

Specific examples of this work have been documented. Figure 16 shows field crews removing two channel spanning junipers (Debris id: 22, Figure 5) that could have encouraged future debris jams. This was a high priority debris removal because it was upstream and in close proximity of a landowner's property access bridge. Figure 17 shows the removal of a very large cottonwood tree that caused neighbor disputes, and Figure 18 shows clearing the floodplain debris in the constricted upper reach of Big Cottonwood Creek where numerous homes are built within close proximity to the creek.

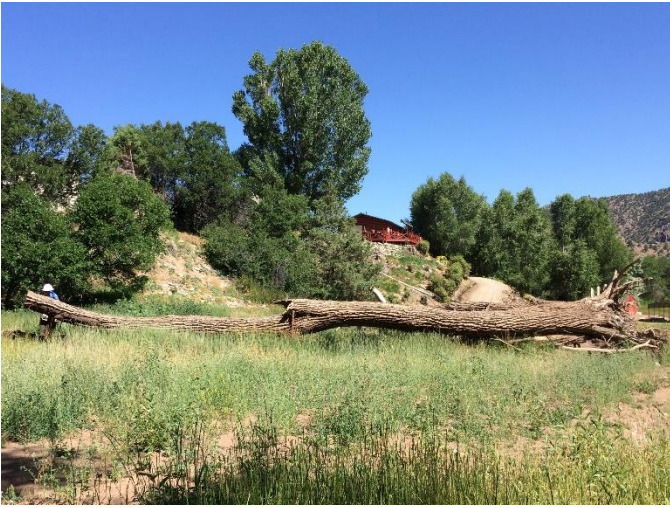
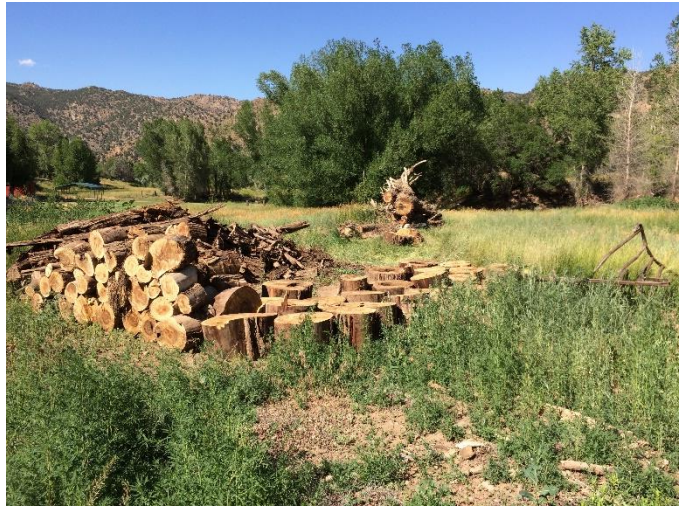
*Figure 17: Large cottonwood tree deposited during July, 2018 flood event (Debris id: 1, Figure 4) before removal (left), and after the majority of removal (right).*

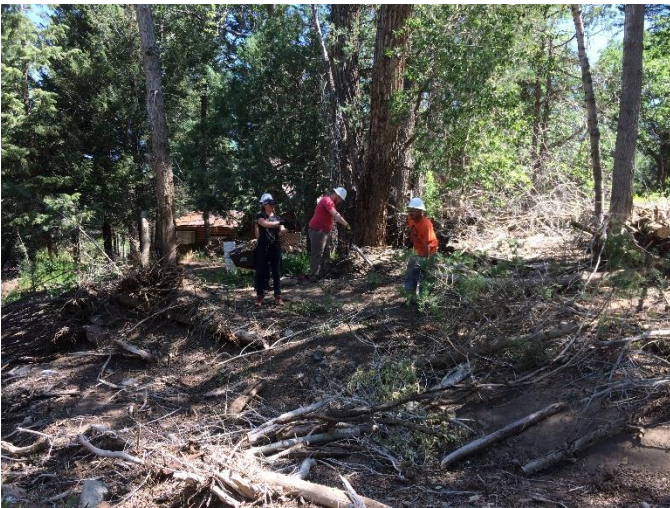
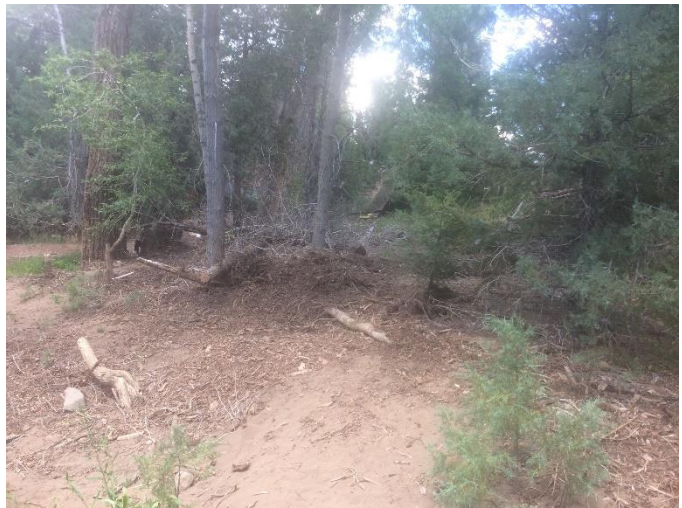
*Figure 18: Field crews removing debris (Debris id: 10 and 11, Figure 7) during removal (left) and after removal (right).*
