Case Study in Community-Based Recovery Response

HAYDEN PASS FIRE & FLOOD RECOVERY

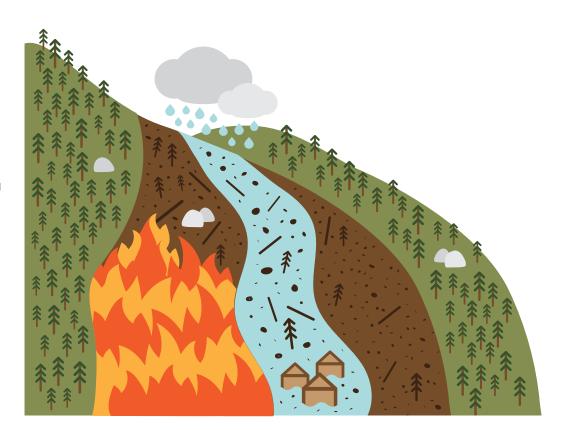
Dangers of Post-Fire Flooding

Fires strip trees & vegetation from hillsides.

Fire-scorched soils become hydrophobic soil (a temporarily impermeable soil layer), which cannot absorb rainwater.

Without vegetation or stable soil, debris such as burned trees, soil and ash flow downhill during rain events.

Communities downstream from these flows are at serious risk for flooding.

As rains wash over burned soils, flooding continues to sculpt the land for many years after the flames are extinguished. Hillsides stripped by fire of trees and other vegetation can no longer absorb or catch rainfall. Burned, unstable soils slough easily with even modest amounts of precipitation. Burned trees fall and can be swept downhill with water, soil, ash and other materials in flows that pose a serious threat downstream.

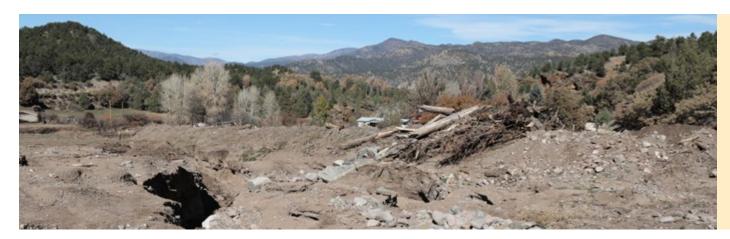
The confluence of three burned drainages in the Big Cottonwood area was the most heavily damaged private reach. This area became the focus of the NRCS Emergency Watershed Protection project. **Photo: ARWC**

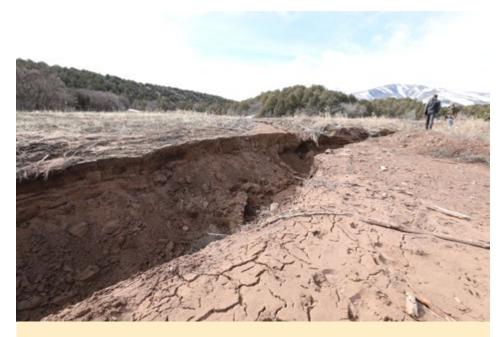
A local landowner leads Luke Javernick of River Science along a large flood-caused headcut bisecting a road in the Mosher and Sullivan Creeks area.

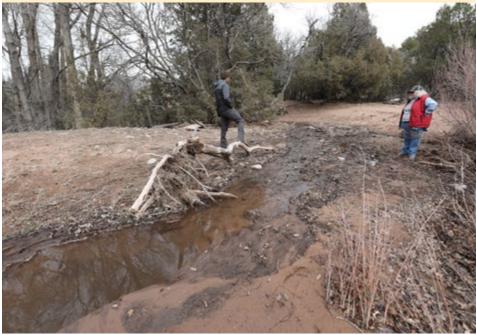
Post-fire flooding scoured the drainage, damaging domestic and agricultural water infrastructure and creating water quality impairments in and below the flooded area.

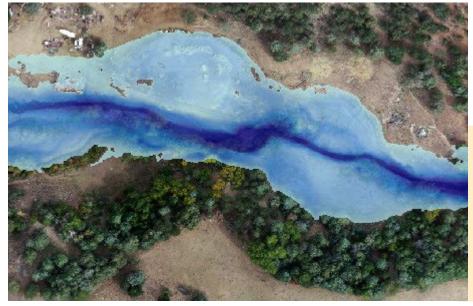
Bottom. A flood inundation map illustrates the extent of the flood water and debris in the Big Cottonwood Creek area during the July 2018 flood. This information informs recovery work and assists in planning for future floods. **Image: River Science**

Luke Javernick of River Science and Seth Mason of Lotic Hydrological completed hydraulic modeling and a hydrologic study for the Big Cottonwood Creek drainage, supporting rapid need identification and prioritization for the highly impacted area. In the Hayden Pass Fire recovery work, these models were essential in helping the team better understand risks and identify immediate threats within the drainage. Additionally, the team used the models to support discussions with landowners on potential risks or non-risks on individual properties. Today, these models are shaping the foundation for long-term recovery efforts throughout the watershed.

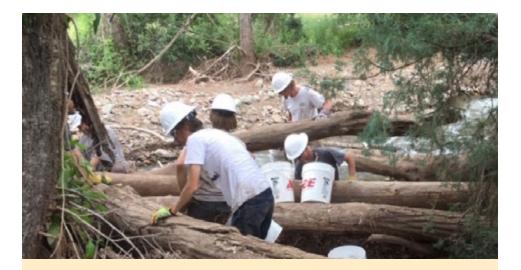
A workforce crew from Canon City clears a flood-borne debris dam in Big Cottonwood Creek, allowing flows to move freely through the channel rather than diverting toward homes and the road. **Photo: ARWC**

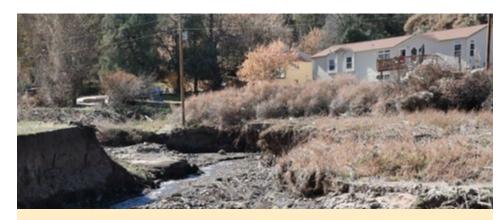
When post-fire flooding hit the Big Cottonwood area community, landowners faced fears for their safety and significant damages to their property. We slowly built trust by listening to - and responding honestly - to their concerns. **Photo: ARWC**

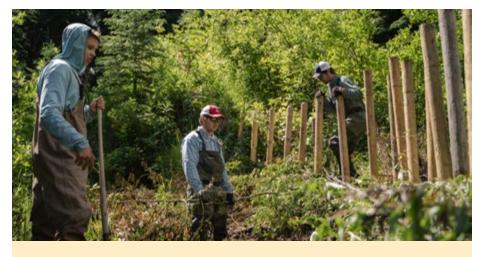
A Trout Unlimited crew builds a riparian restoration structure in Washington's Upper Columbia River Basin. Similar projects across the west have effectively restored degraded streams and the methods demonstrate the potential to improve riparian resilience after a fire. Our long-term plan explains similar low-cost, highly effective projects for recovery in the Hayden Pass Fire area. Photo: Matteo Moretti/Trout Unlimited Odyssey

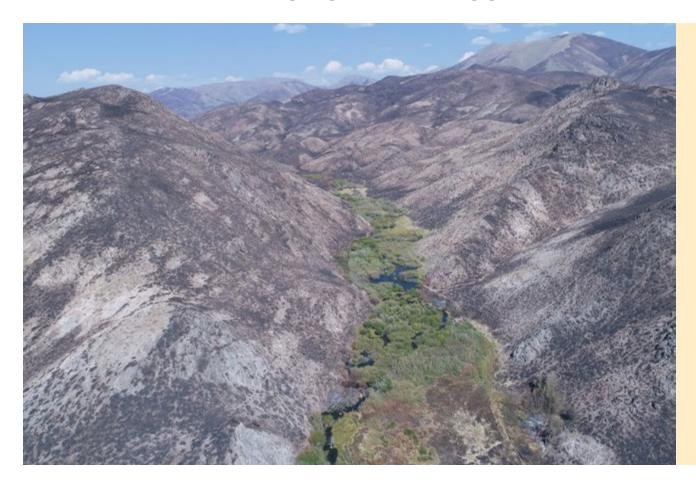
Restored riparian ponds provide
a refuge for fish and wildlife in
a burn scar near Hailey, Idaho.
Restored riparian ponds help to rebuild
and protect critical riparian habitat
after fire. Our long-term recovery plan
provides the background and resources
needed to complete similar projects in
the Hayden Pass Fire area.
