Big Cottonwood Creek Recovery Plan: (5+ Yrs.) Opportunities & Recommendations

Colorado Water
Conservation Board

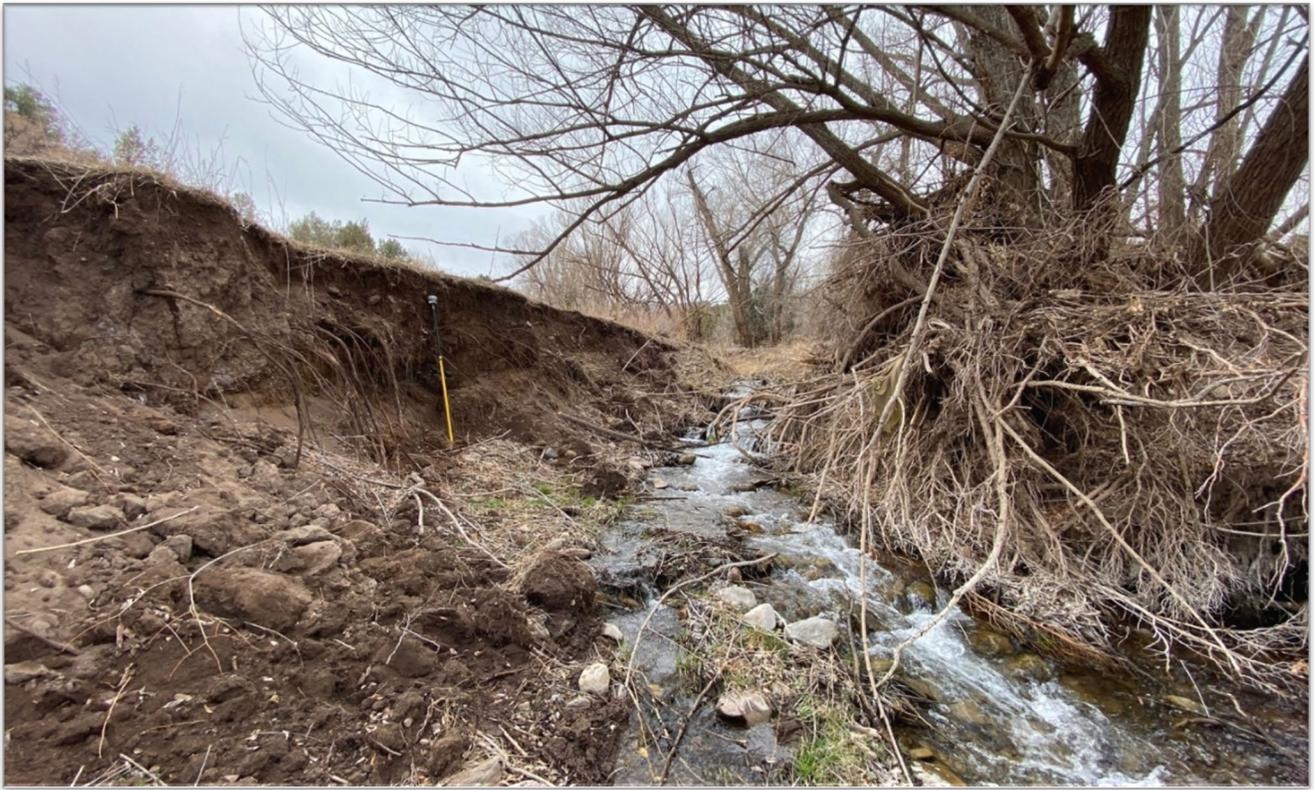
Figure 1. Image of Big Cottonwood Creek (taken April 2021) depicting the prevalent channel incision, highly mobile fine sediment, and a lack of habitat (i.e., no pools).

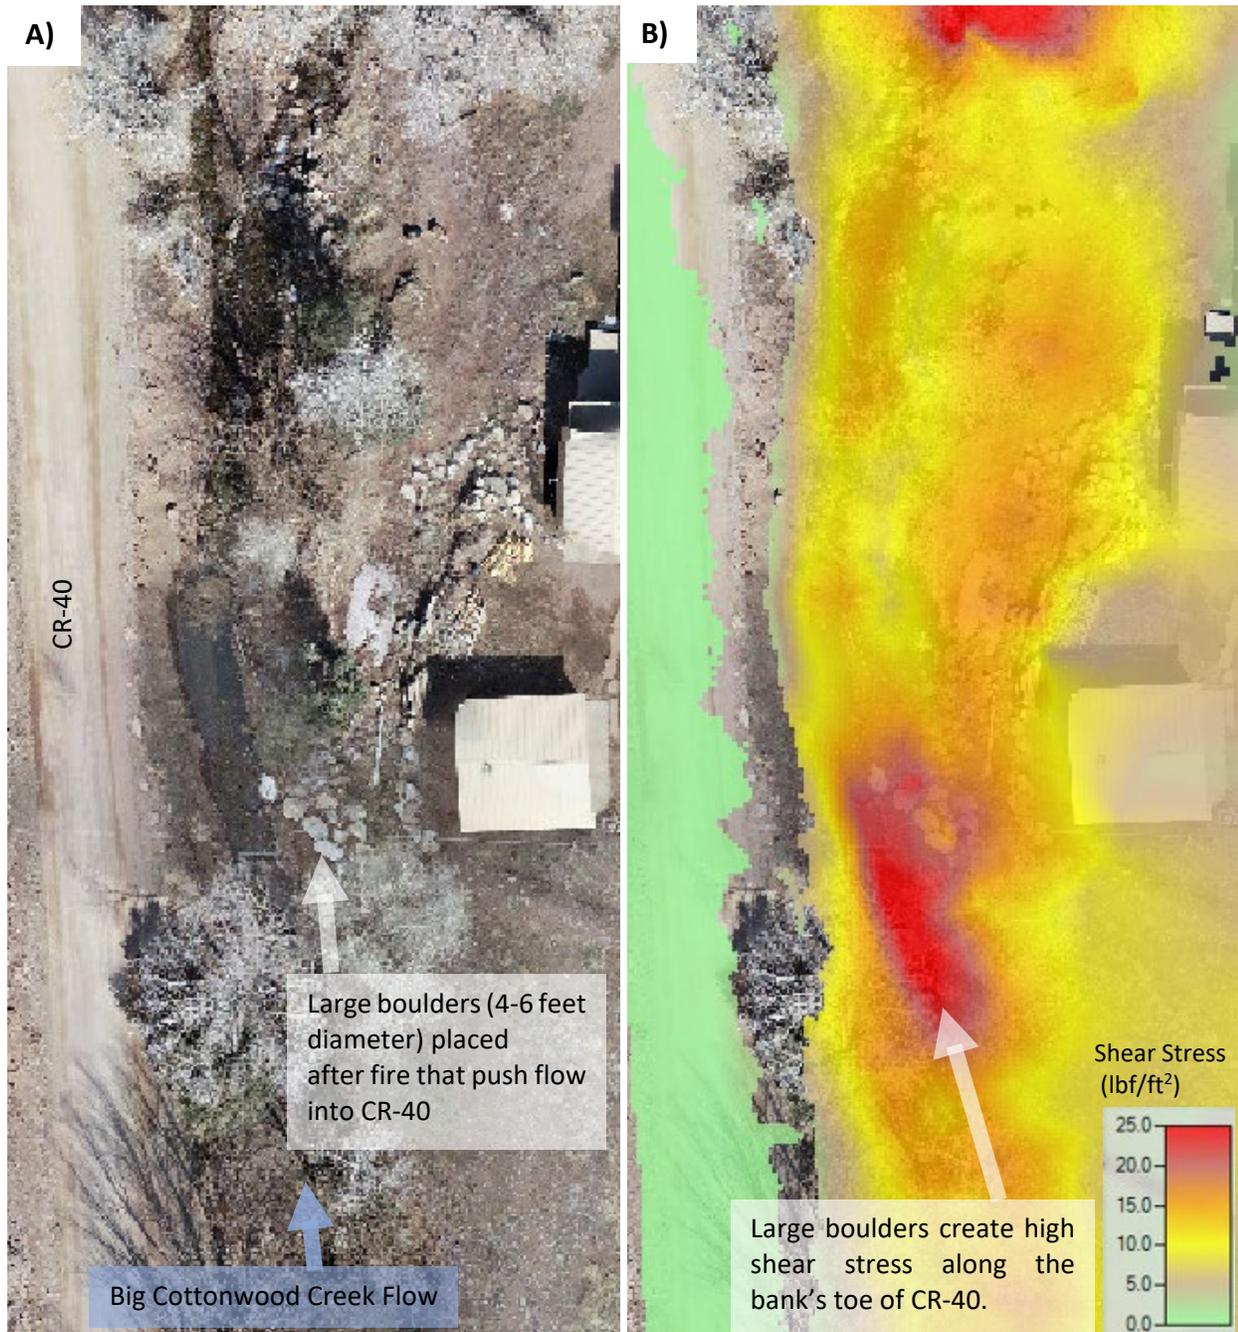
Downstream of the intersection of County Road 40 (CR-40) and the Dinkle Ditch Road bridge crossing, there are large boulders (4-6 feet axis) placed on east bank of Big Cottonwood Creek. These boulders deflect water to the west (Figure 3A). These boulders constrict flow as well as push the concentrated flow directly toward the bank that supports CR-40. Hydraulic simulations show significant erosive power with high shear stress (Figure 3B) occurring at the toe of the bank supporting CR-40. This bank of CR-40 is steep and does not contain suitable

vegetation or bank protection to resist future flooding erosion. Under the scenario of future flooding, bank erosion could prevent CR-40 access, and could prevent 14 different residents from escaping and/or returning home.

Figure 3: Large boulders have been placed along the eastern bank of Big Cottonwood Creek just downstream of where County Road 40 (CR-40) intersects with Dinkle Ditch Bridge. These boulders are: A) orientated to deflect flow away from the nearby housing and by doing so force greater flow toward the toe of CR-40's bank, which causes B) higher concentrations of shear stress and erosion potential.

The issues of CR-40 should be reviewed by the Fremont County officials and to consider possible options for protecting CR-40. Removal of the boulders or bank protection along CR-40 should be reviewed to ensure the bank's toe is not eroded during future flood events.

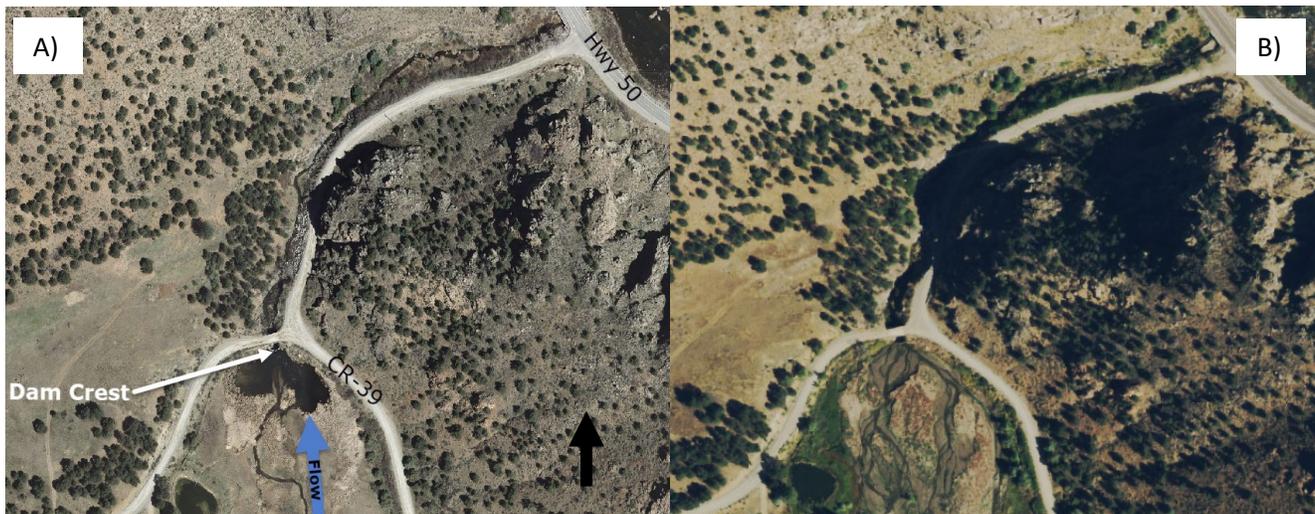
Harry Walker Dam is located at the downstream end of Big Cottonwood Creek where the CR-39 bridge crosses the creek (Figure 4A, pre-fire condition). Over the last several decades, the Harry Walker reservoir has been filling with sediment and losing capacity. However, the reservoir acted as a detention basin for the post-fire flood events and trapped large amounts of debris and sediment, protecting the Arkansas River just downstream. Since the

2018 flood event, this reservoir has filled with sediment and has become super-aggraded with several nearby sediment bars up to 5-6 feet above the dam crest elevation (Figure 4B, post-fire conditions). The result is that the Harry Walker Dam is constantly overtopping, and the dam crest creates a waterfall with a 15-foot vertical drop. Following the fire and 2018 floods, Fremont County officials and Colorado State Dam Safety officials reviewed the dam. According to Mark Perry, the Colorado Dam Safety Engineer, the Harry Walker Dam’s “concrete apron below the dam, intended to protect the foundation, is being undermined [by flowing water] and is failing” where eventually the dam’s fill foundation may be completely undermined “allowing a path for water and sediment under the dam” (personal communication, June 14, 2021). Mr. Perry went on to state that “it is not considered to be a serious dam safety issue [and] we do not expect the concrete gravity dam to fail catastrophically, and the downstream hazard potential is considered to be low”. Despite this low hazard, the Colorado Dam Safety has made the dam owner aware of these issues and has required foundation repairs, which is the maintenance and liability of the dam owner.

In its current condition, the dam’s infrastructure would not be able to act as a catchment basin for future flood events. Further, if the apron fails, the reservoir’s trapped sediment will begin to flush downstream to the Arkansas River. As discussed in Section 2.2.2., the elevated post-fire sediment loads have already degraded the Arkansas River’s fishery, recreation/tourism, and impacted water quality downstream of Big Cottonwood Creek. Allowing the dam to fail will have consequences to the Arkansas River and all those who rely on this resource. The current dam owner has expressed many times that he would like to restore the reservoir to its formal capacity. Although this is a private reservoir, we believe there should be a vested interest in rehabilitation by other parties for the purposes of protection of the Arkansas River and for future habitat improvements (discussed in Section 3).

Figure 4: Harry Walker Dam A) aerial image taken in 2016 pre-fire/flood showing capacity, and B) post-fire/flood showing sedimentation and braided channels overtopping the dam crest.

Harry walker Dam's overtopping was initially reviewed and determined to be no concern, but the dam's apron is being undermined, which will eventually lead to failure whereby sediment will flush out of the dam. While it is the responsibility of the current dam owner, this dam should be reviewed by Fremont County officials on a regular basis to ensure that the concrete outlet and CR-39 bridge abutments are withstanding the waterfall's erosive power and to monitor the apron's integrity. Allowing the dam's apron to fail will release large amounts of fine sediment into the Arkansas River. Such large amounts, and the extended time to flush the sediment trapped behind the dam will greatly degrade the fishery for several years, potentially create hazard. While dredging the reservoir would be expensive (historic estimates done by the local NRCS were well above \$500,000), this reservoir could provide improvements for sediment storage for improved water quality to the Arkansas as well as valuable future aquatic and terrestrial habitat.

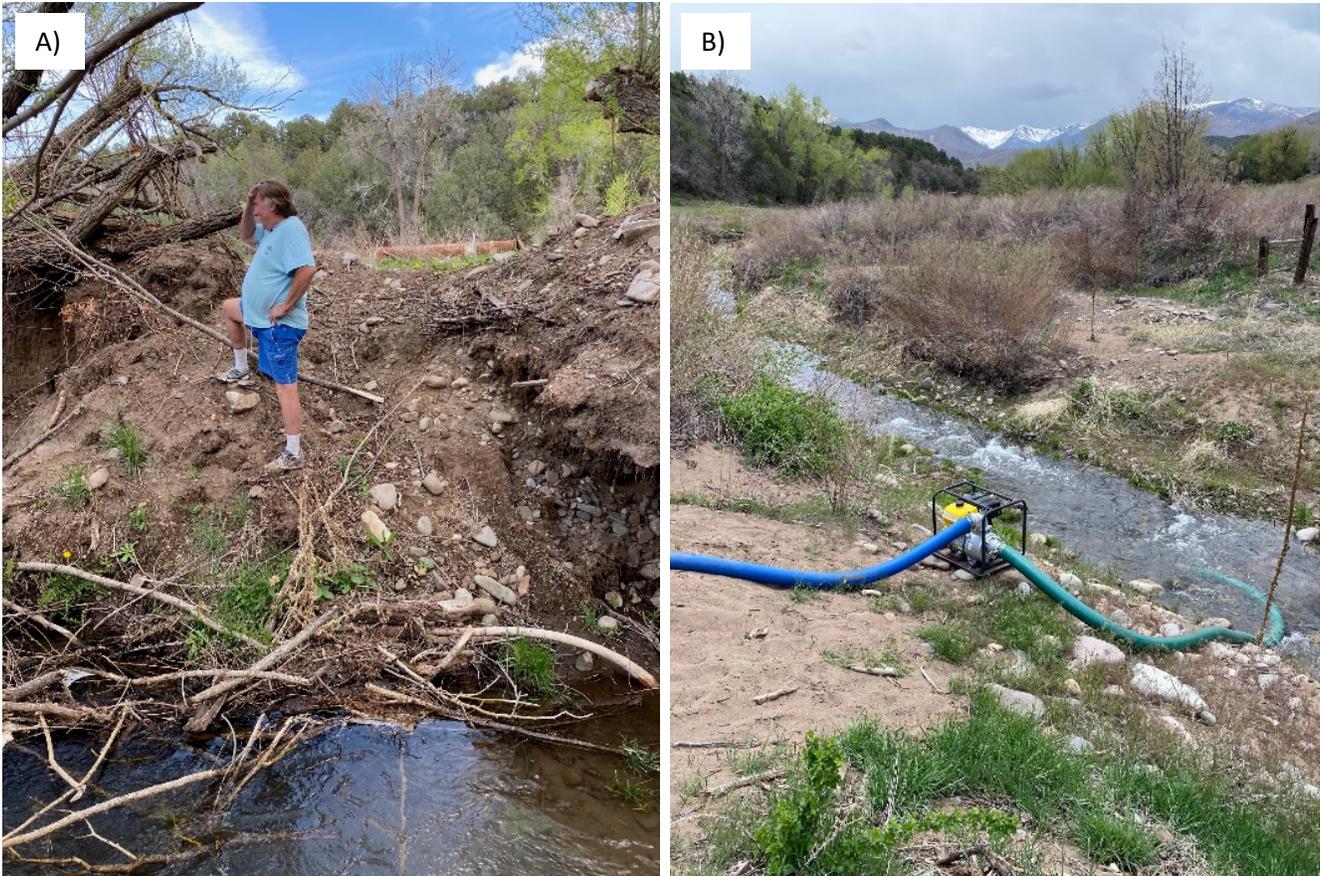
Post-fire flooding damaged all irrigation diversions and filled in many areas of open channel ditches. Irrigated parcels are dependent upon Big Cottonwood Creek, which has suffered throughout this post-fire period. Five ditches were initially impacted, including (listed from upstream to downstream): State Ditch No. 1, Dinkle Ditch, Baker Potter Ditch, John Baker Ditch, A L Smith Ditch, A M Smith Ditch. To date, landowners have repaired most ditches; however, State Ditch No. 1, and A M Smith Ditch still do not have fixed diversions to provide water to water rights owners. The State Ditch NO. 1 suffered realignment of the Big Cottonwood Creek to the east, which washed out the diversion and the irrigation pipe that connects the ditch. The A M Smith Ditch diversion has also been washed away, and the channel incision has caused the creek bed to be 8 feet lower (Figure 5A). The A M Smith Ditch users are currently pumping water from the creek to the ditch (Figure 5B) in an area downstream;

however, this is both expensive and failing to meet their diversion needs. A M Smith Ditch users are preparing an NRCS EQIP application for partial repair funding that would require work to raise the creek bed by 3 feet and then trench several hundred feet downstream where a pipe can carry water to the appropriate ditch grade. In addition to irrigation, the A M Smith Ditch provides the only source of augmentation water for the evaporative loss associated with the Harry Walker Dam.

Figure 5: A M Smith Ditch shown A) at diversion area with significant channel incision and B) with current pumping that is not capable of supplying enough flow for all water users' needs.

Restoring the A M Smith Ditch will require piping the flow into a downstream section of the ditch where the elevation would then flow to the downstream users. However, for this system to work, the creek bed elevation

would need to rise vertically 3 feet. This would require either a large diversion structure to raise the water surface elevation or raising the riverbed elevation and a minor diversion. Once diverted, the ditch will be piped several hundred feet to meet the appropriate elevation and grade to continue to flow water in the existing ditch. Estimates are not finalized for this work but are expected to cost several thousands of dollars.

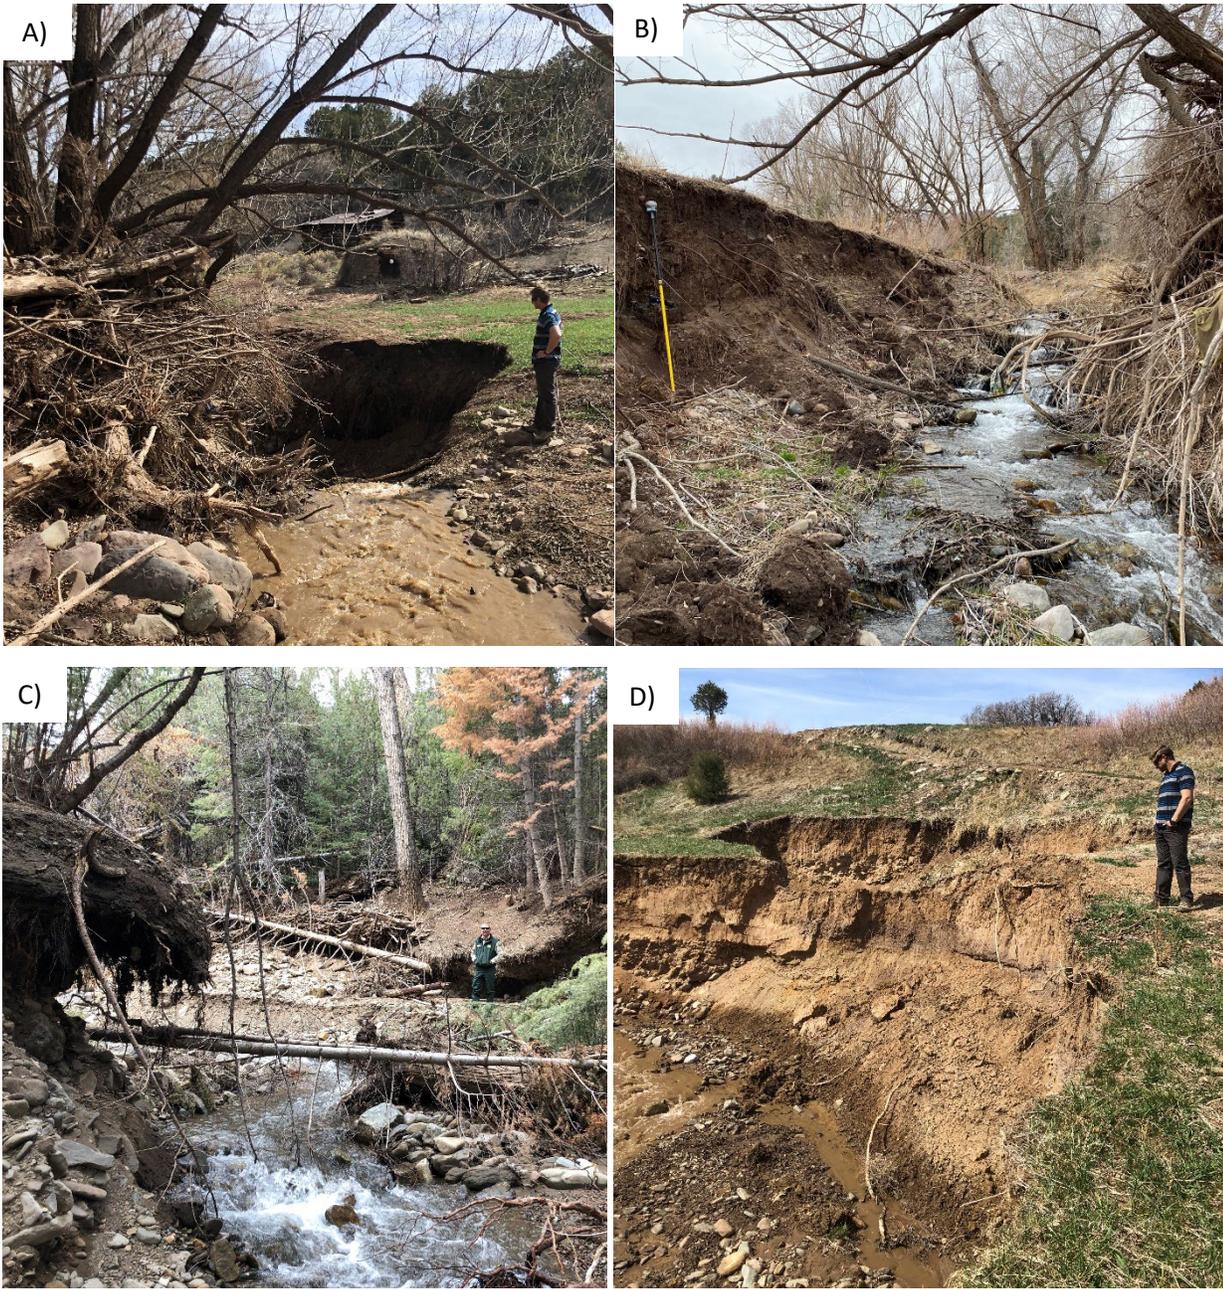
Numerous areas have deep incisions (8-12 feet shown in Figures 6A, 6C, 6D), undermined banks and trees, and significant head cuts that continue to propagate upstream (Figure 3B). These massive head cuts and deep incision causes steep and unstable banks that are dangerous to private landowners and the public. Hydraulic concerns are focused on the incised channels and increased sediment transport due to concentrated flows. These concentrated flows continue to cut the channel down, cause bank failures, and deliver enormous amounts of sediment downstream (including to the Arkansas River). While the fire burned several thousand acres above these drainages, several thousand acres of unburned forest still exist upstream. The potential for future fires and

Figure 6. Post-fire flood events on the Big Cottonwood Creek have caused: A) large head cuts that continue to cause incision, and B) numerous areas of incision that range from 8-12 feet, C) large numbers of undermined trees, and D) significant bank erosion and sediment sources.

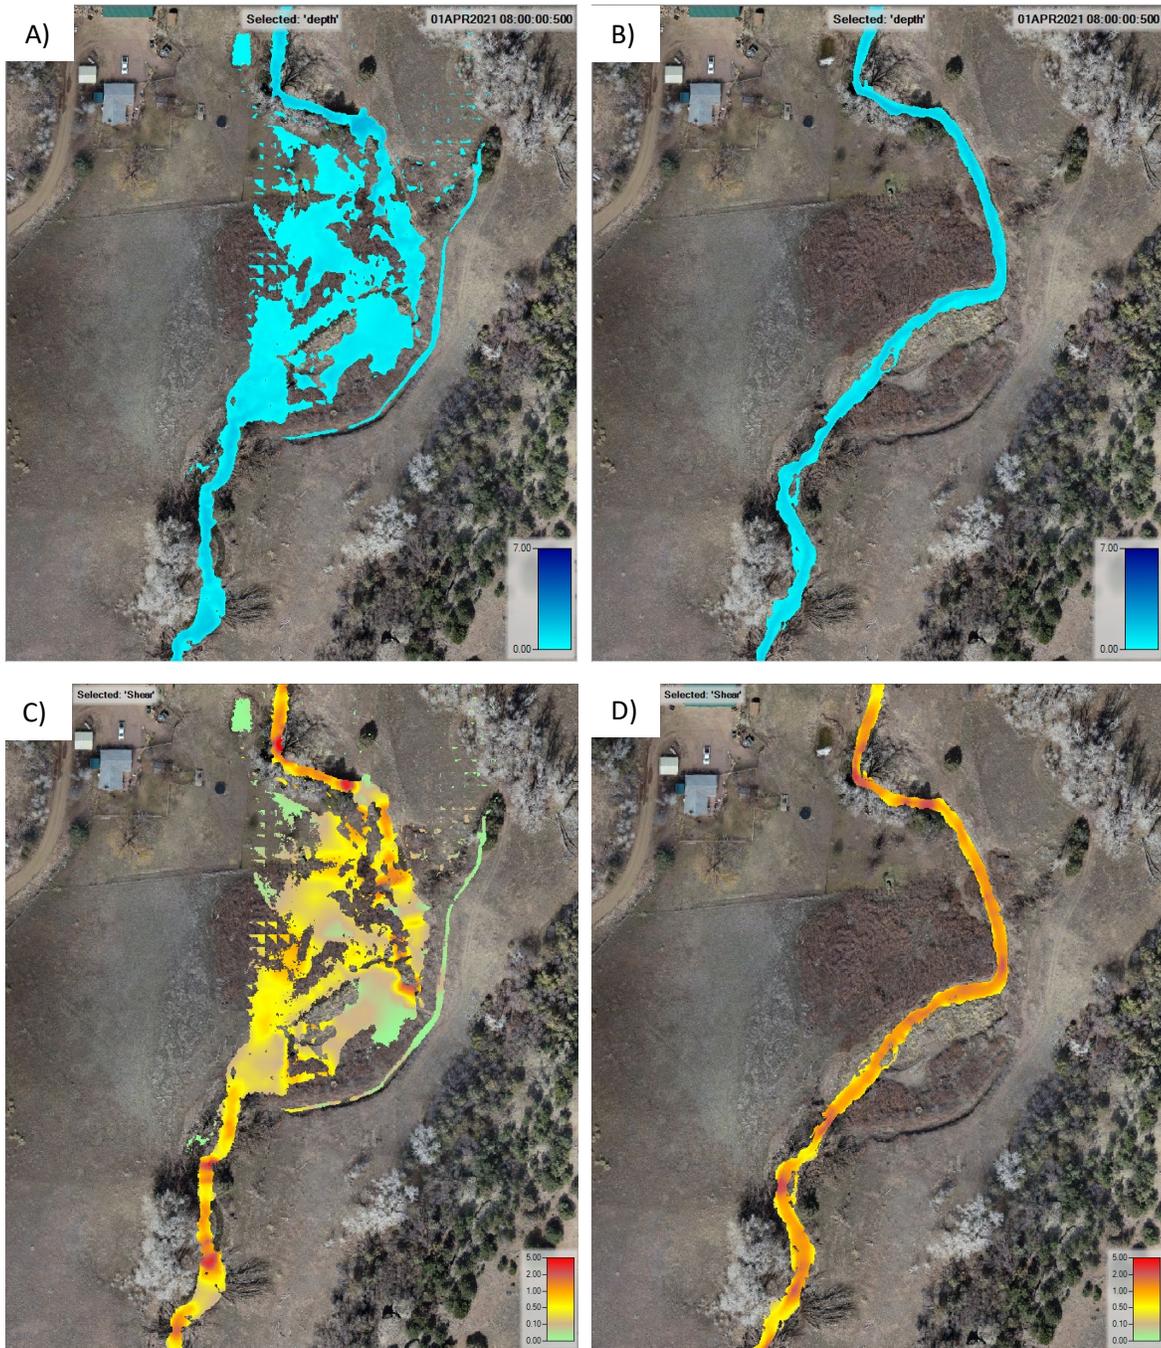
Hydraulic model simulations were used to explore the stream's changes. Simulations were performed in the same low-flow conditions with the pre-fire elevation data of 2016 and current 2021 elevation data (Figures 7 and 8). Model results show a drastic reduction in the existing topography's ability to spread flow and significantly higher shear stress values. Calculating the total inundation area pre-fire, Big Cottonwood Creek had 11.1 acres inundated with 1.95 acres ponded. Post-fire and flood show 6.3 acres inundated and 0.3 acres ponded. This equates to a ~40% reduction in low flow inundation and ~85% reduction in ponded areas.

As shown in Figures 7A and 7C, the 2016 channel geometry had several areas of floodplain connectivity and lower shear stress values compared to the 2021 conditions shown in Figures 7b and 7D. Similar results are shown in

Figure 7. Hydraulic modeling results that show: A) pre-fire and flood events depth and C) shear stress, and post-fire and B) flood depth and D) shear stress.

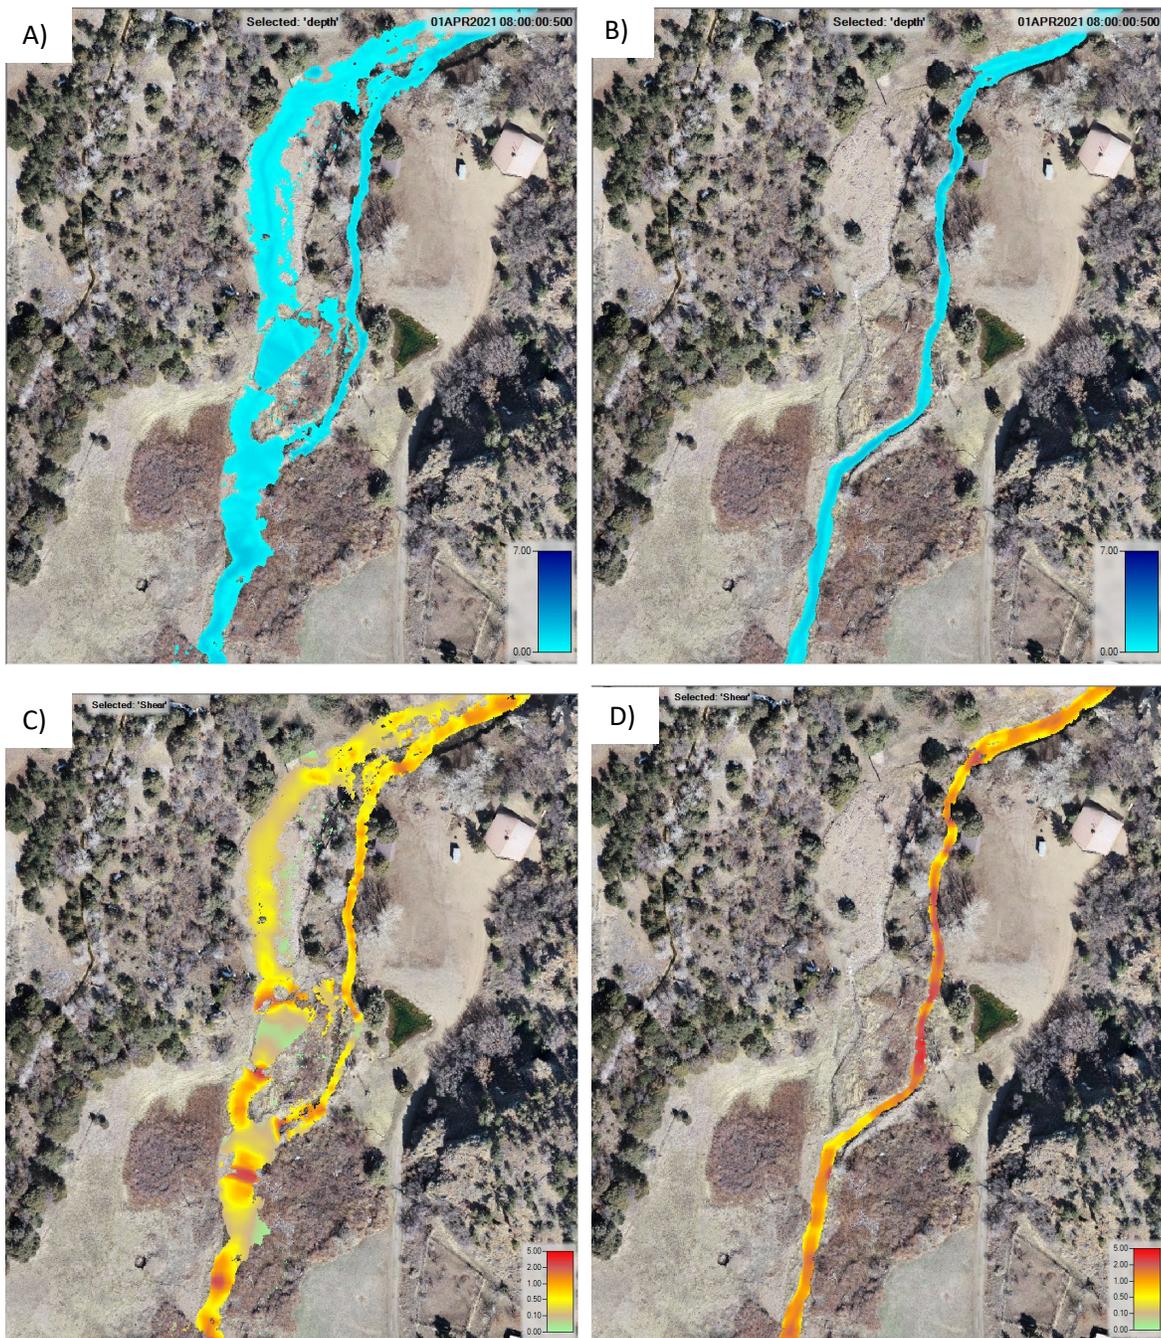
Figures 8A-8D for a different reach. Inundation extent changes for all sections of Big Cottonwood Creek below USFS Wilderness designation are shown in Appendix A. These hydraulic conditions will continue to cause deeper incisions and bank failures, which will increase sediment generated and transported (diminishing water quality). As much of the upstream watersheds remain unburned, this area can experience another wildfire. The post-fire flood events could be more devastating in the future, given these creeks confined and concentrated flows. Further, the riparian system is not prepared to withstand future post-fire flooding.

Figure 8. Hydraulic modeling results that show: A) pre-fire and flood events depth and C) shear stress, and post-fire and B) flood depth and D) shear stress.

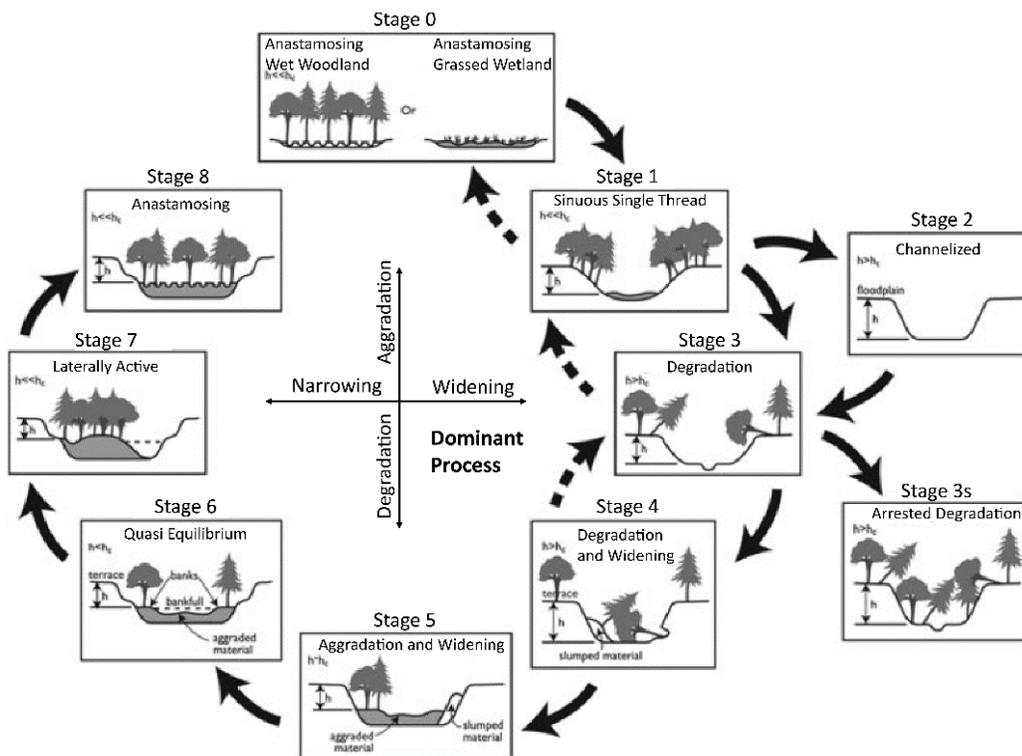
Following the Stream Evolution Model shown in Figure 9, Big Cottonwood Creek may likely widen and aggrade overtime to one day become a well-connected floodplain. However, this evolution from the current stage (2 or 3) to pre-fire conditions (ranging from stage 7, 8, 0, and 1) may take hundreds, possibly thousands of years. During this time, Big Cottonwood Creek would continue to suffer from the impairments listed above. However, targeted restoration aimed at accelerating this stream evolution could be done with cost-effective process-based restoration (PBR) methods as outlined by Wheaton et al. (2019).

Figure 9. Stream evolution model (SEM) proposed by Cluer and Thorne (2014) illustrating approximate stages and pathways associated with recovery to Stage 0. Restoration in Big Cottonwood Creek could accelerate recovery trajectories.

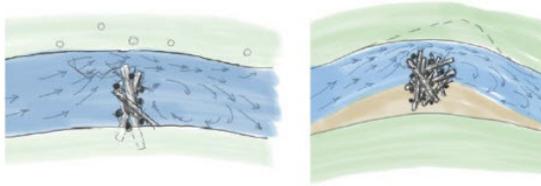
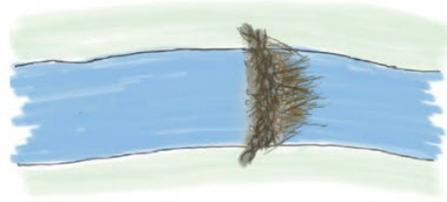
Figure 11: Depiction of the basic PBR treatments of PALS (Post Assisted Log Structures) and BDAs (Beaver Dam Analogs).

PBR focuses on using the creek's flow and stream power to help perform the restoration labor. Through carefully planned treatments, hand-built structures in series can be used to restore the lacking geomorphic processes. For example, using local and natural materials, a channel spanning treatment (Figure 11 and Figure 12C, D, F, H) can be used as a grade control structure. The structure would trap sediment, raise the channel bed elevation, slow the flow's velocity, and reduce fine sediment. Other treatments can force flow into banks (Figure 11 and Figure 12 A, B, E, and G) that accelerate bank erosion and migration that can supply downstream the channel spanning grade control structures with new sediment sources, which helps widen and aggrade the channel. Such treatments provide much-needed structure to the creek by providing pools, shelter, slower water for the struggling macroinvertebrate life, and potentially future habitat and quality conditions necessary for the Greenback Cutthroat Trout. These treatments that aim to widen and aggrade the channel will also help to reduce the issues listed above in section 3.2. (Riparian Needs and Opportunities section).

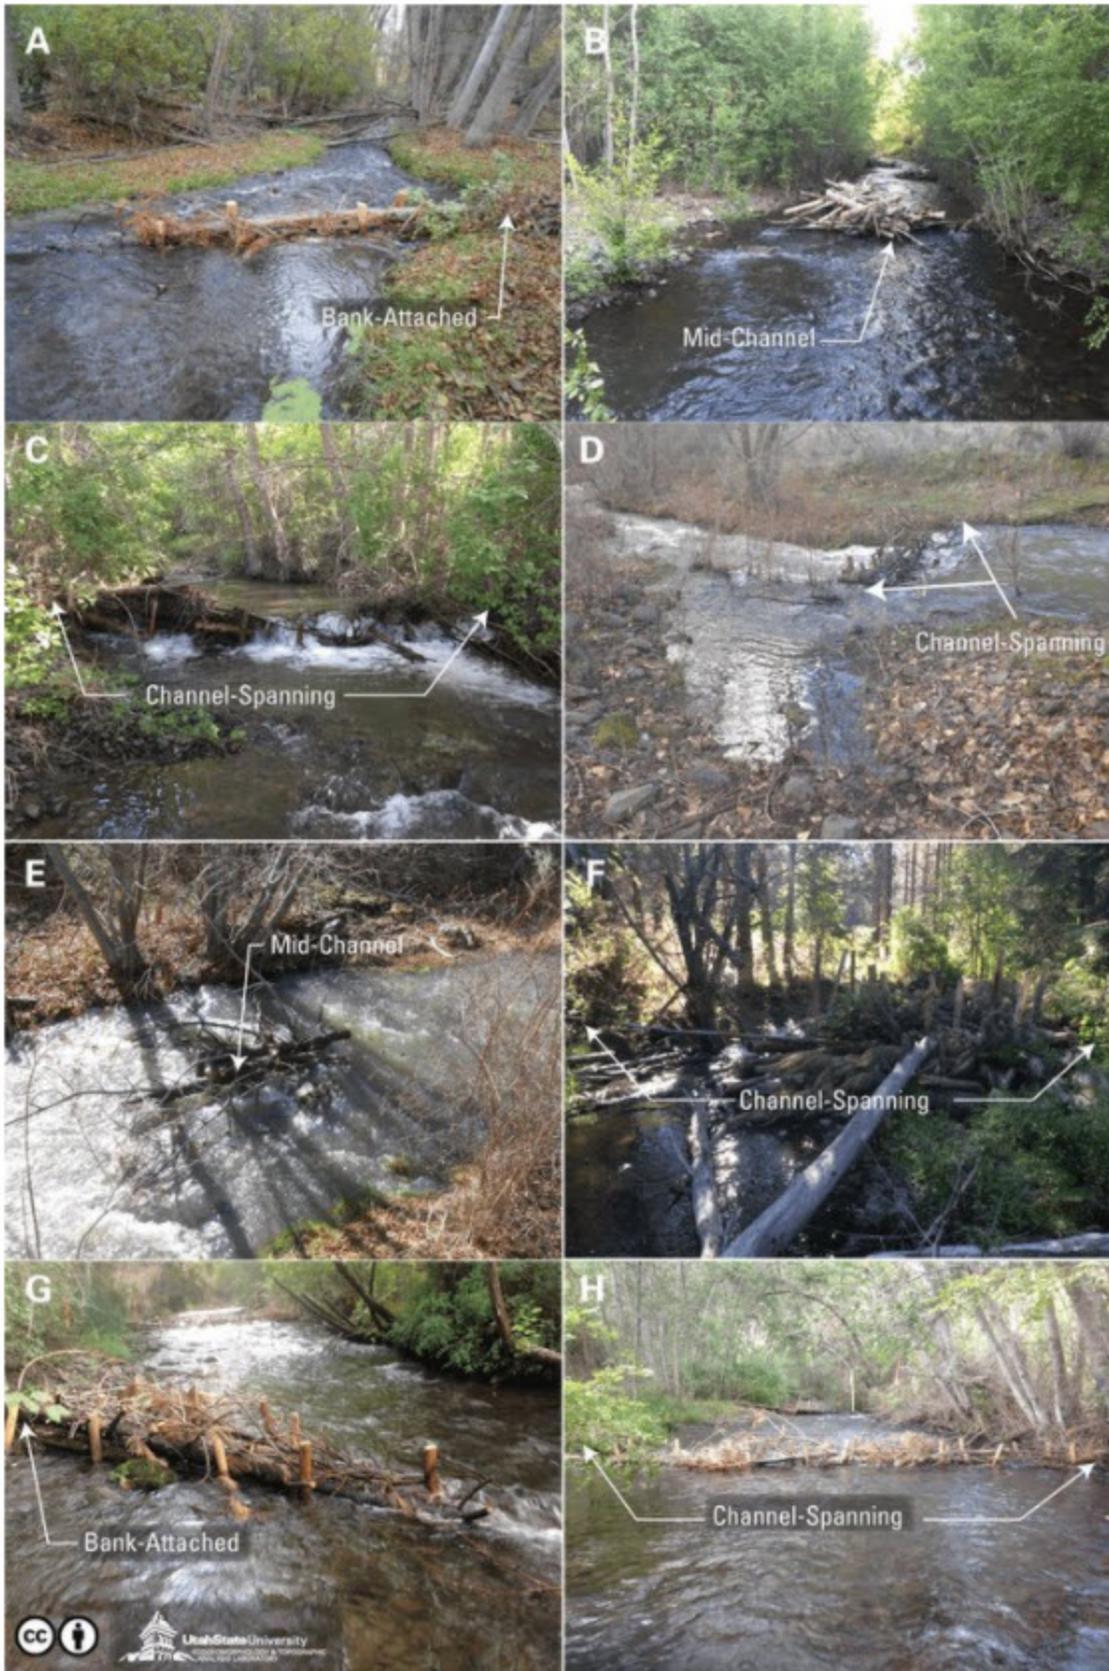
Figure 12: Images of PBR treatments that show Channel-Spanning BDAs and PALS, bank-attached PALS, and mid-channel PALS.

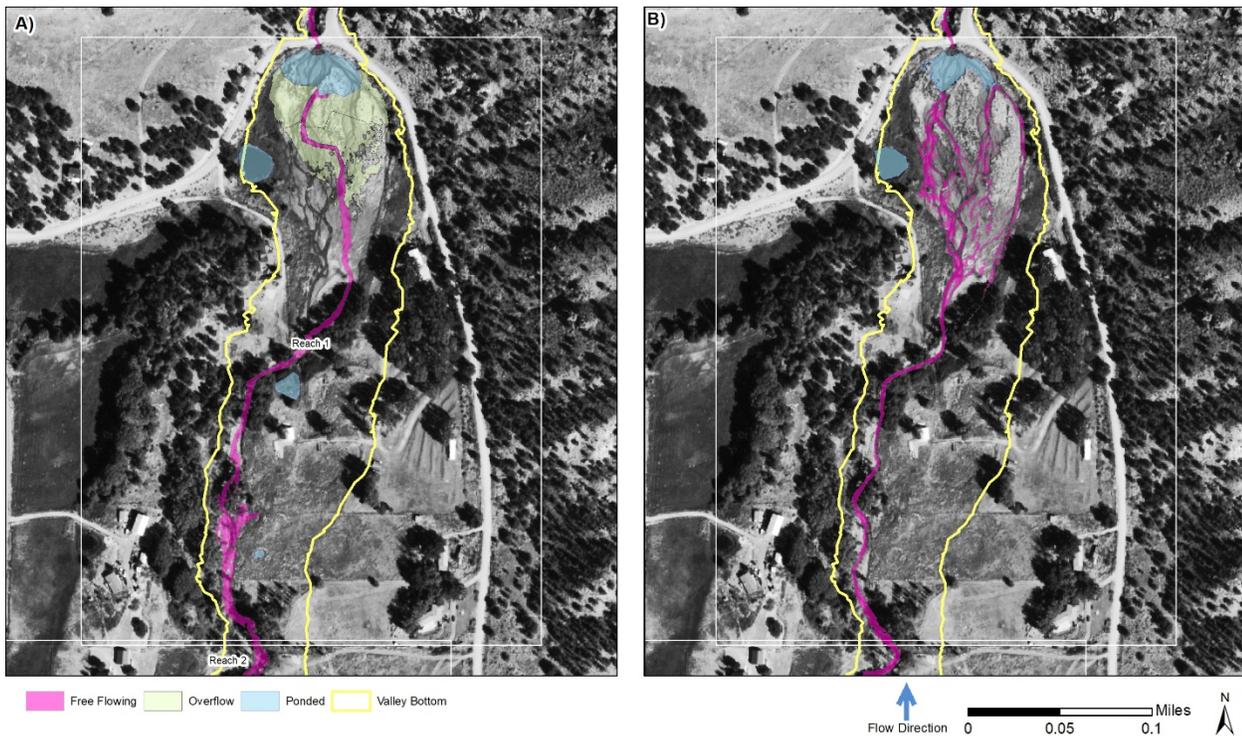
Figure A1: Reach 1 showing A) pre-fire conditions, B) post-fire conditions, and C) the valley bottom and potential restoration treatments and zone of influence of such treatments.

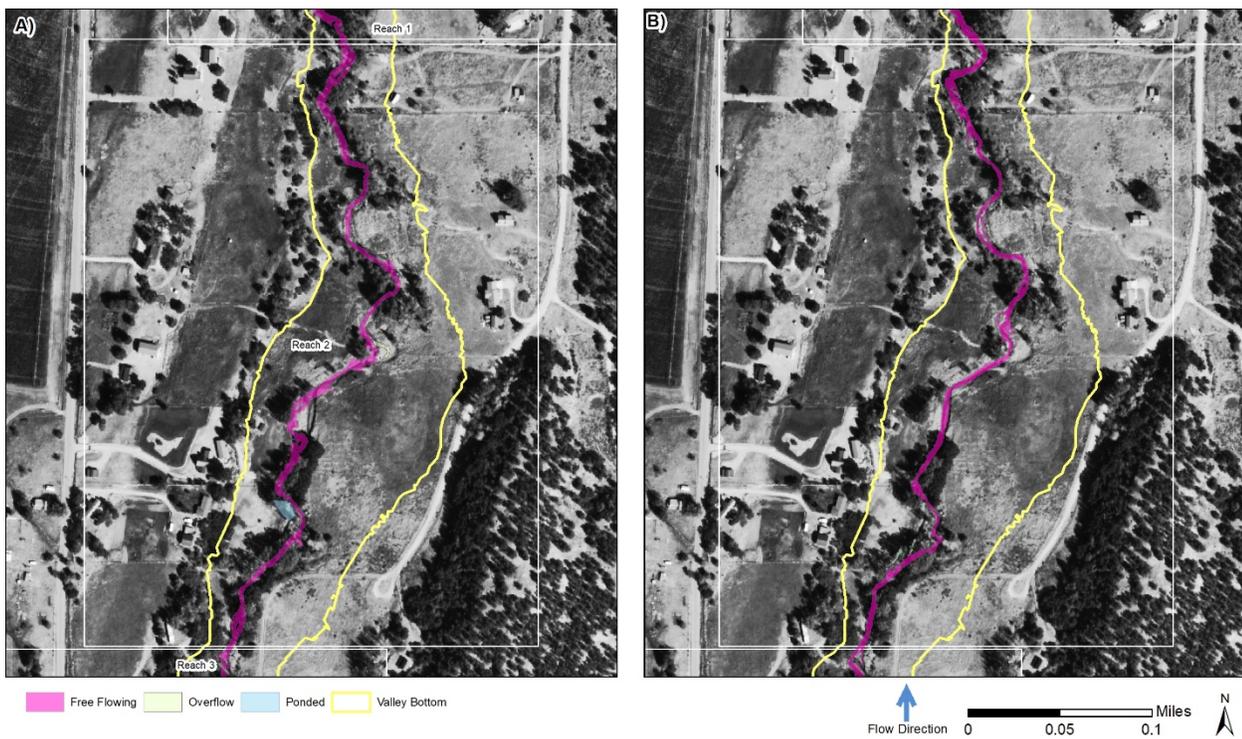
Figure A2: Reach 2 showing A) pre-fire conditions, B) post-fire conditions, and C) the valley bottom and potential restoration treatments and zone of influence of such treatments.

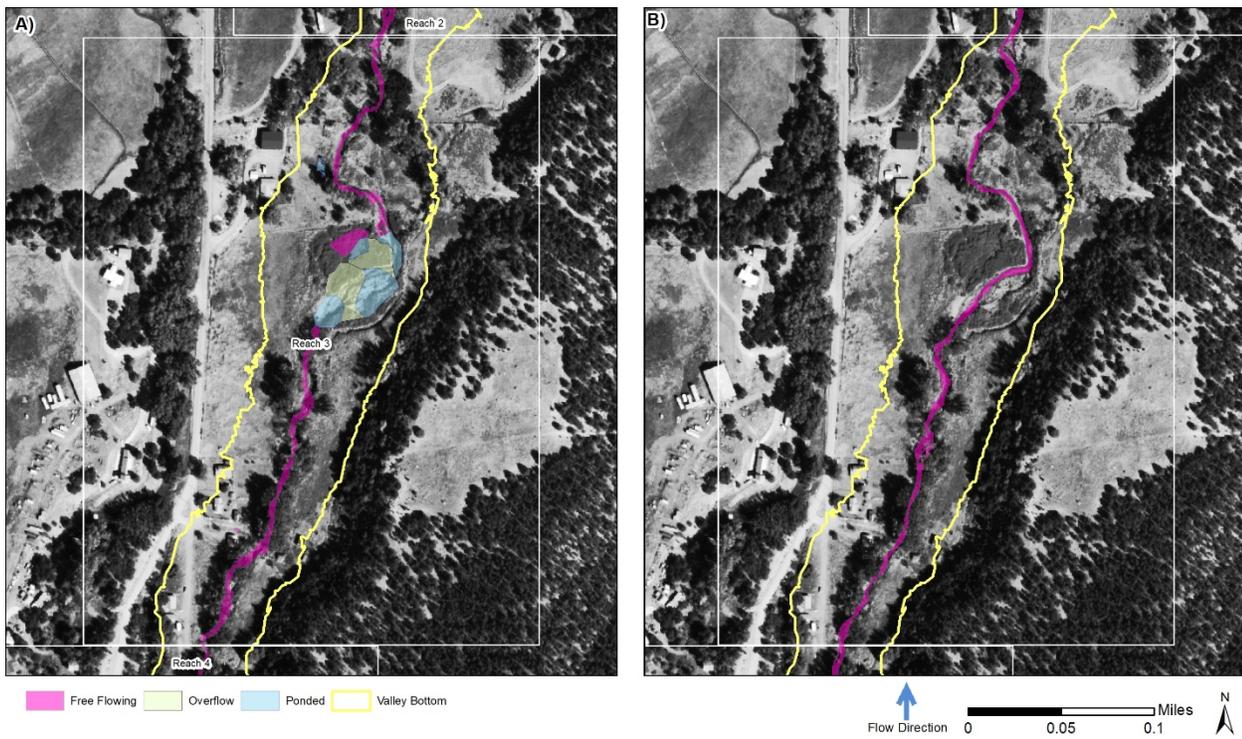
Figure A3: Reach 3 showing A) pre-fire conditions, B) post-fire conditions, and C) the valley bottom and potential restoration treatments and zone of influence of such treatments.

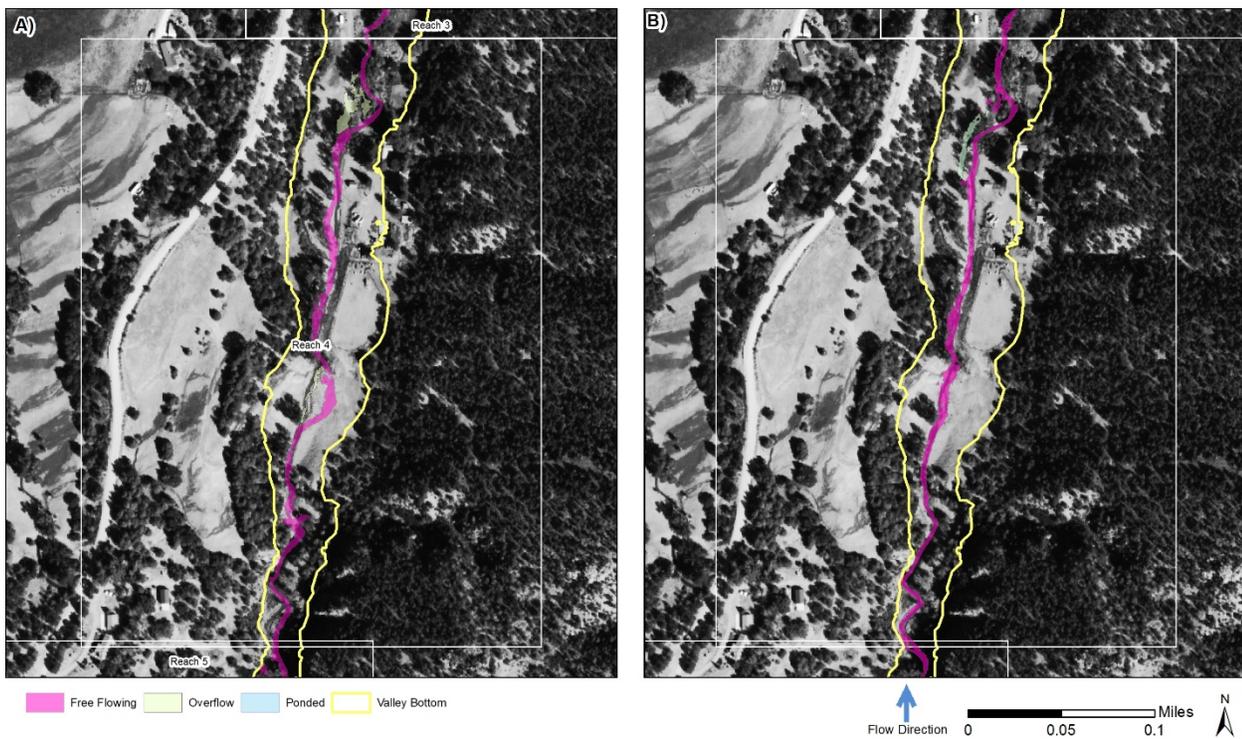
Figure A4: Reach 4 showing A) pre-fire conditions, B) post-fire conditions, and C) the valley bottom and potential restoration treatments and zone of influence of such treatments.

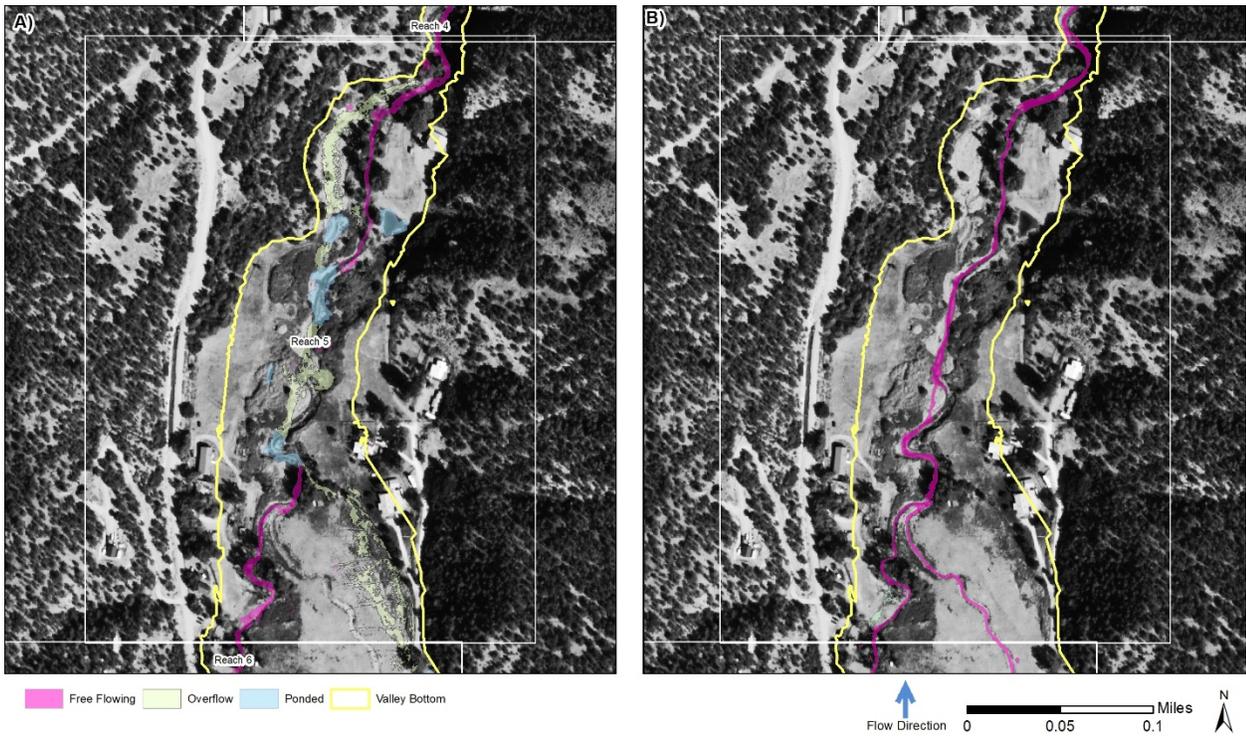
Figure A5: Reach 5 showing A) pre-fire conditions, B) post-fire conditions, and C) the valley bottom and potential restoration treatments and zone of influence of such treatments.

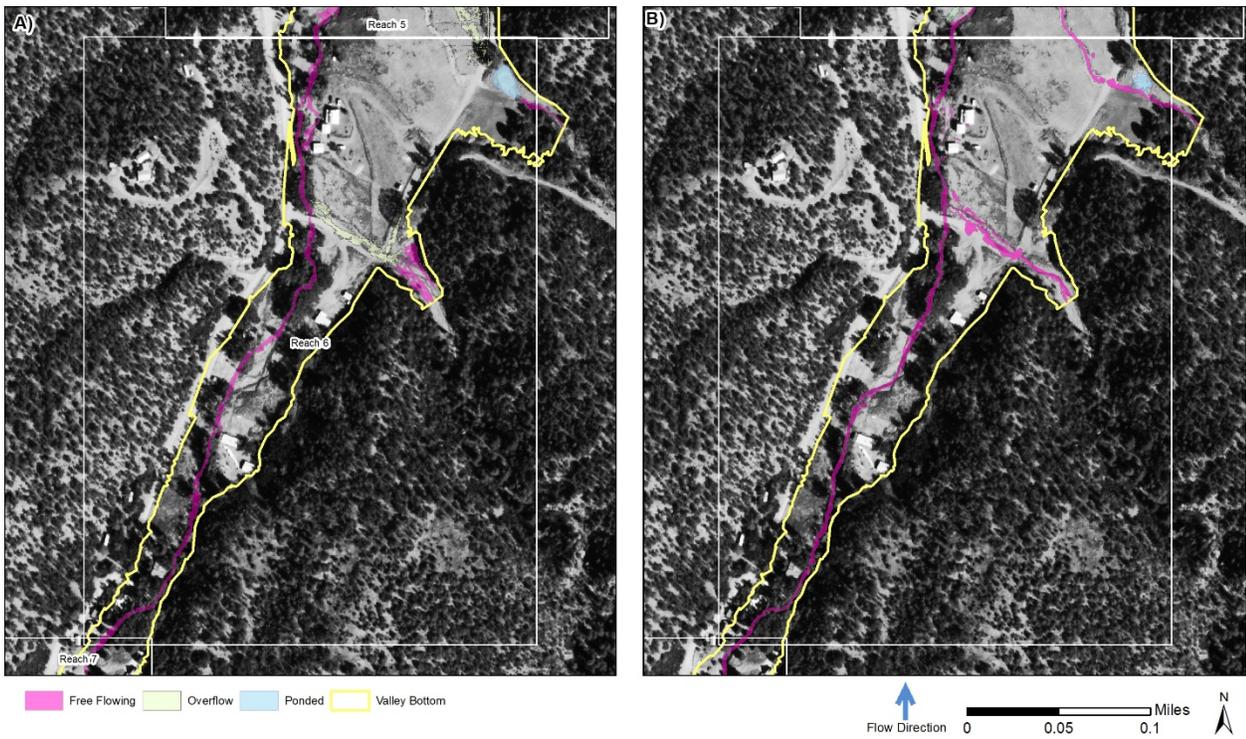
Figure A6: Reach 6 showing A) pre-fire conditions, B) post-fire conditions, and C) the valley bottom and potential restoration treatments and zone of influence of such treatments.

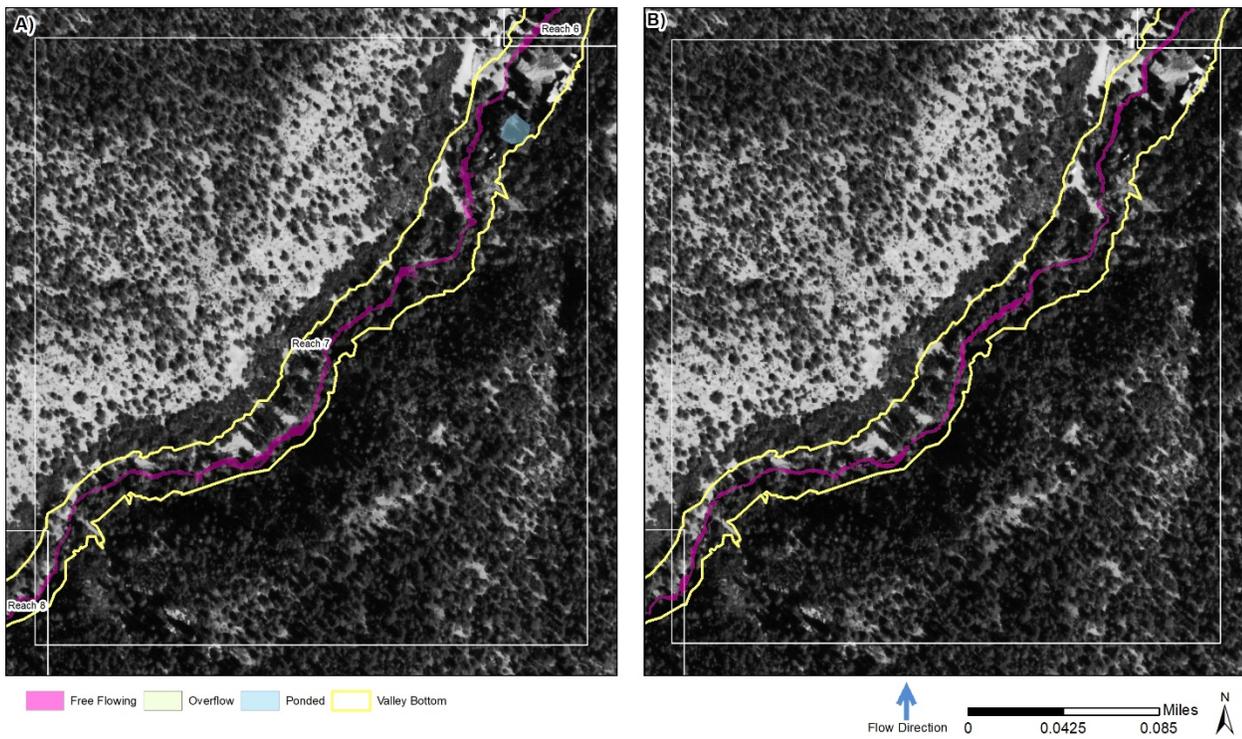
Figure A7: Reach 7 showing A) pre-fire conditions, B) post-fire conditions, and C) the valley bottom and potential restoration treatments and zone of influence of such treatments.
