Big Cottonwood Creek Recovery Plan: (5+ Yrs.) Opportunities & Recommendations

Colorado Water
Conservation Board

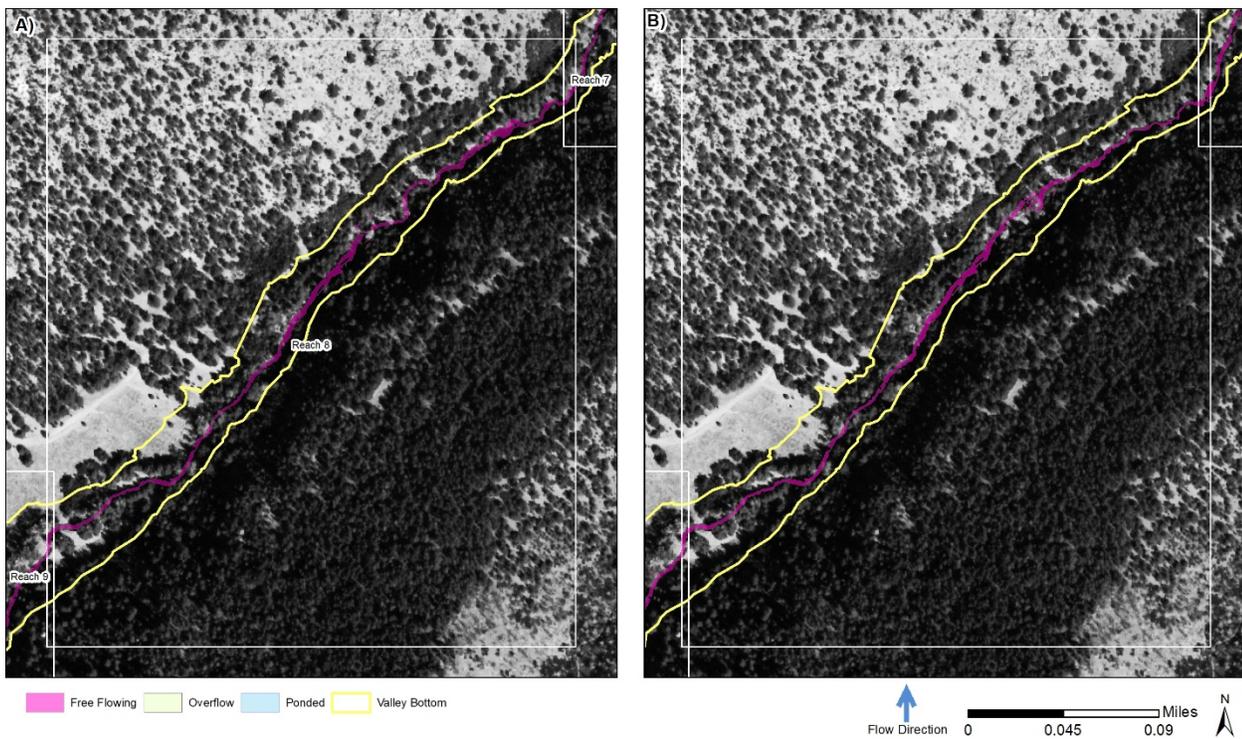
Figure A8: Reach 8 showing A) pre-fire conditions, B) post-fire conditions, and C) the valley bottom and potential restoration treatments and zone of influence of such treatments.

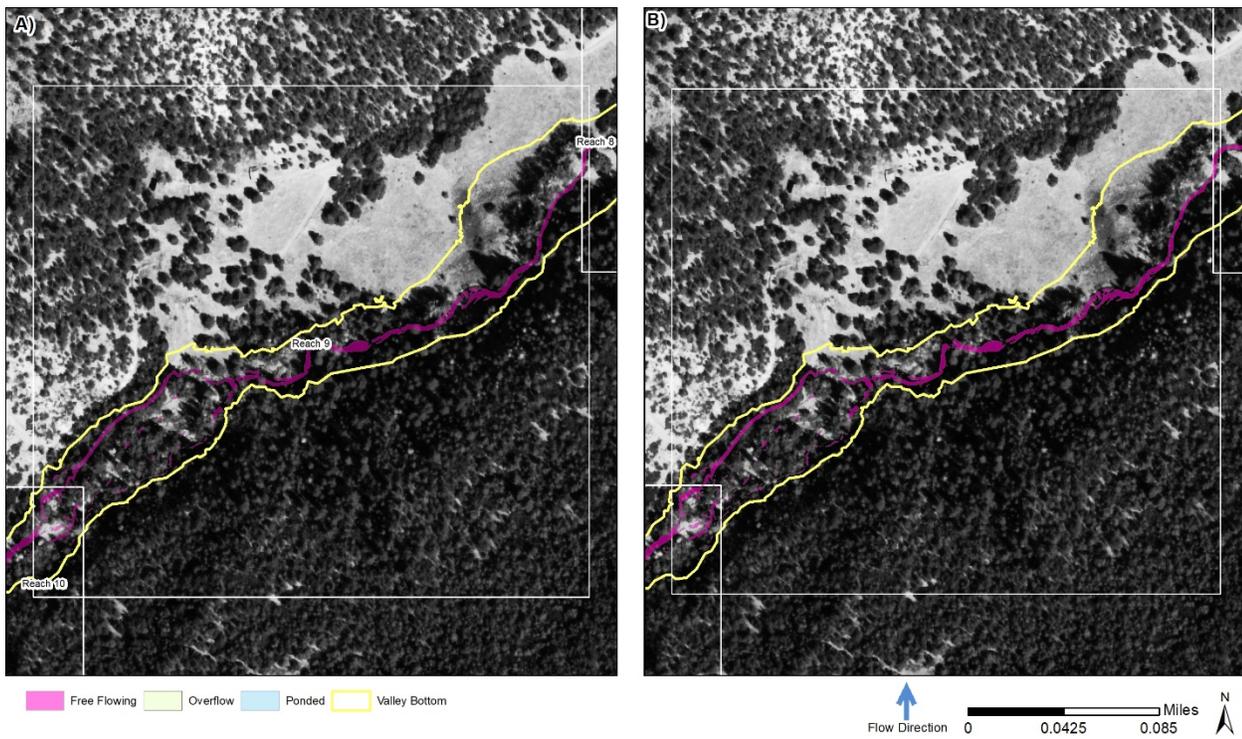
Figure A9: Reach 9 showing A) pre-fire conditions, B) post-fire conditions, and C) the valley bottom and potential restoration treatments and zone of influence of such treatments.

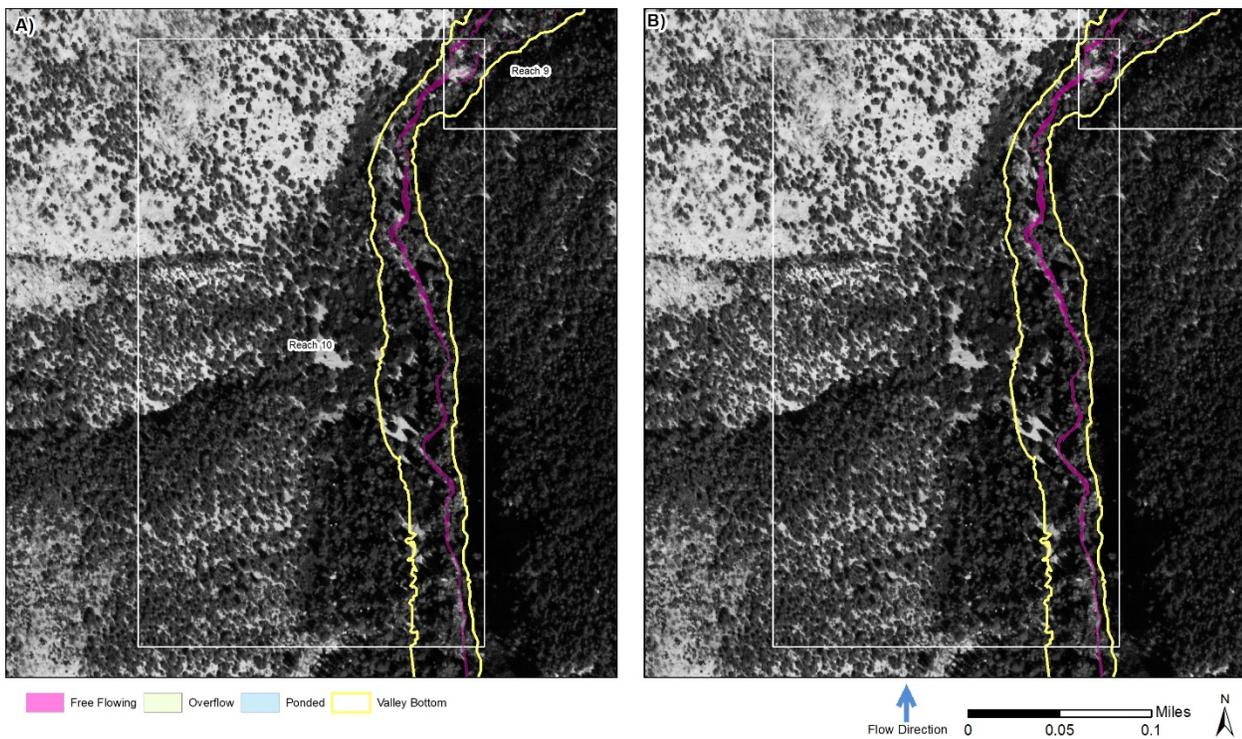
Figure A10: Reach 10 showing A) pre-fire conditions, B) post-fire conditions, and C) the valley bottom and potential restoration treatments and zone of influence of such treatments.

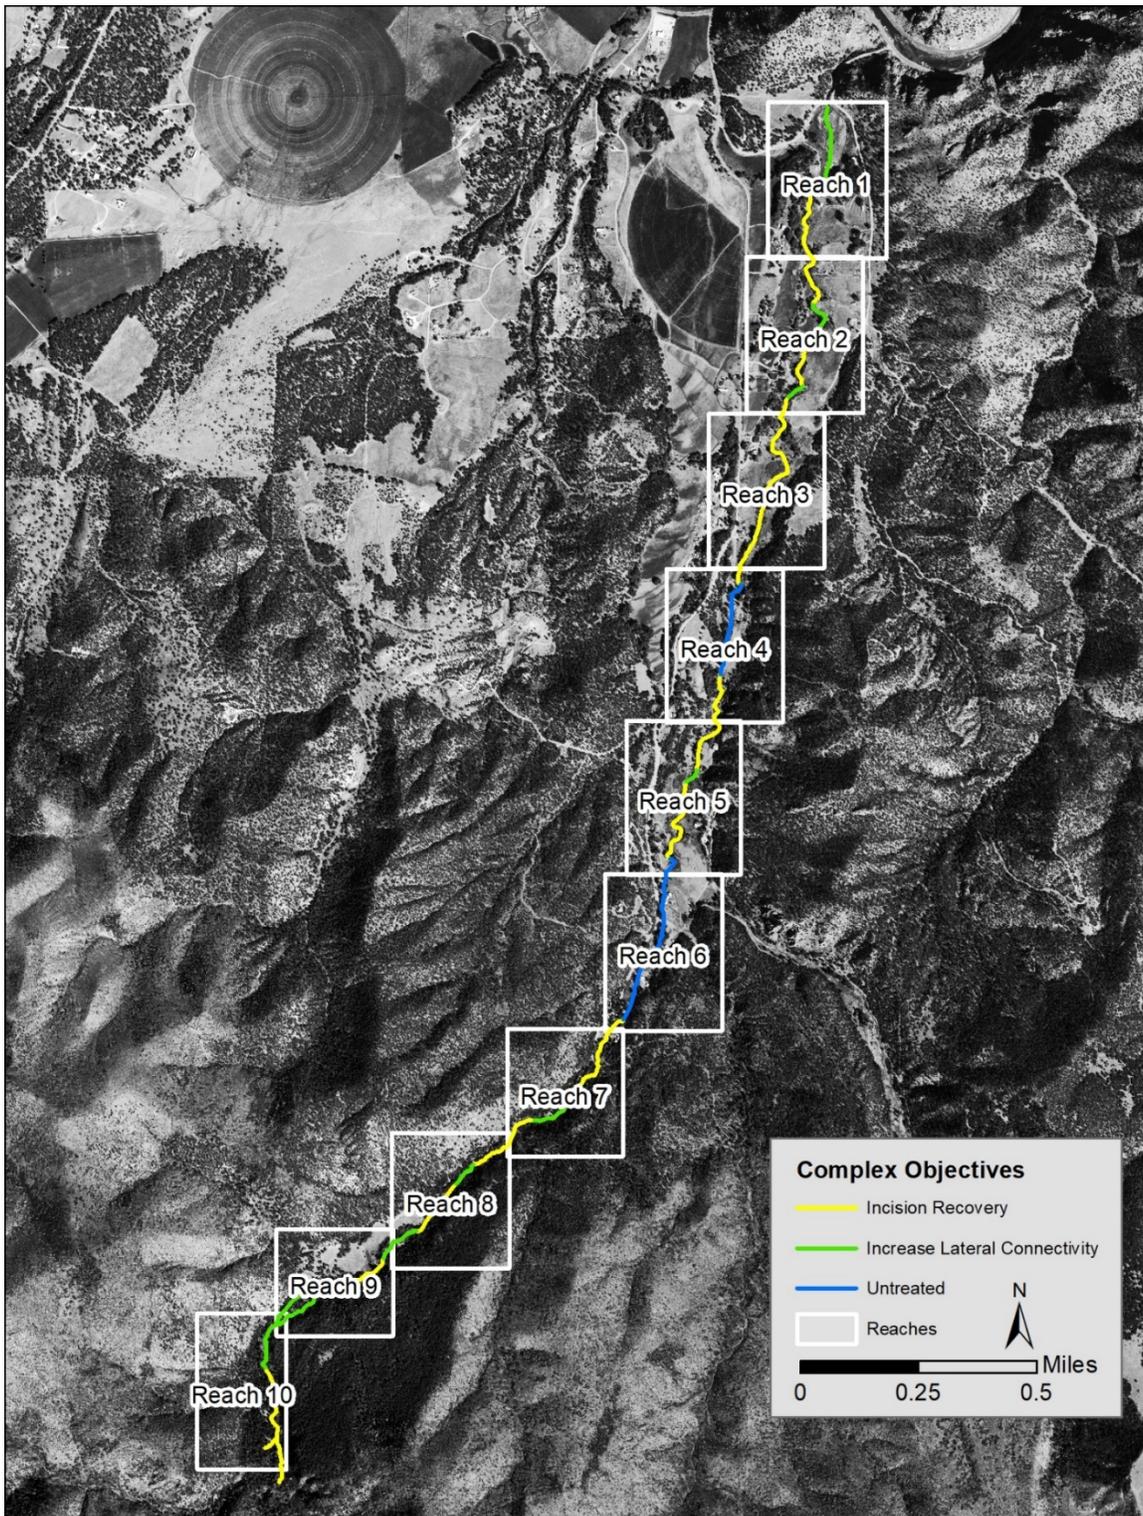
Figure B2: Reference map of individual reaches with restoration complex objectives shown.

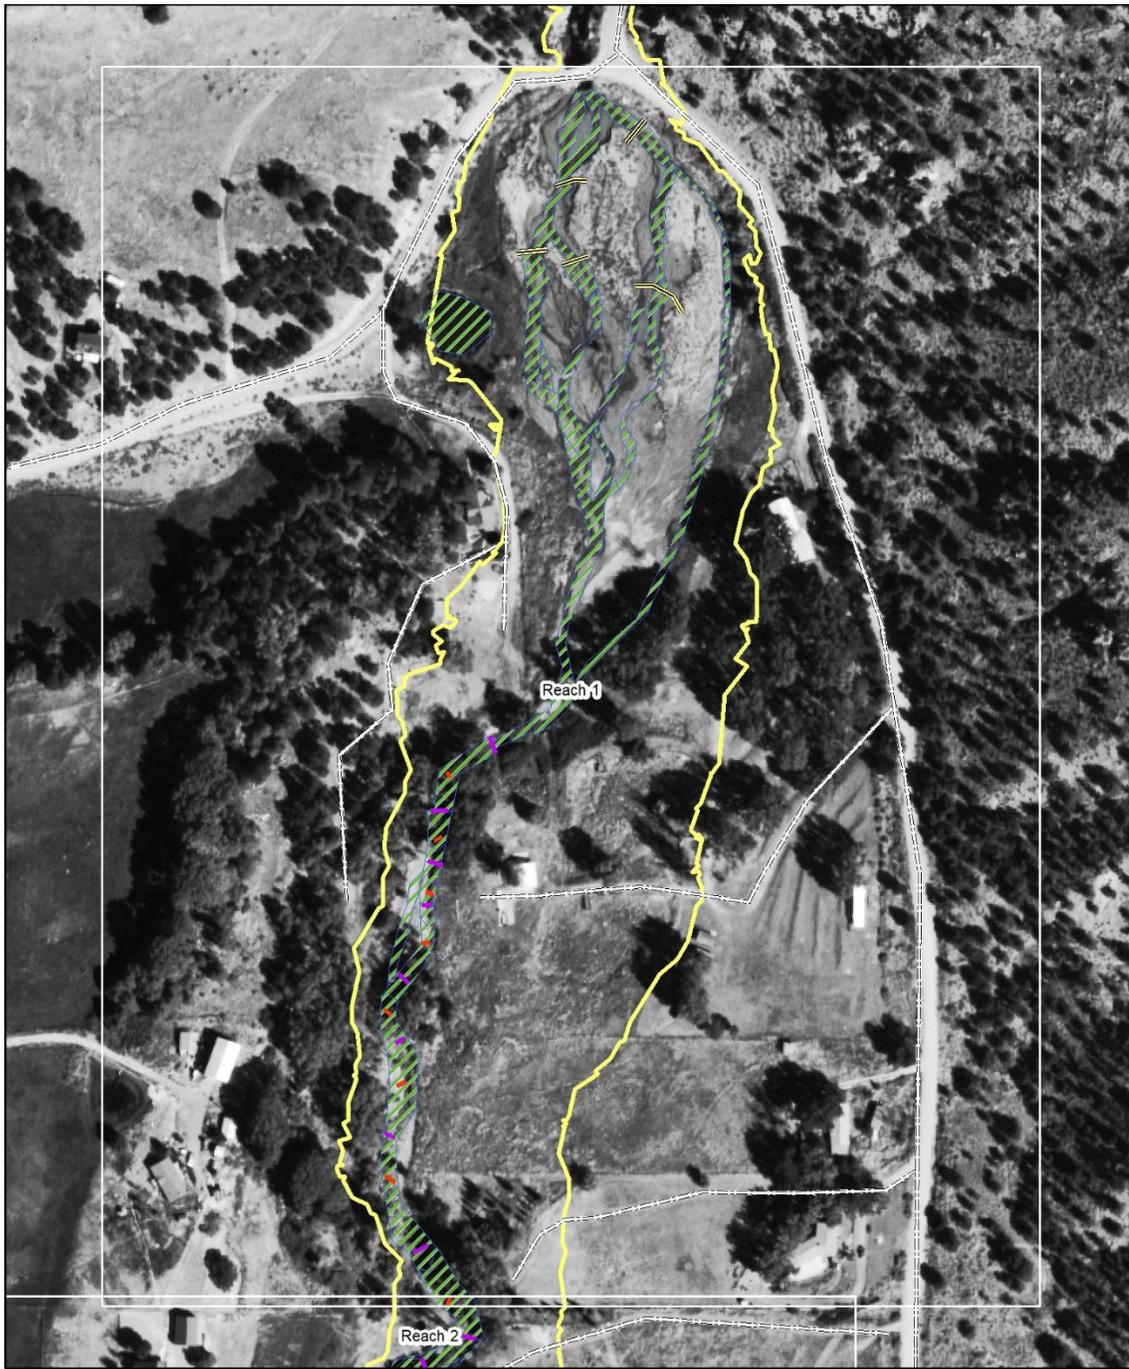
Figure B4: Reach 1 showing the valley bottom, potential restoration treatments, and the hydraulic and geomorphic zone of influence (ZOI).

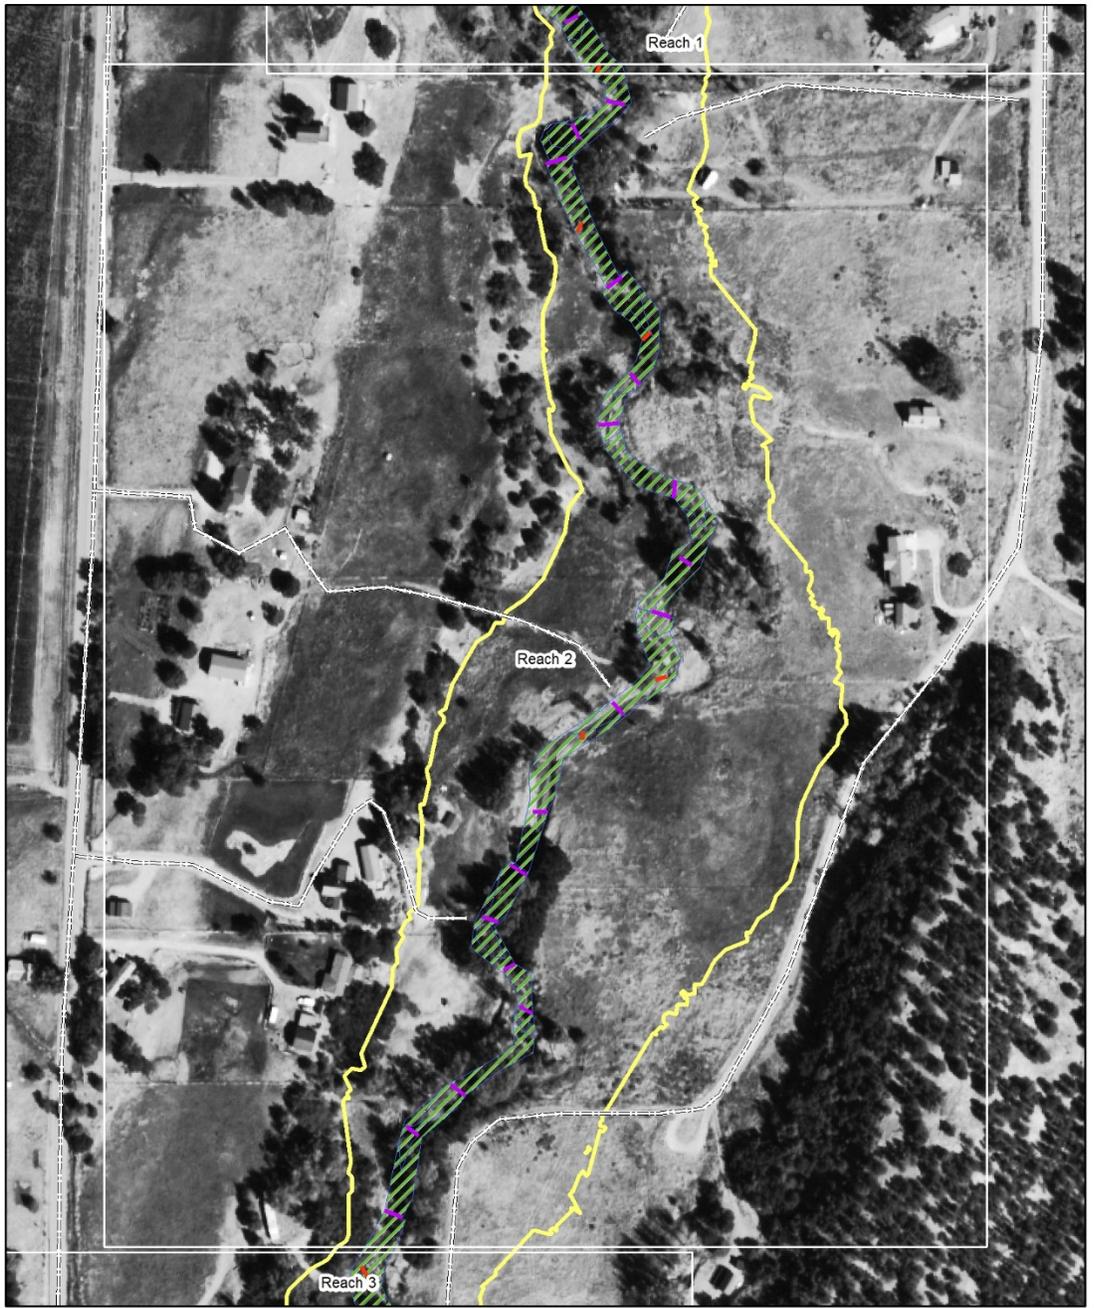
Figure B5: Reach 2 showing the valley bottom, potential restoration treatments, and the hydraulic and geomorphic zone of influence (ZOI).

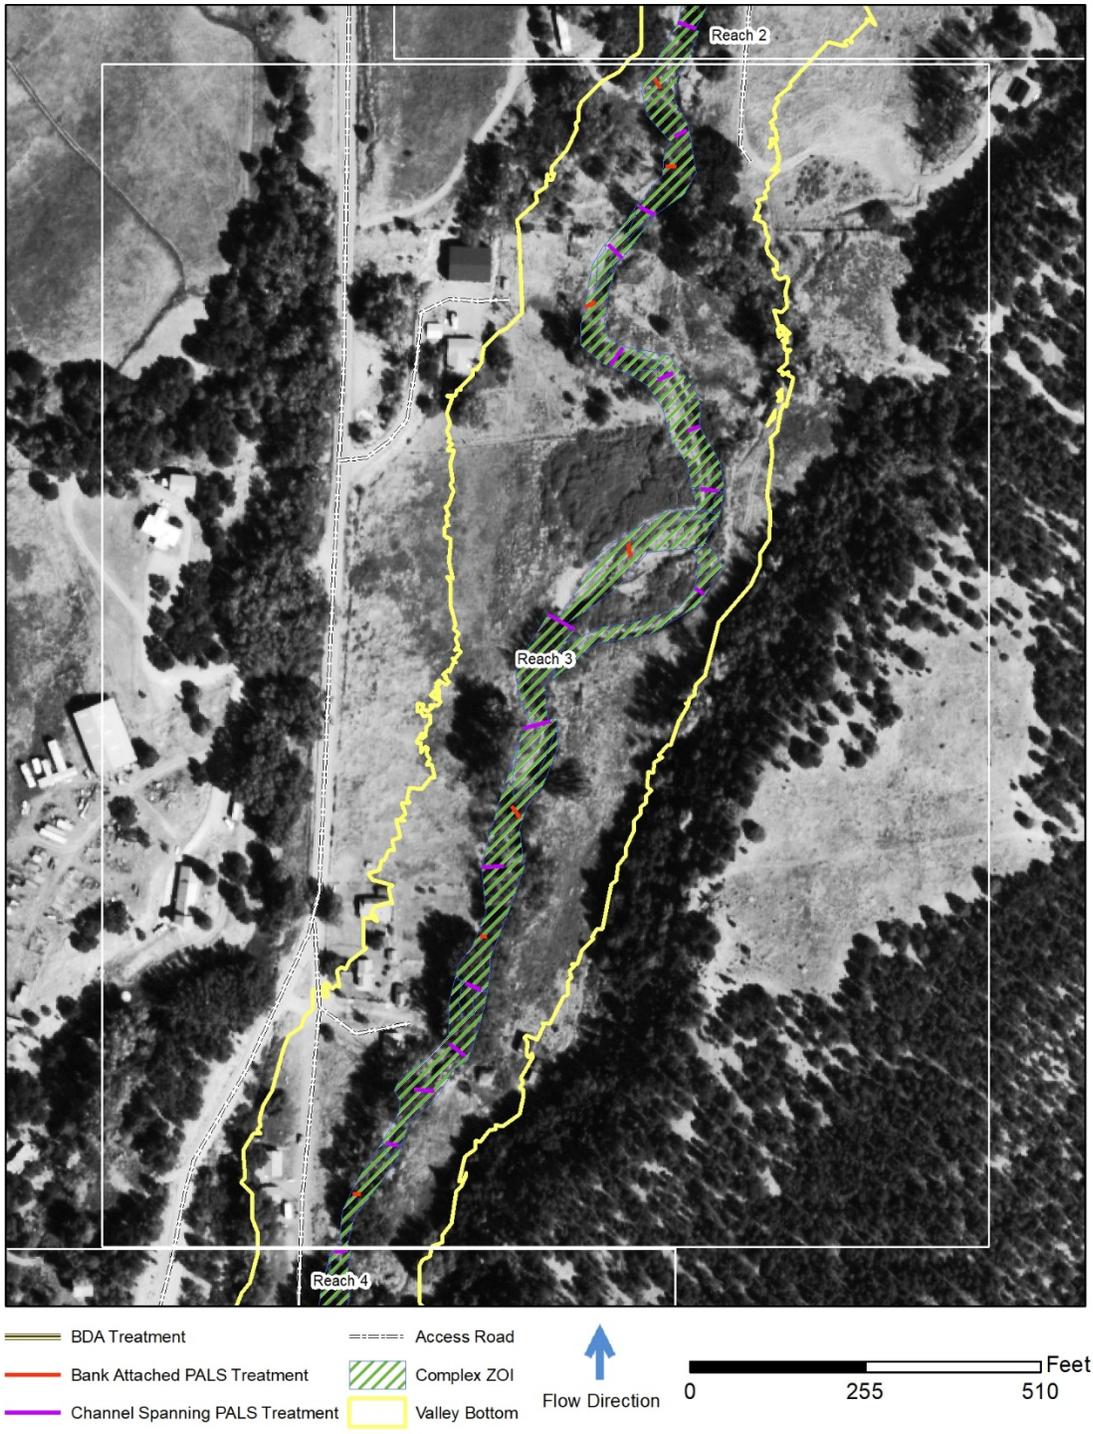
Figure B6: Reach 3 showing the valley bottom, potential restoration treatments, and the hydraulic and geomorphic zone of influence (ZOI).

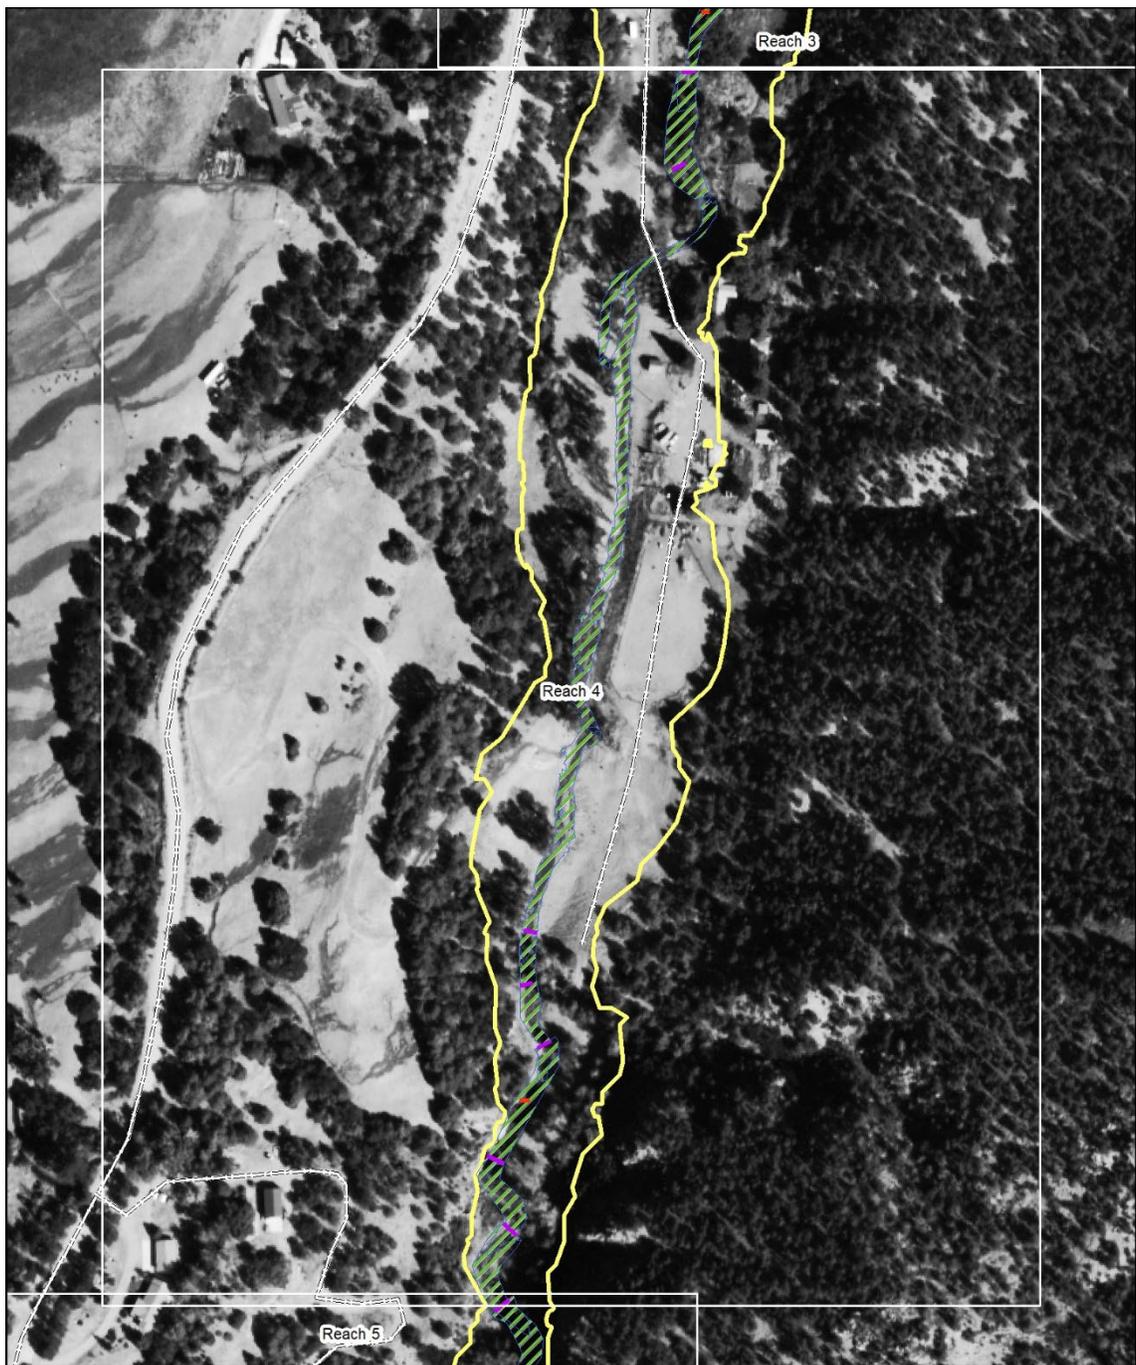
Figure B7: Reach 4 showing the valley bottom, potential restoration treatments, and the hydraulic and geomorphic zone of influence (ZOI).

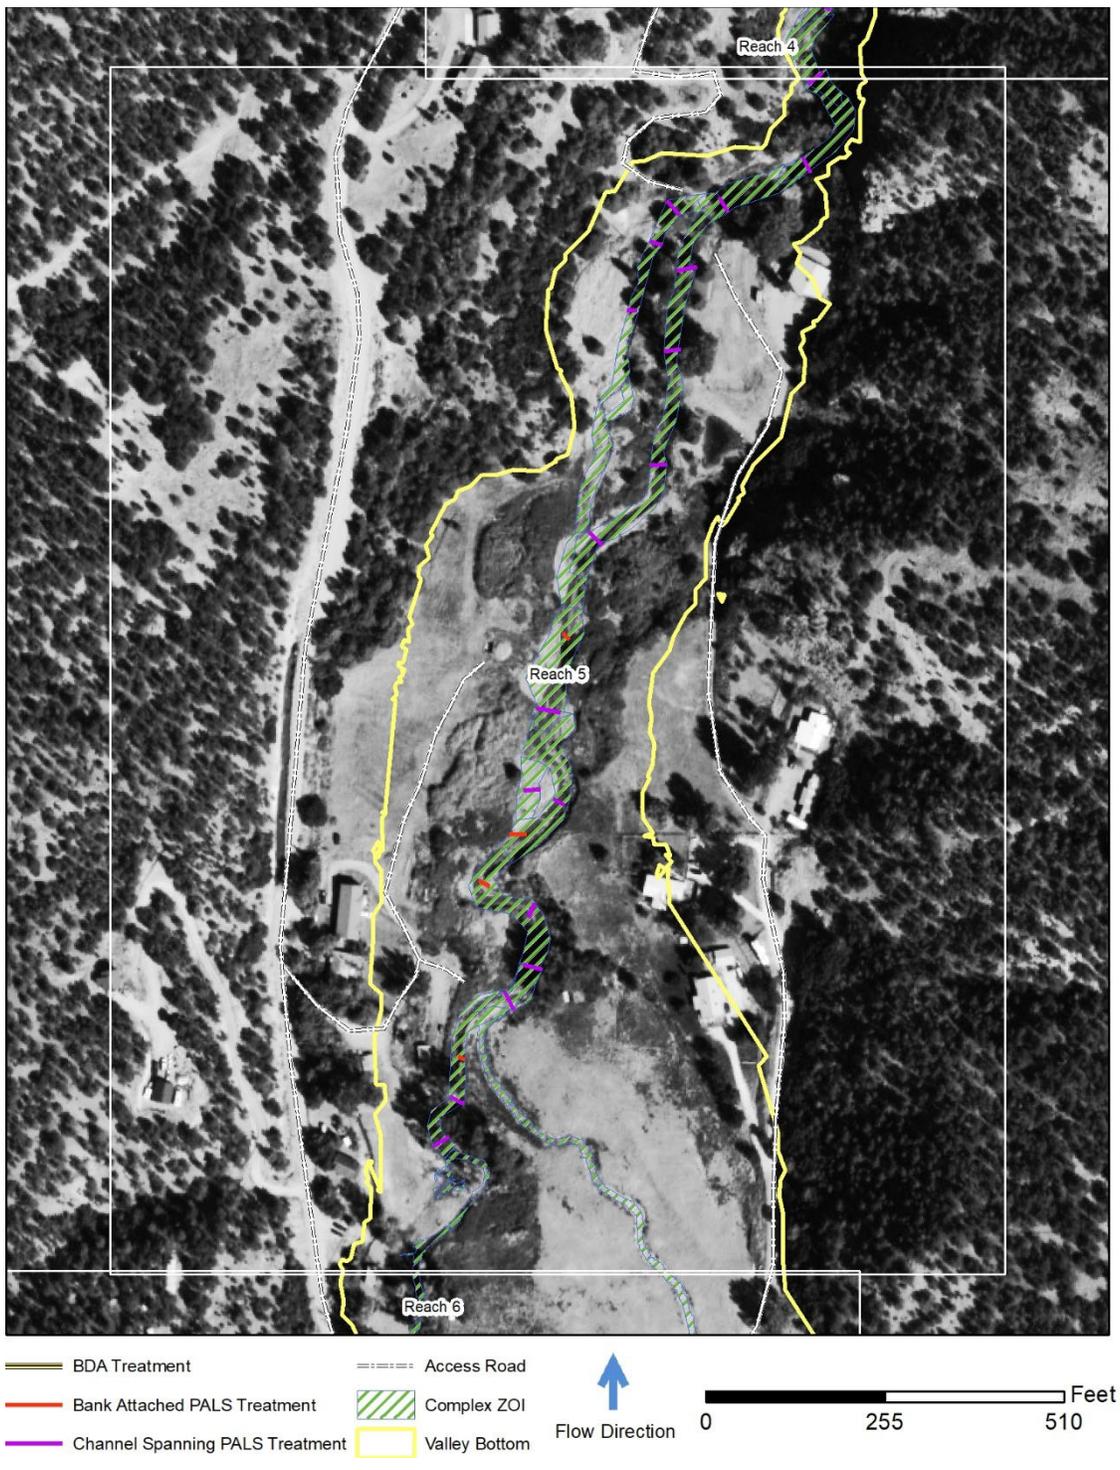
Figure B8: Reach 5 showing the valley bottom, potential restoration treatments, and the hydraulic and geomorphic zone of influence (ZOI).

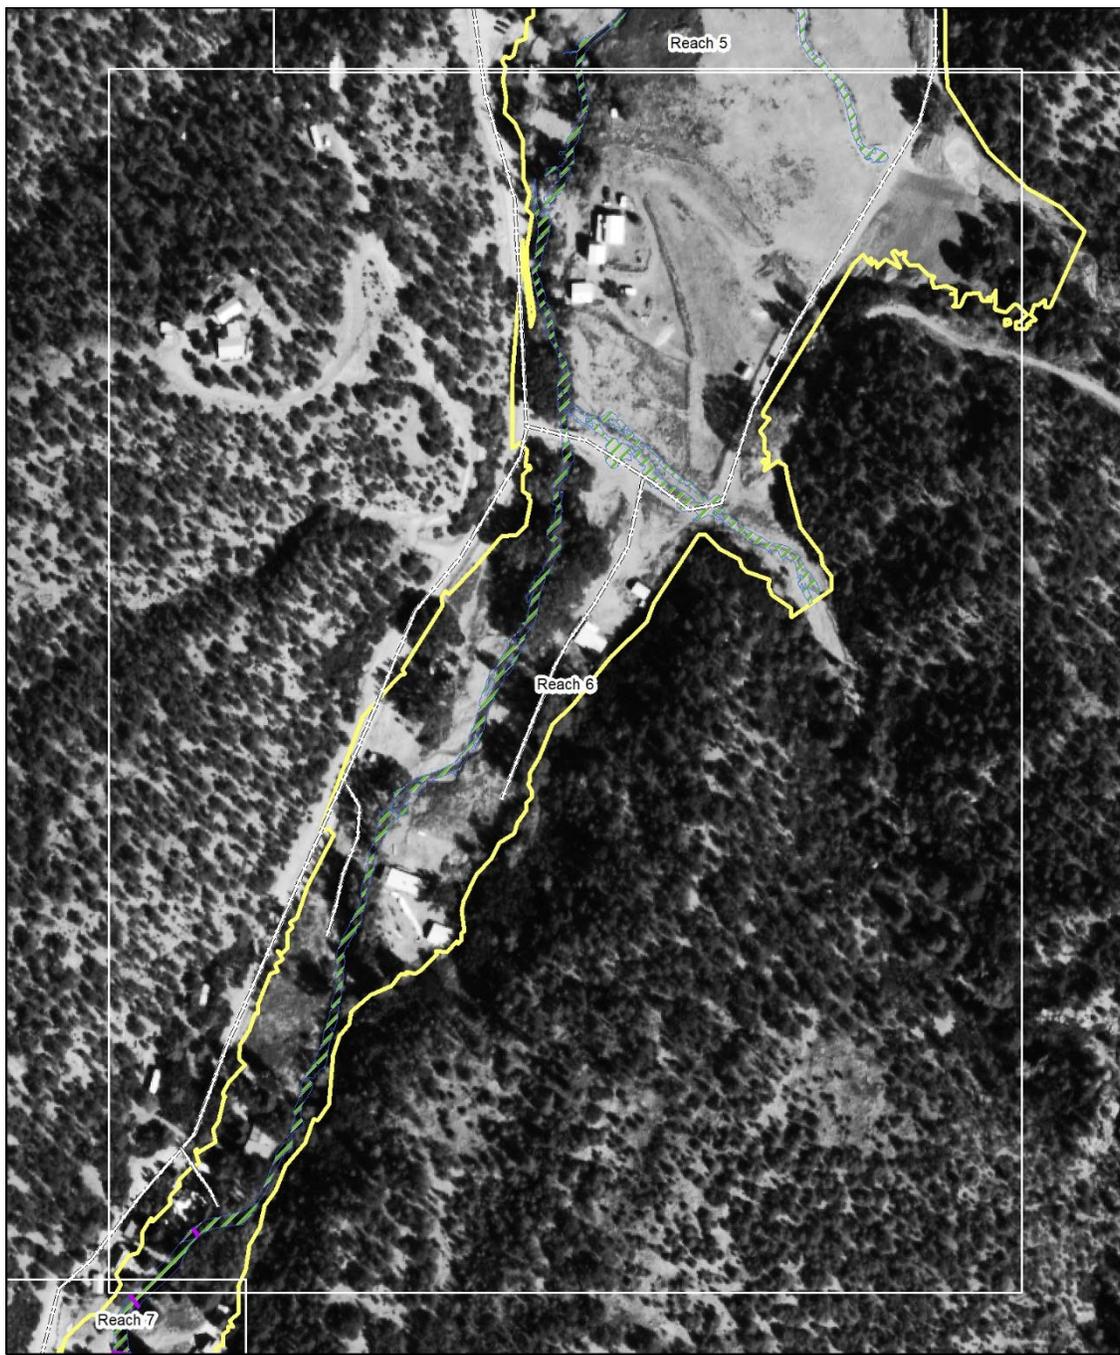
Figure B9: Reach 6 showing the valley bottom, potential restoration treatments, and the hydraulic and geomorphic zone of influence (ZOI).

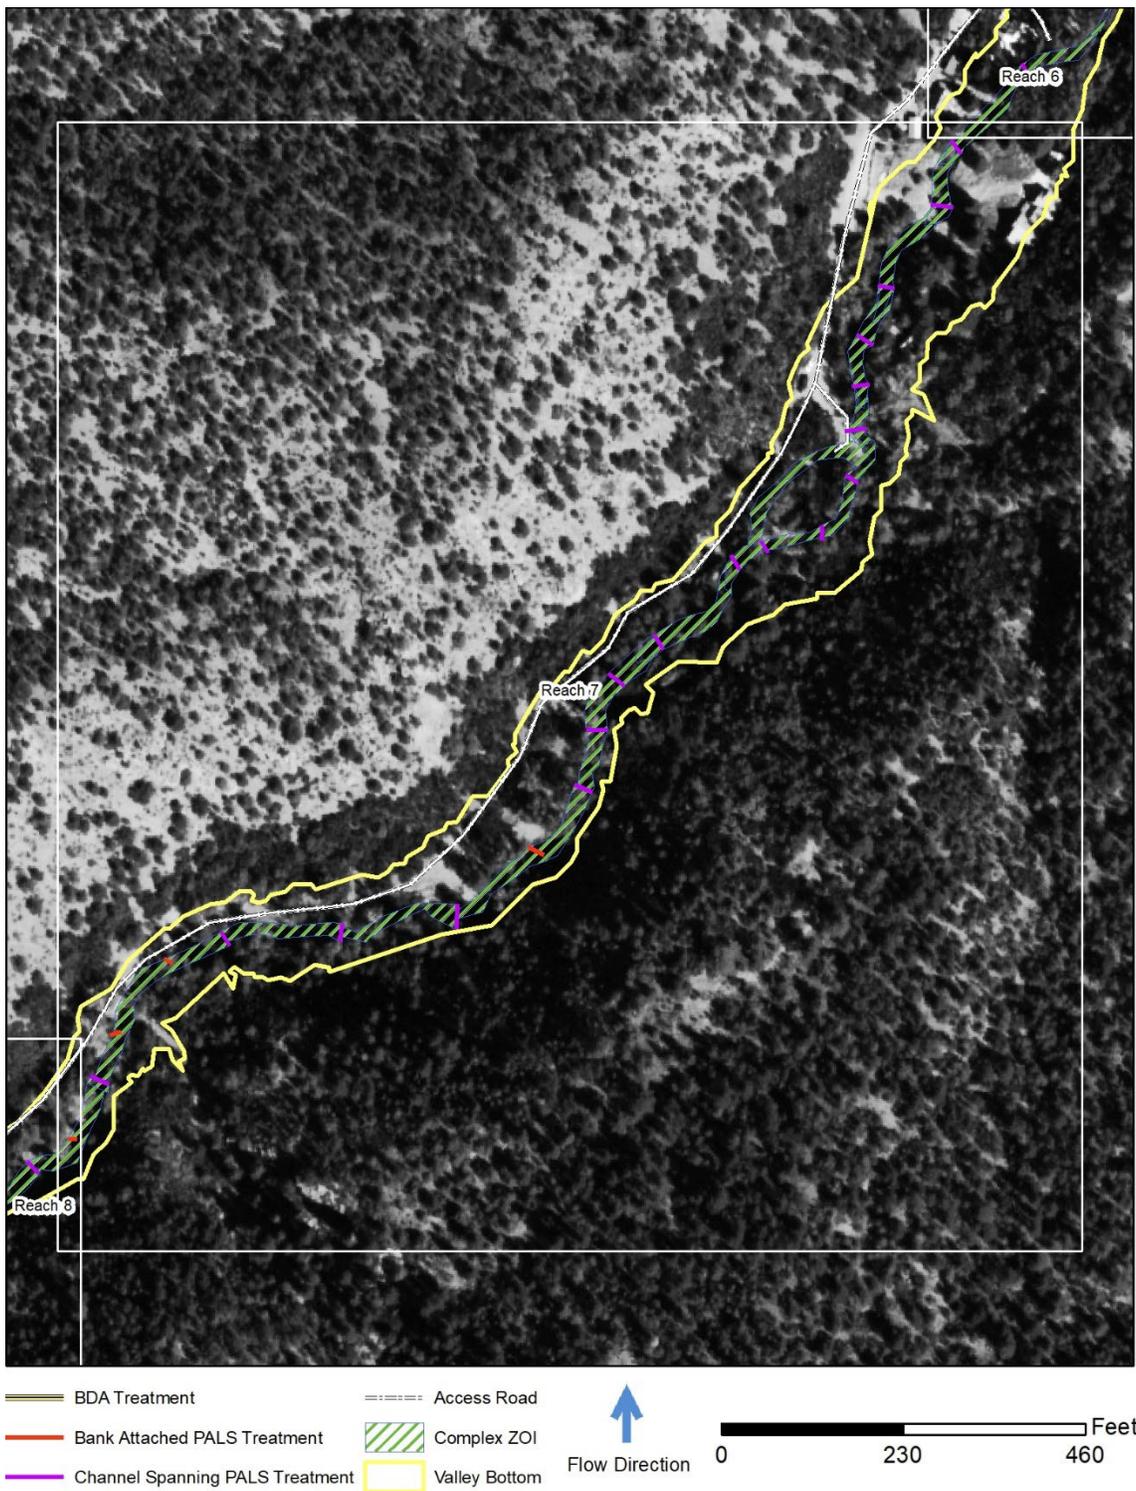
Figure B10: Reach 7 showing the valley bottom, potential restoration treatments, and the hydraulic and geomorphic zone of influence (ZOI).

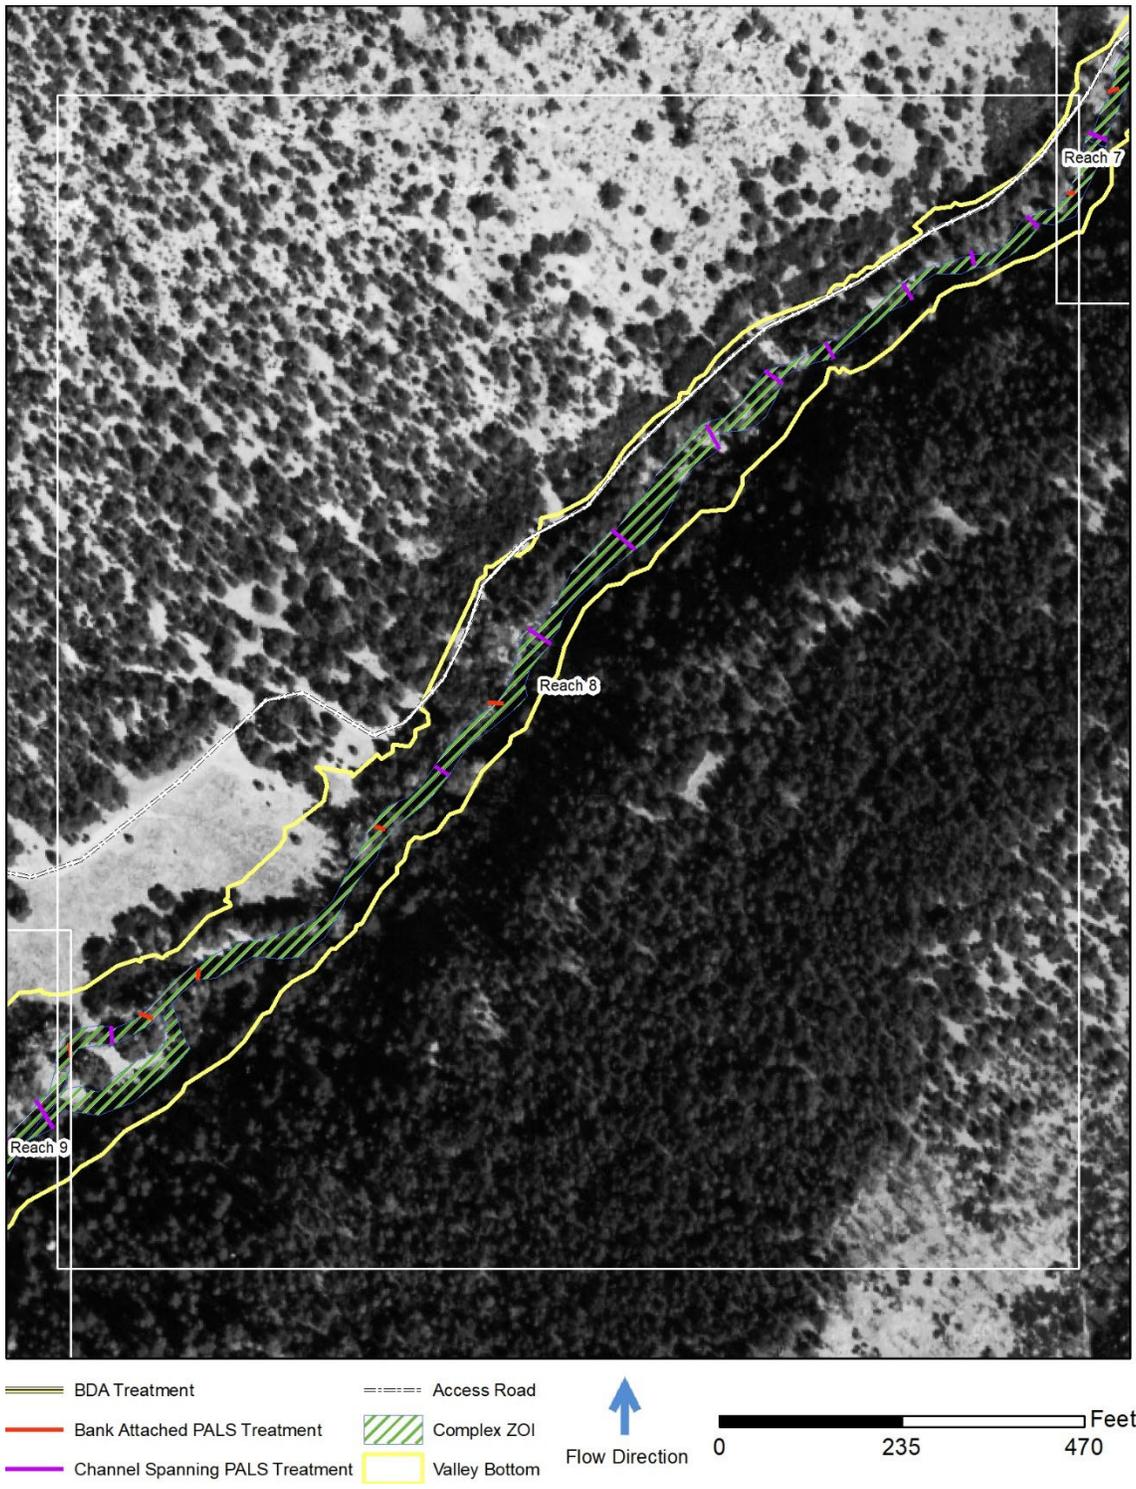
Figure B11 Reach 8 showing the valley bottom, potential restoration treatments, and the hydraulic and geomorphic zone of influence (ZOI).

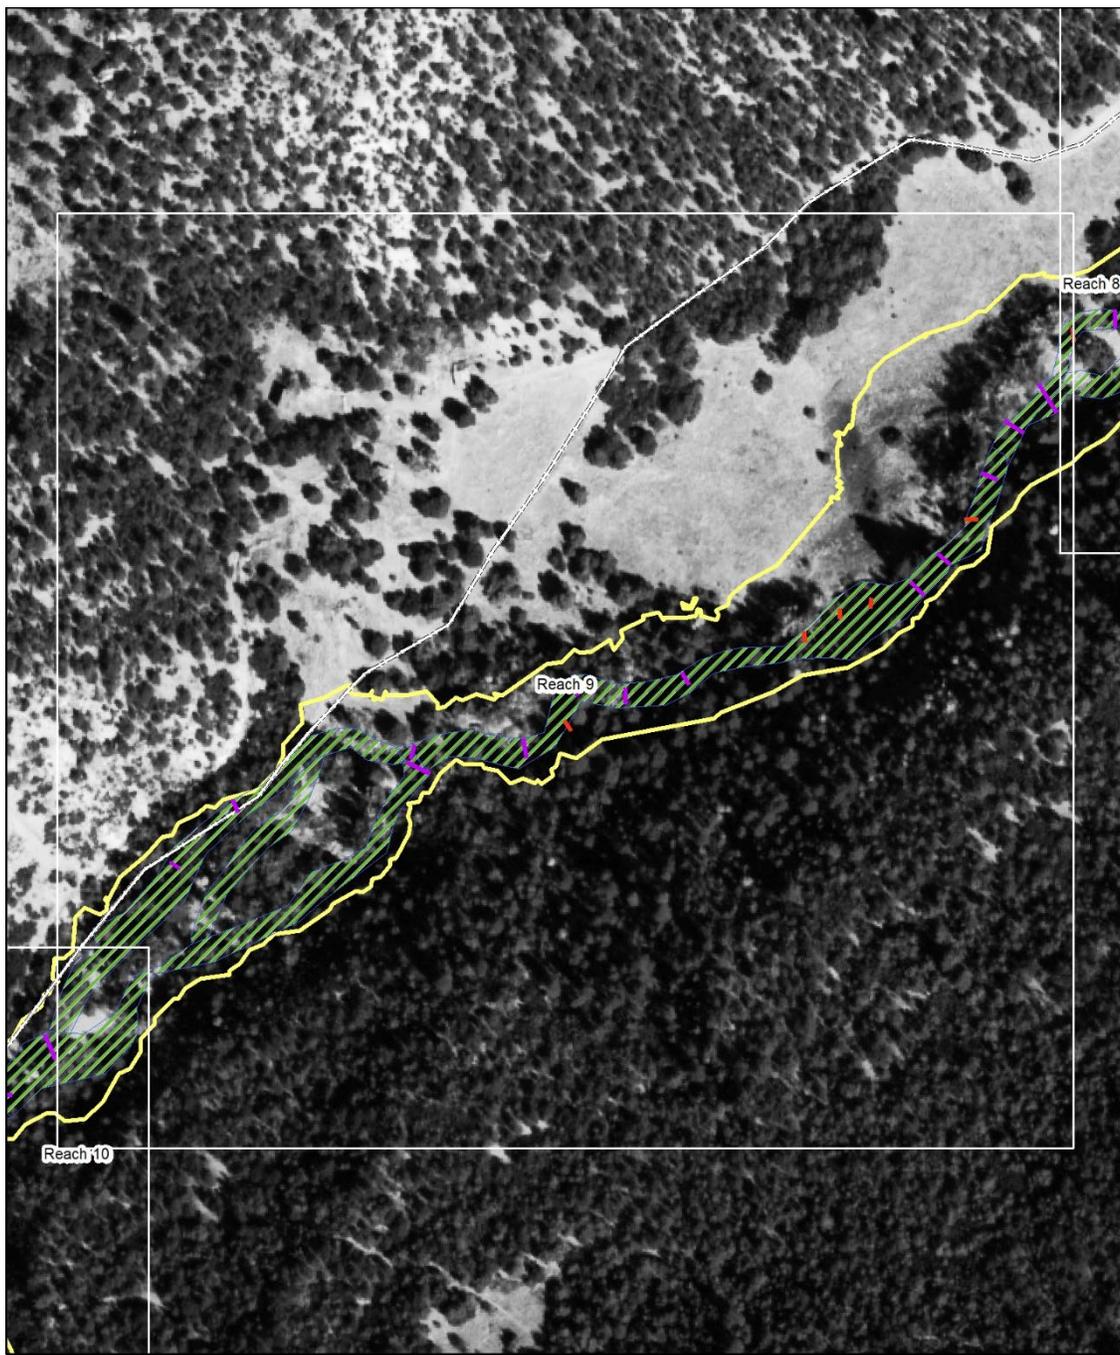
Figure B12: Reach 9 showing the valley bottom, potential restoration treatments, and the hydraulic and geomorphic zone of influence (ZOI).

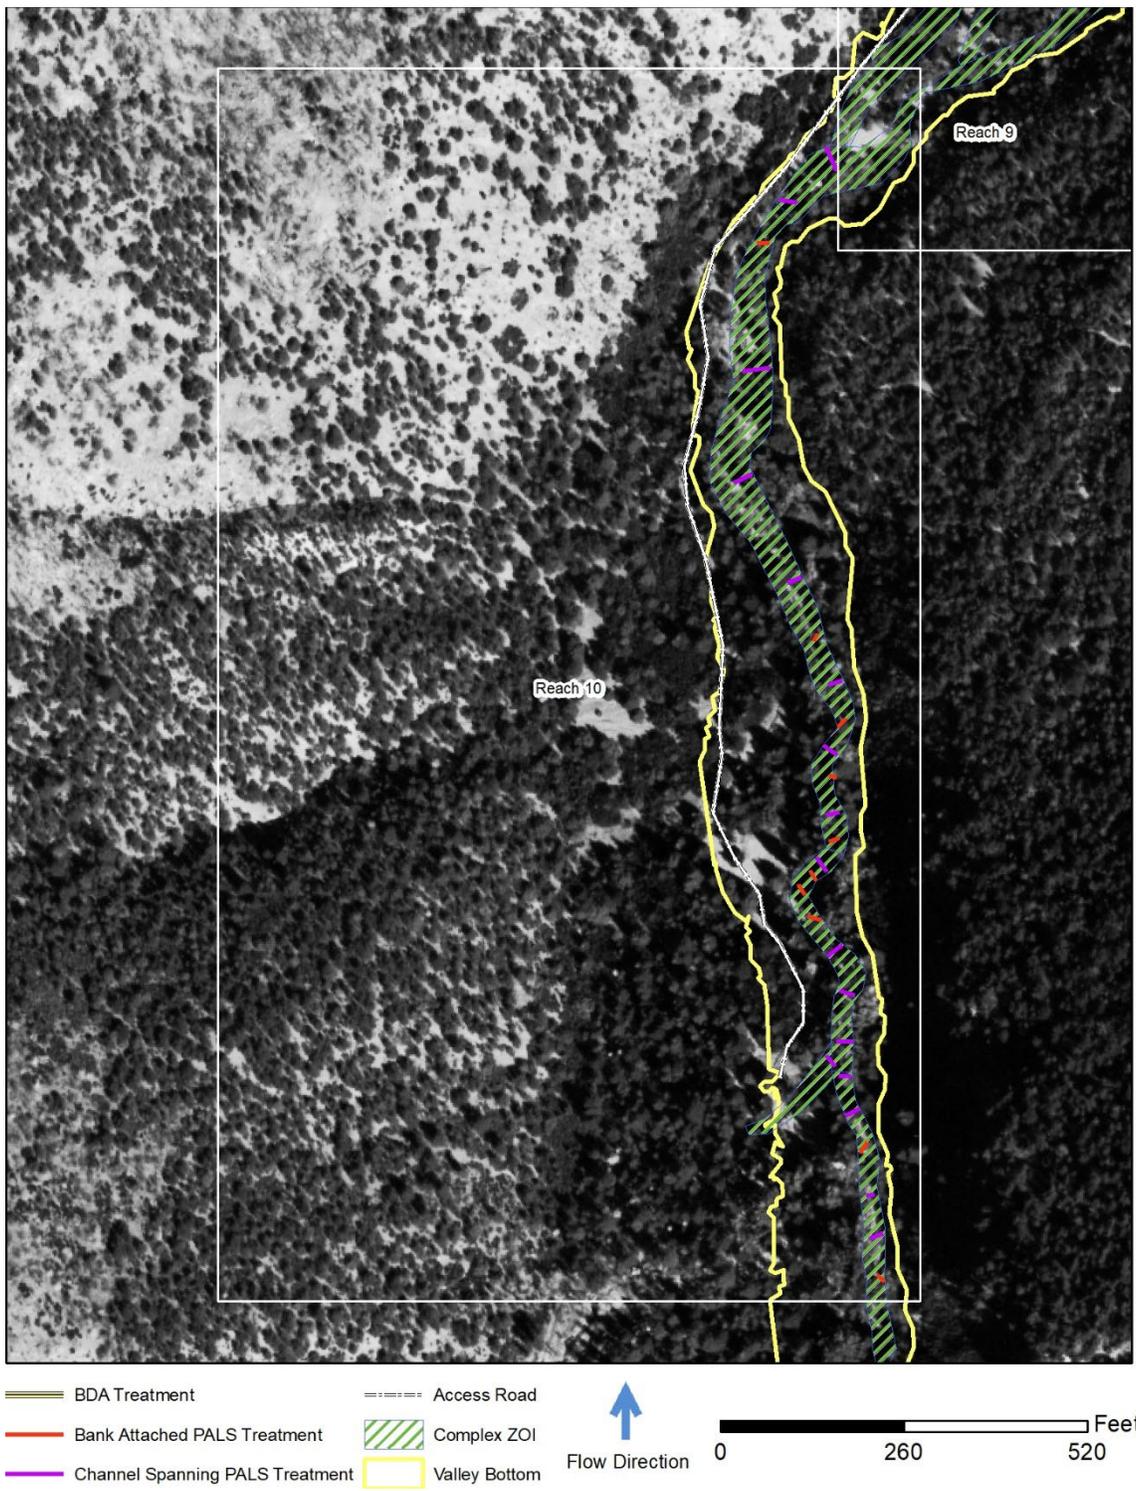
Figure B13: Reach 10 showing the valley bottom, potential restoration treatments, and the hydraulic and geomorphic zone of influence (ZOI).
