# Hayden Pass Fire – Big Cottonwood Drainage Recovery Plan | 2018

## *Hazard Characterization Report*

Arkansas River Watershed Collaborative

River Science

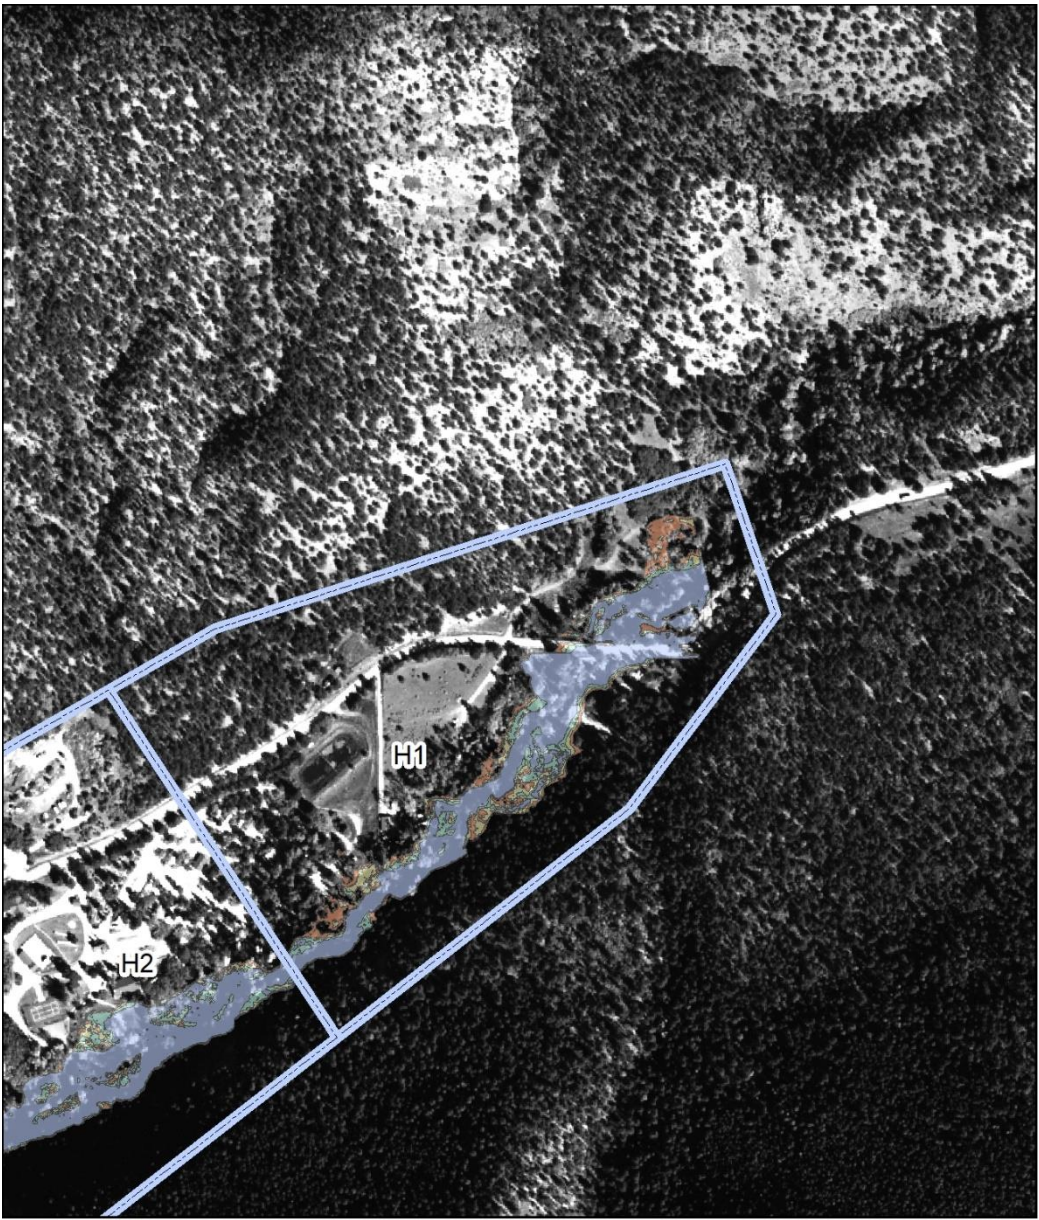
Figure A11: Hazard identification and prioritization for Reach H1 of Hayden Creek. Note: no debris, dangers, or channel issues determined in this reach.

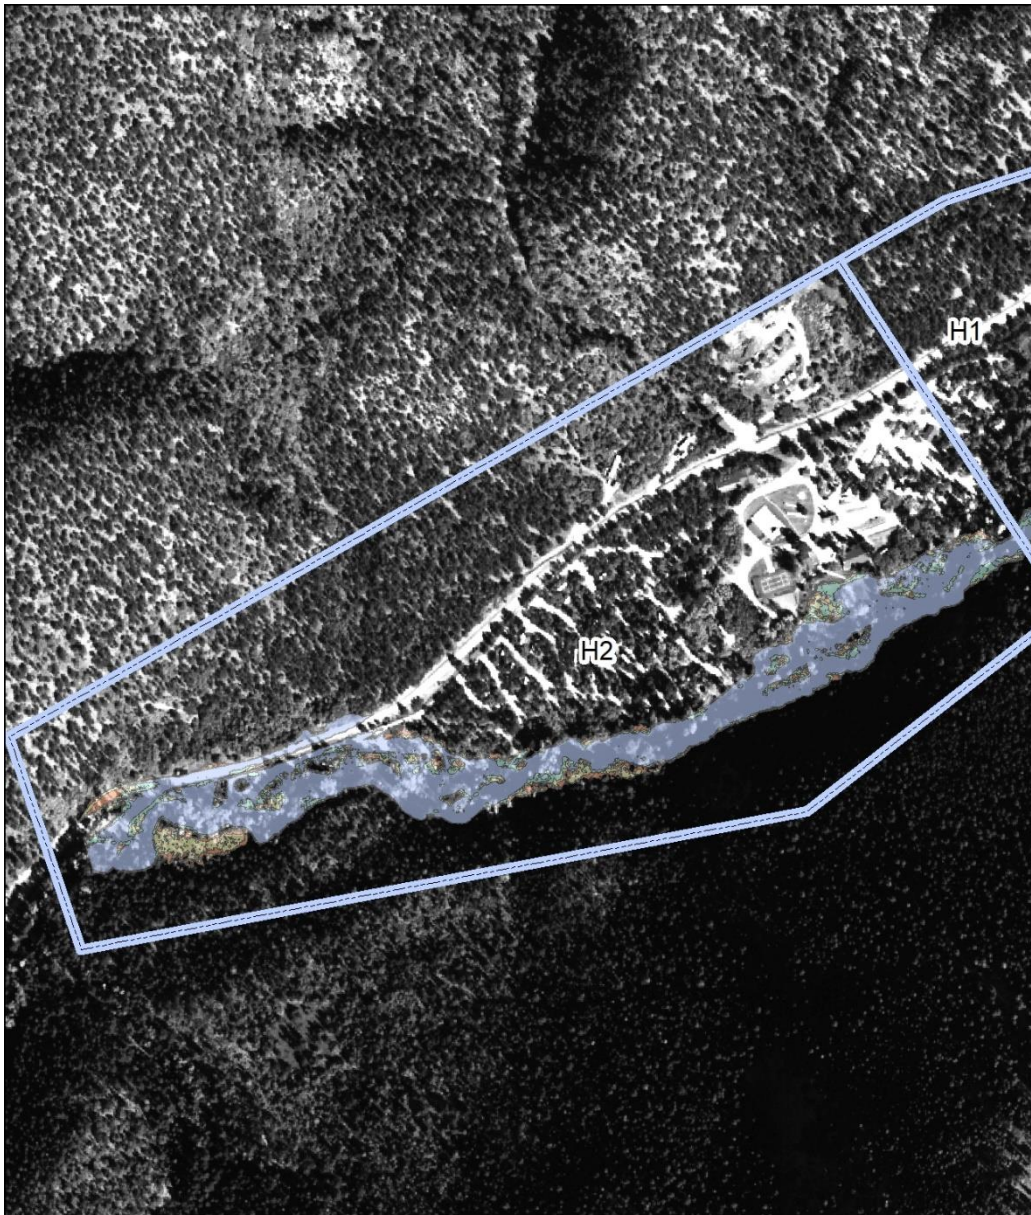
Figure A12: Hazard identification and prioritization for Reach H2 of Hayden Creek. Note: no debris, dangers, or channel issues determined in this reach.
